# Coastal Rail Resiliency Study

Initial Assessment Technical Memorandum

Cities of Dana Point and San Clemente, CA

Last Updated: February 13, 2024

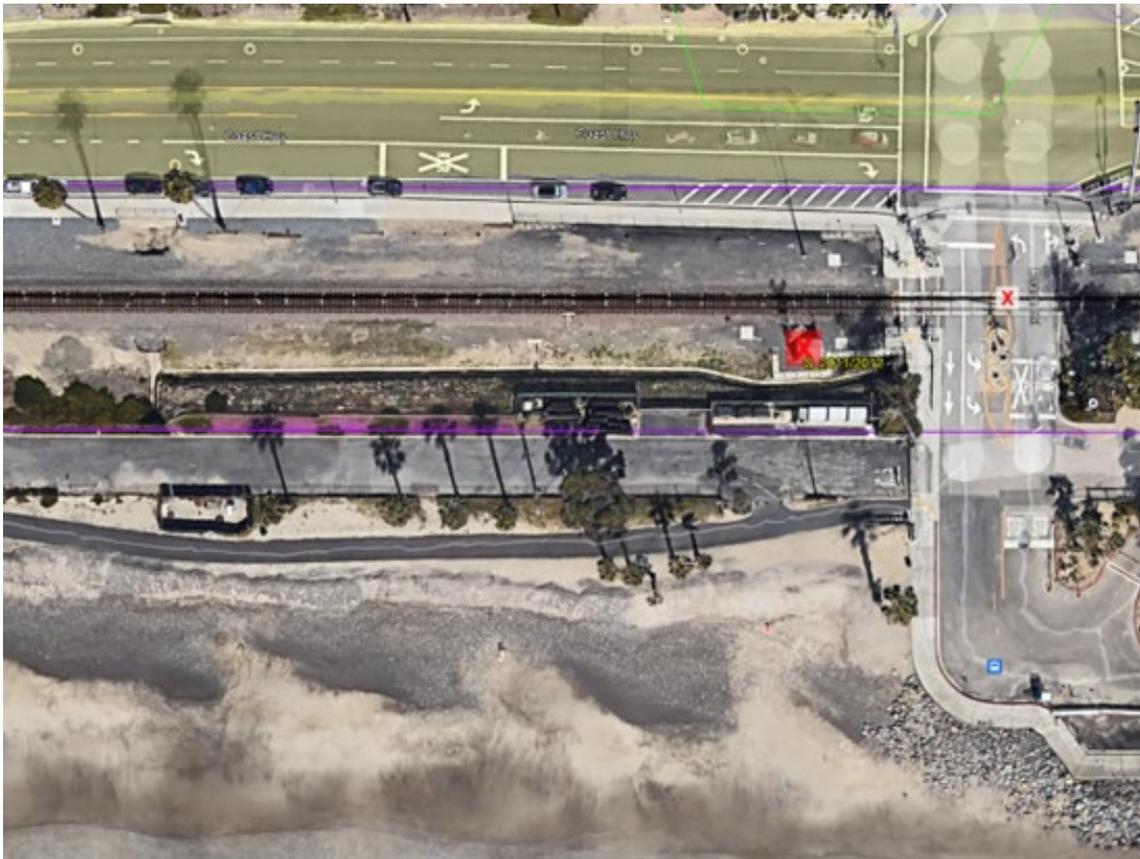
The adjacent shoreline infrastructure at Doheny State Beach (see Figure 6) to the west and Capistrano Beach Park to the east have experienced erosion, and erosion control measures have been implemented. The project team recommends shoreline monitoring in this area where beach has not yet eroded to the point of imminent threat to the rail but may do so in the future. Semi-annual monitoring concurrent with spring/fall beach monitoring is recommended.

**Figure 6. Monitoring Site 1: South Doheny Beach Erosion near Parking Lot**

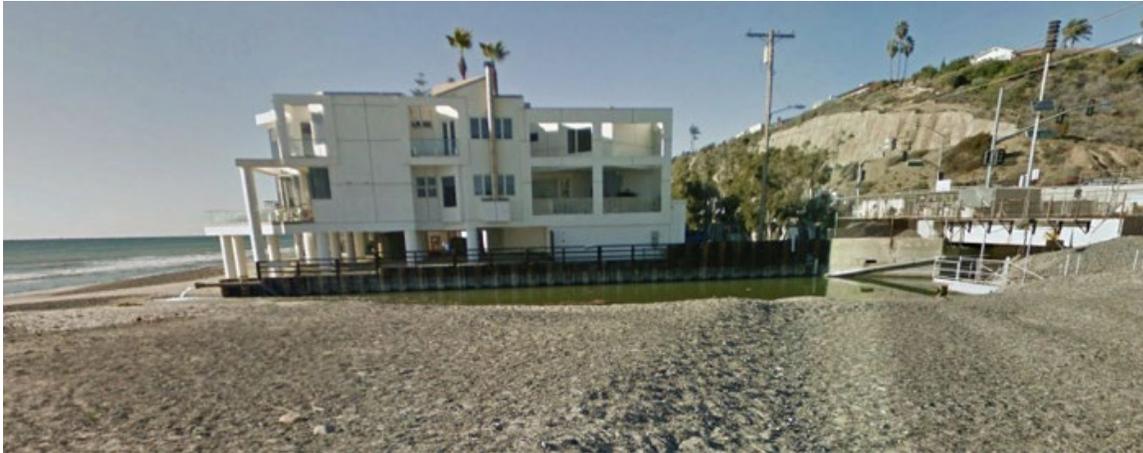
Outfalls and drainages allow waves to propagate inland, and in combination with ongoing beach erosion may erode the rail ROW in future. Quarterly monitoring is recommended. See Figure 7.

**Figure 7. Monitoring Site 2: MP 202.70, Poche Beach Outfall and Pedestrian Underpass**

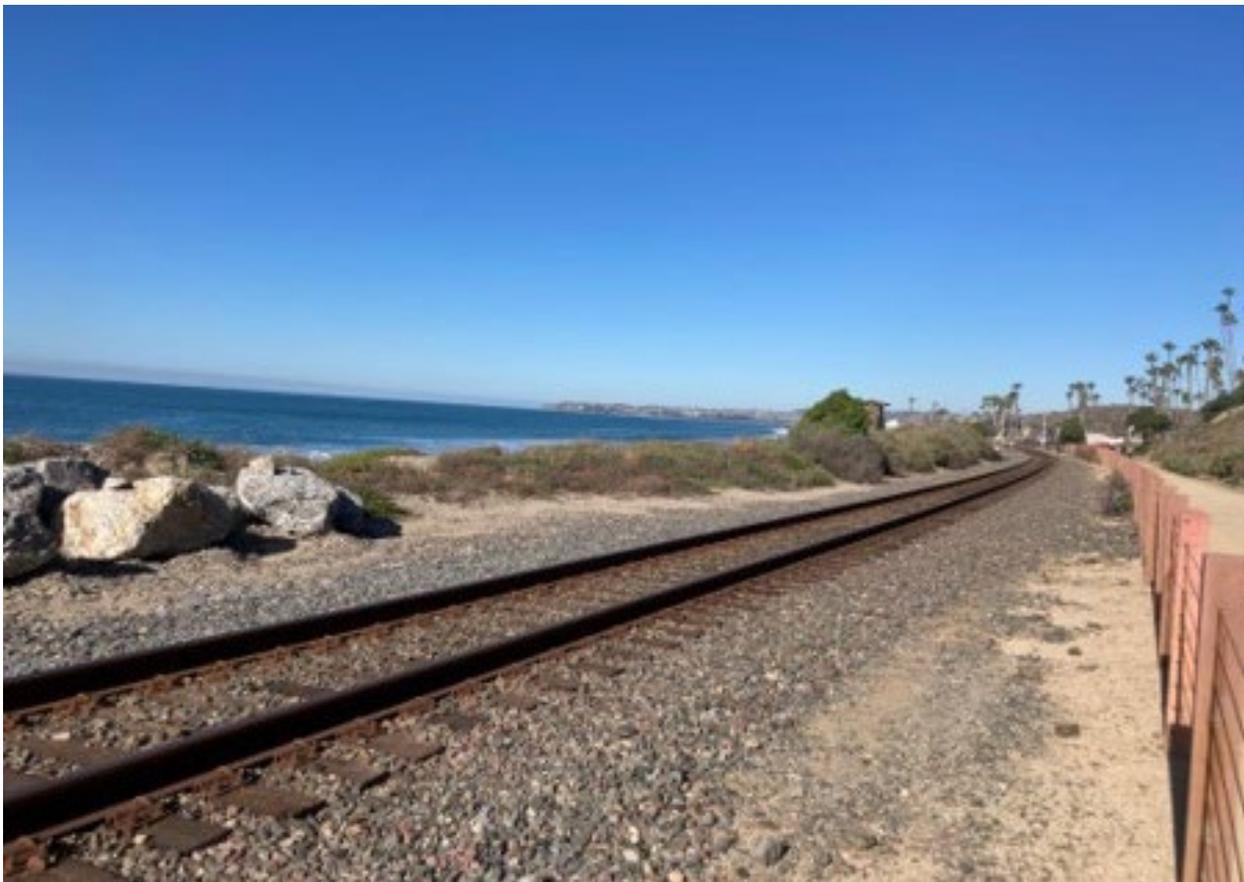
There is ongoing coastal erosion at the base of the riprap slope causing stone to be undermined and dislodged downslope. This reach should be monitored as part of the coastal shoreline monitoring program. See Figure 8.

**Figure 8. Monitoring Site 3: MP 203.65, North Beach, November 2023**

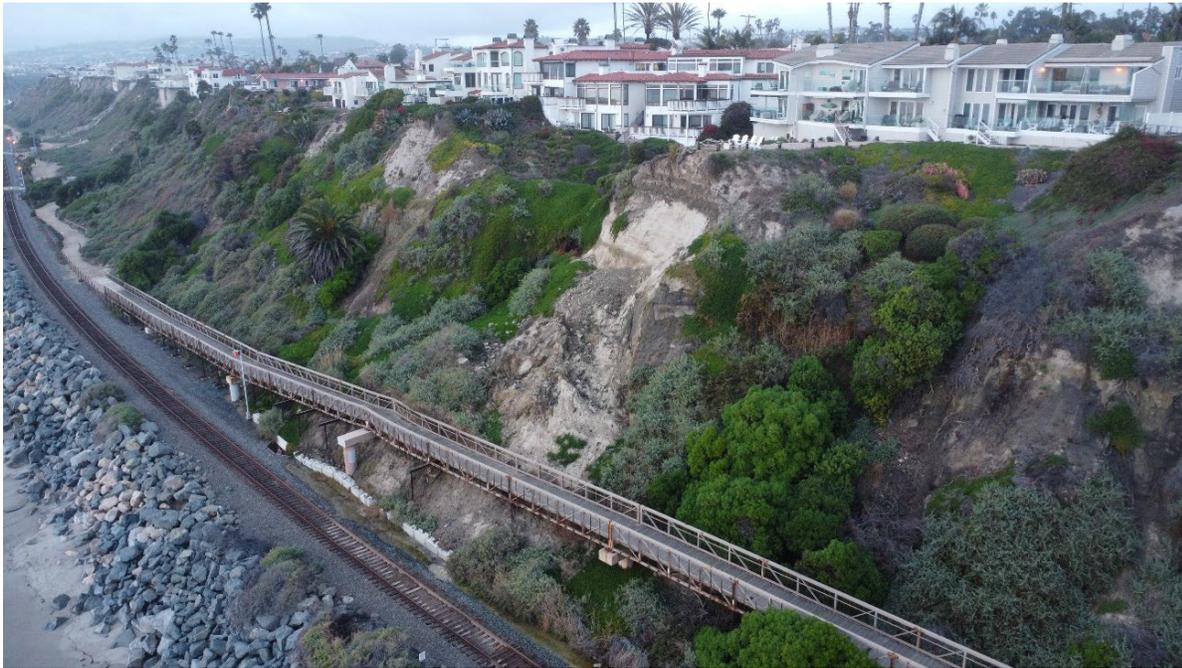
There is ongoing coastal (beach) erosion along the base of riprap slopes causing stone to be undermined and dislodged seaward. This reach should be monitored as part of the coastal shoreline monitoring program. See Figure 9.

**Figure 9. Monitoring Sites 4 and 5: MP 204.00–204.30, Mariposa Pedestrian Bridge – January 21, 2024.**

The project team recommends installation of a series of slope monitoring equipment such as inclinometers, tilt sensors, gauges, etc. along an approximately 1,000-linear foot rail corridor section, between the rail corridor and existing pedestrian bridge. Casings should be installed approximately 100 feet on-center and penetrate saturated surficial sediments (fill, colluvium, slide debris), and extend into competent bedrock at depth. Baseline readings (monitoring) should be performed during the week following installation. Future rounds of monitoring should be conducted twice within the next month and once a month thereafter for a year. Subsequent readings should be performed twice annually. Monitoring should also take place following significant events that could potentially manifest in track movement, including, but not limited, to future earthquakes, bluff failures, significant storms, or significant beach erosion.

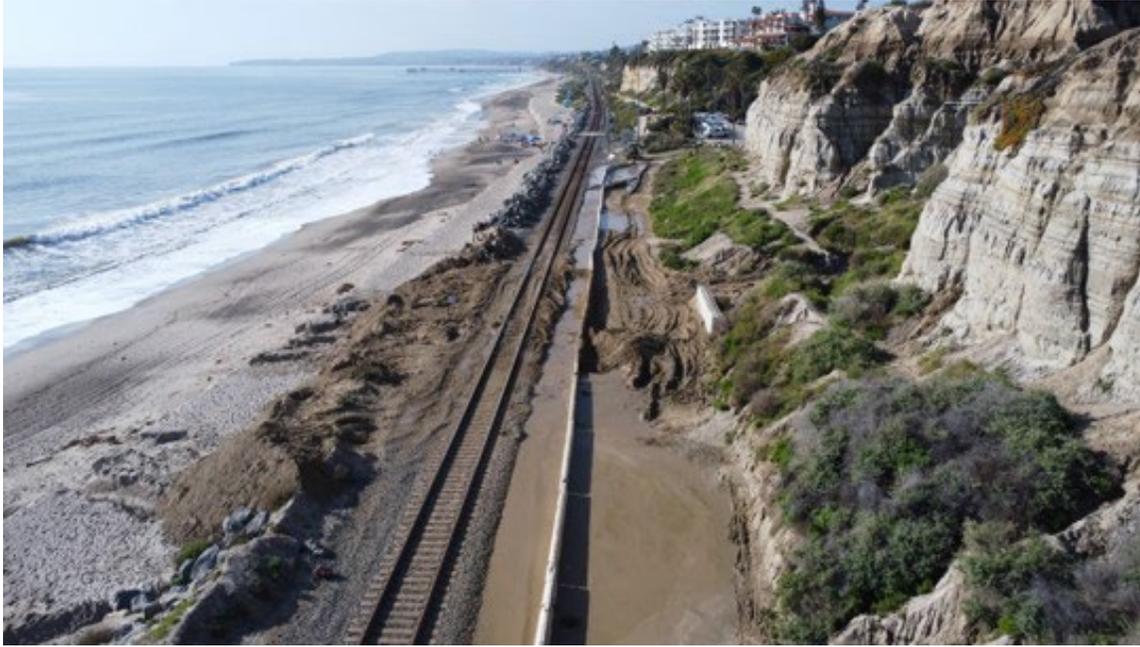
The face of the sea cliff is entrenched by several small to large size re-entrant canyons generating periodic sediment discharge into low-lying terrain along the landward Rail Corridor margin. Impacts have included flooding, blocking of drainage structures, and deposition of sediment within the Rail Corridor during larger storm events. See Figure 10. Frequent post-

storm maintenance efforts have been required to preserve train service, including removal of sediment and ponded water, restoration of surface flow, and installation of concrete blocks at the mouth of canyons in attempt to restrain sediment transport.

**Figure 10. Monitoring Site #6: MP 206.10, Calafia State Beach, January 2024**

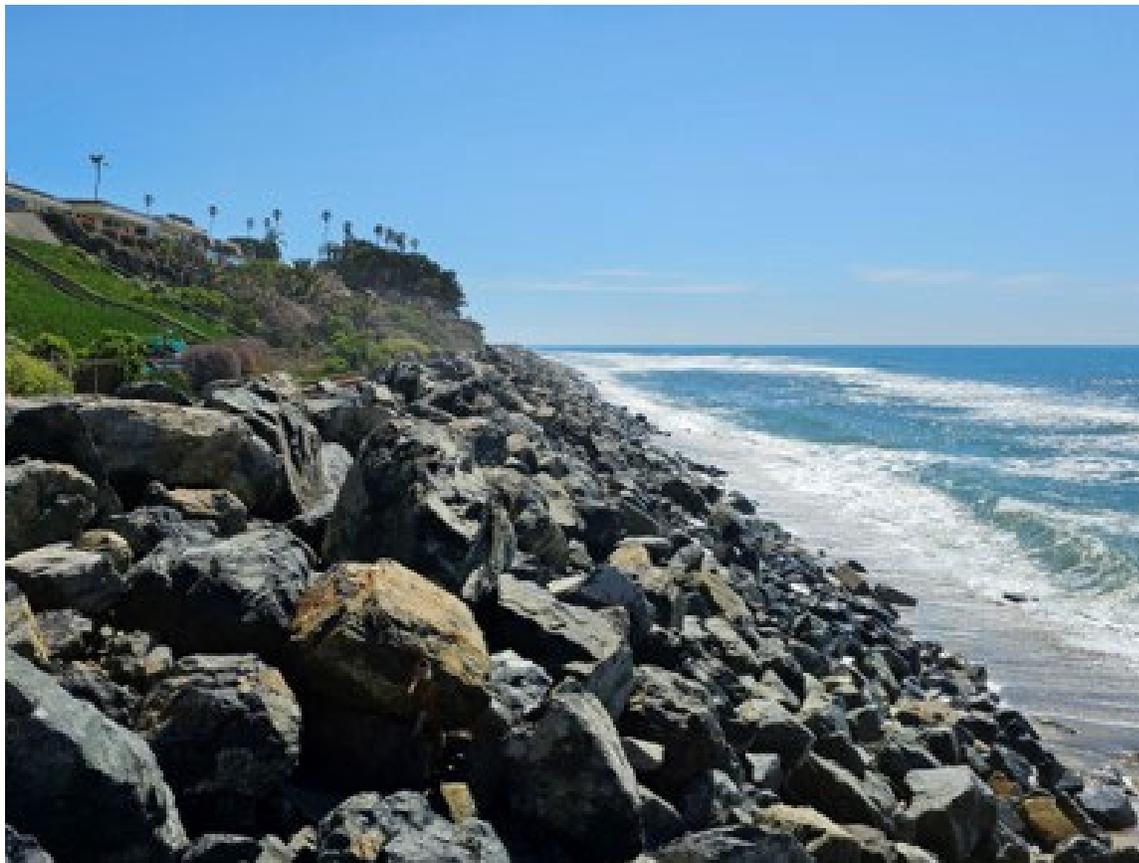
- In the vicinity of MP 207.00, Metrolink personnel indicated emergency riprap repairs have been required.
- Riprap was observed to also include much smaller stone and the upper portions of the slope are very steep (steeper than 1:1) (see Figure 11).

This reach (see Figure 11) should be monitored as part of the coastal shoreline monitoring program to ensure that the riprap section is stable and withstanding wave and weather conditions.

**Figure 11. Monitoring Site 7: MP 206.70–207.25, Cyprus Shore to County Line, December 2023**

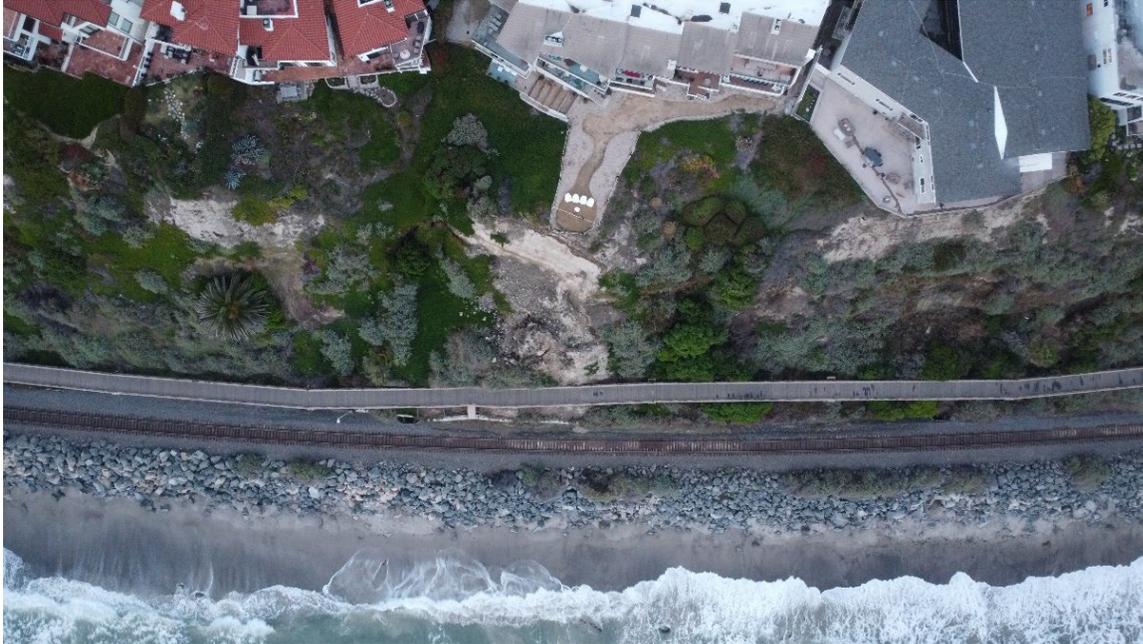
Figure 15. Potential Reinforcement Site 3: MP 204.00 to 204.50, steep bluffs, potential to impact tracks, poor track-side drainage with potential for liquefaction – January 21, 2024

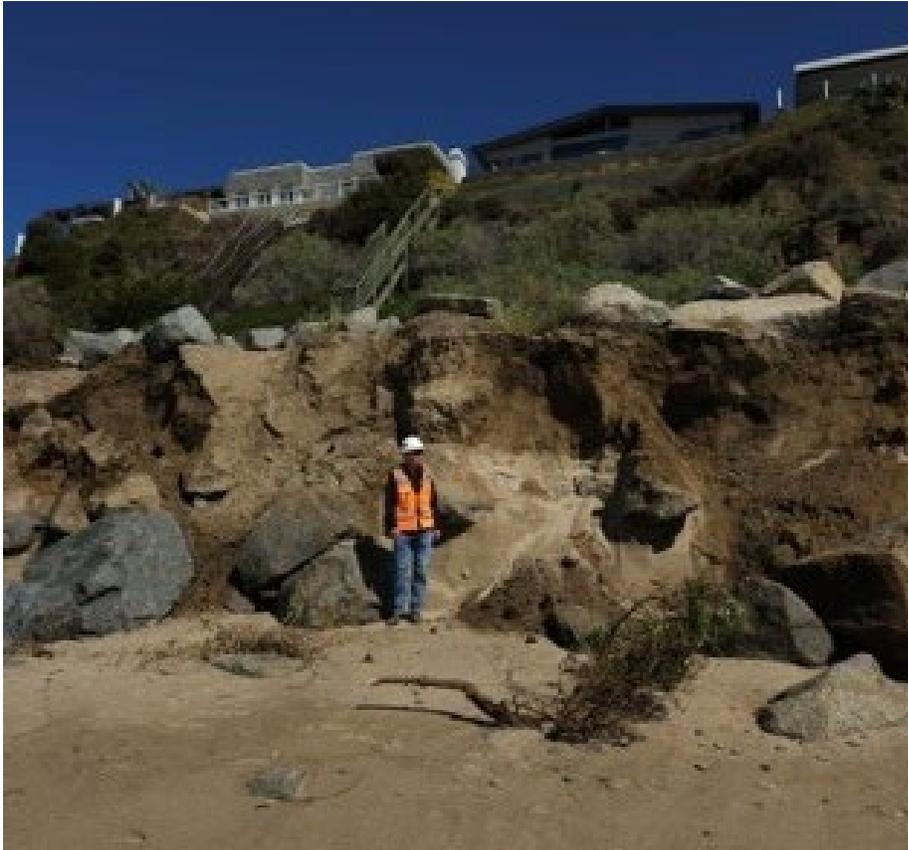
**Figure 17. Potential Reinforcement Site 4: MP 206.00 to 206.67, North End of Cyprus Shore Project, July 2023**

Loss of riprap exposes unstable deposits of beach sand, slide debris, and/or fill deposits beneath ROW, subject to rapid retreat as erosion and toppling during future storms.

Installation of an engineered revetment with filter fabric to minimize piping (movement of fine-grained sediment through voids in the rocks) and a layered-stone placement design with keyway founded in bedrock or to a toe elevation of +2 ft or lower is recommended. Dual purpose of revetment is to arrest continued landward retreat of soils into Rail Corridor. See Figure 17 and Figure 18.
