# M2 Natural Community Conservation Plan/Habitat Conservation Plan– 2019 Annual Report

Prepared by  
**Orange County Transportation Authority**  
550 S. Main Street  
Orange, CA 92863

April 2020

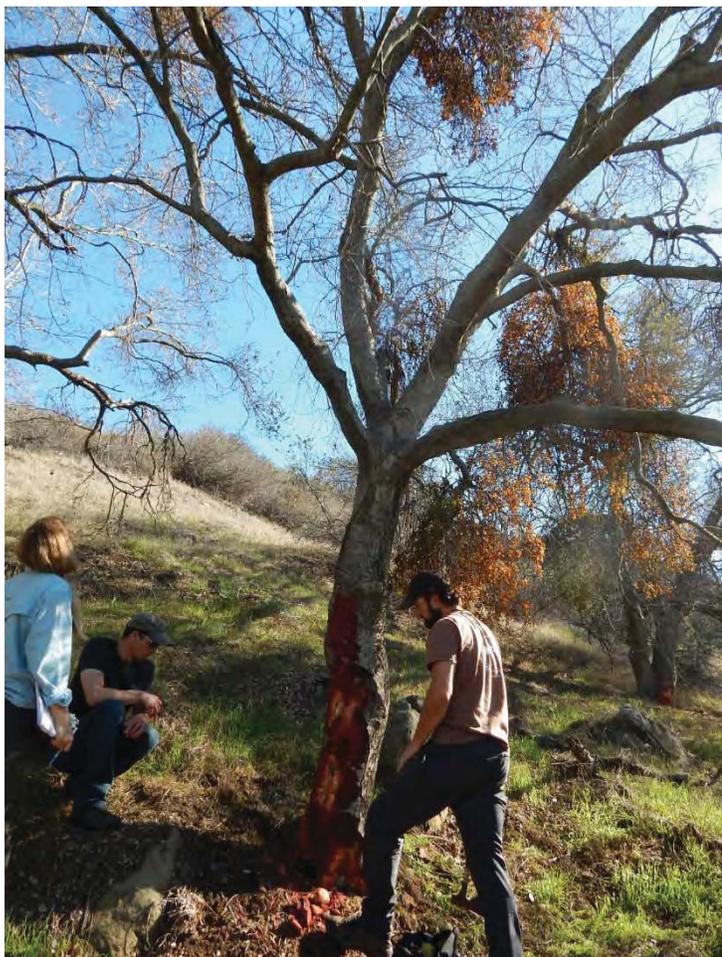
**Figure 1.** Discovery of GSOB in Weir Canyon December 2014, the first known occurrence in Orange County. Ecologist Zach Principe (left) noticed the cluster of dead oak trees on a routine drive through Nature Conservancy conservation easement lands the previous summer. Tom Coleman (USDA Forest Service entomologist (right), Megan Lulow, Irvine Ranch Conservancy ecologist (far left).

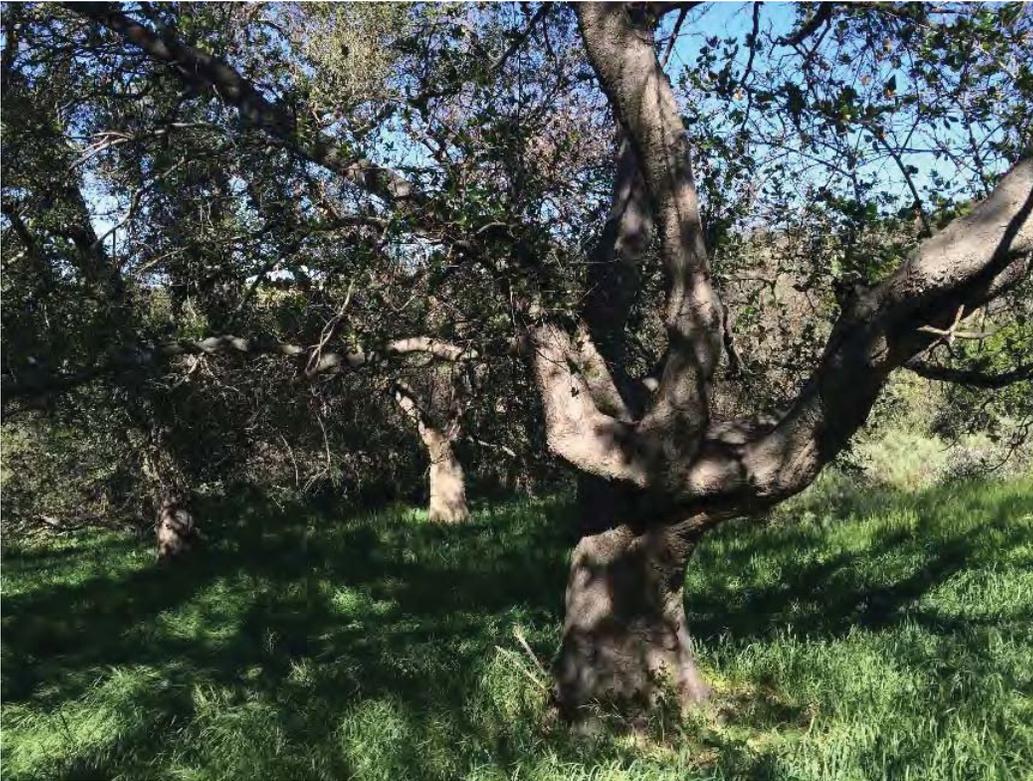
**Figure 5.** Thinning canopy of coast live oaks in Weir Canyon, Irvine Ranch Open Space.

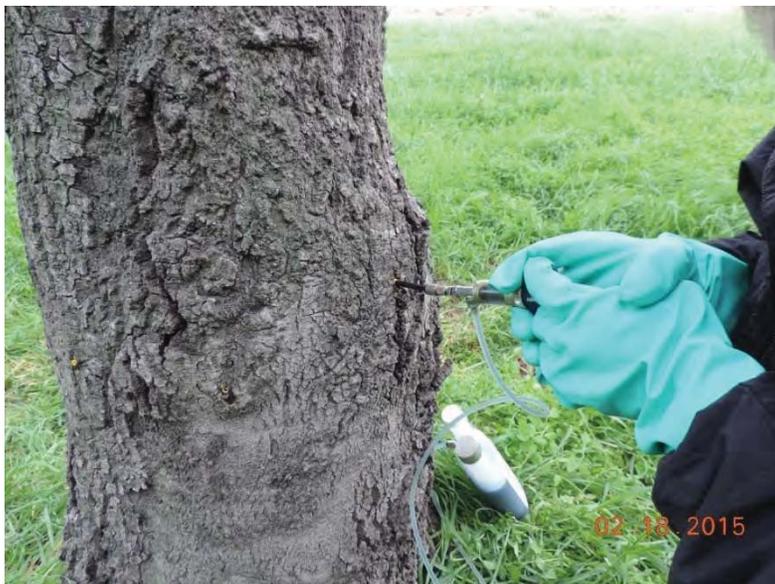
**Figure 15.** Stem injection of systemic insecticide Emamectin benzoate (Tree-äge®) with QuickJet ArborJet application method.

Orange County Agricultural Commissioner. One of the drawbacks of application via trunk injection is that it can injure the tree: long cracks may appear in the bark as a wound response to injection, potentially allowing infection by secondary pathogens. Healthy trees can usually isolate injection wounds without any signs of infection, decay, or structural damage (Doccola et al. 2011). In 2015, the potential benefit of preventing another generation from establishing and maintaining more oak woodland was considered worth the risk of application via injection. In 2016, however, due to an additional year of record drought, canker infection in some trees, and discovering some live larvae in trees that were treated in 2015, Emamectin benzoate (Tree-äge®) was not applied a second time. Dinotefuron (Safari 20SG®) has recently been developed as a topical systemic insecticide that is easy to apply as a trunk spray that may be effective against larvae as well as adults feeding on leaf tissue.

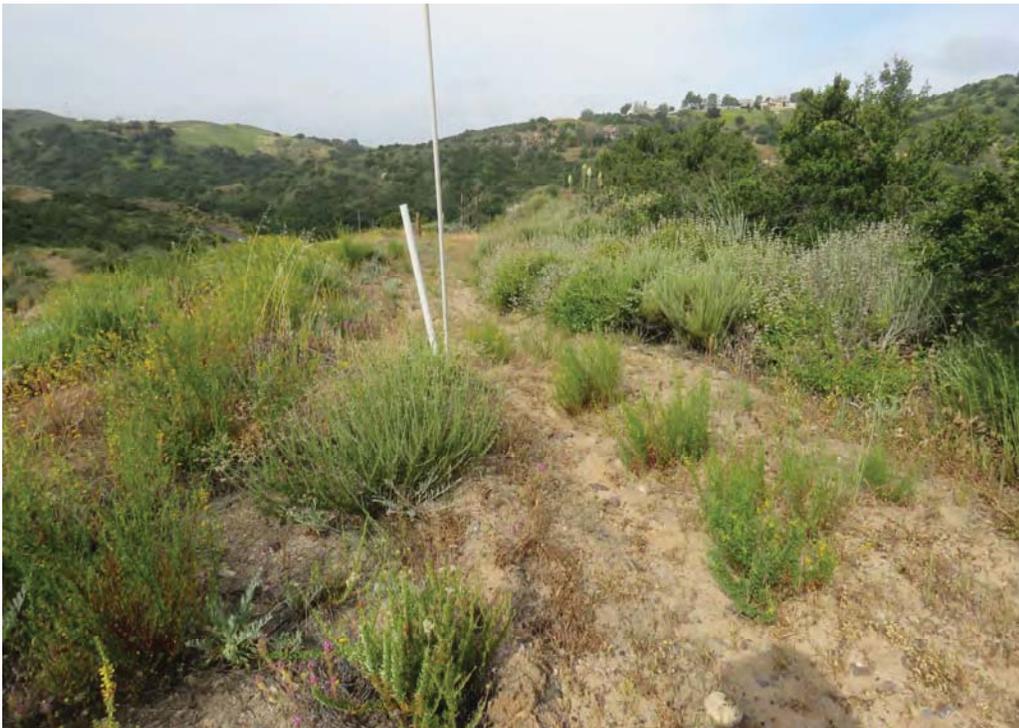
Photograph Location 2: Taken May 2, 2019, depicting growth of deerweed seedlings noted in 2018.

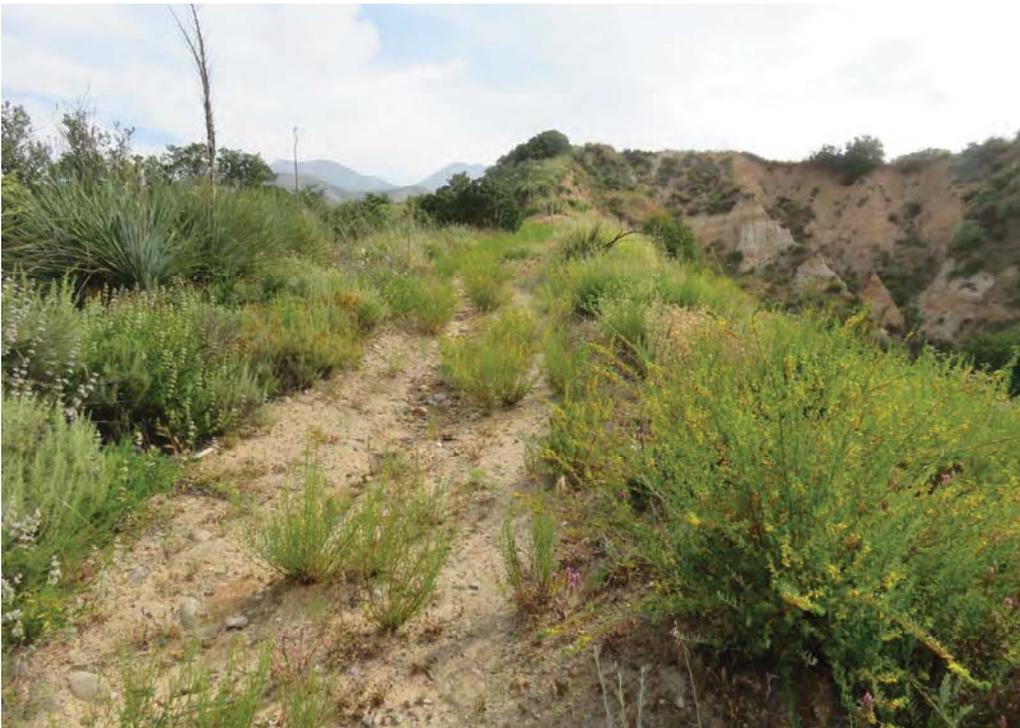
Photograph Location 3: Taken May 2, 2019 depicting growth of deerweed seedlings noted in 2018 and infill of native shrub seedlings including California sagebrush (*Artemisia californica*), California buckwheat, and sandaster (*Corethrogyne filaginifolia*).

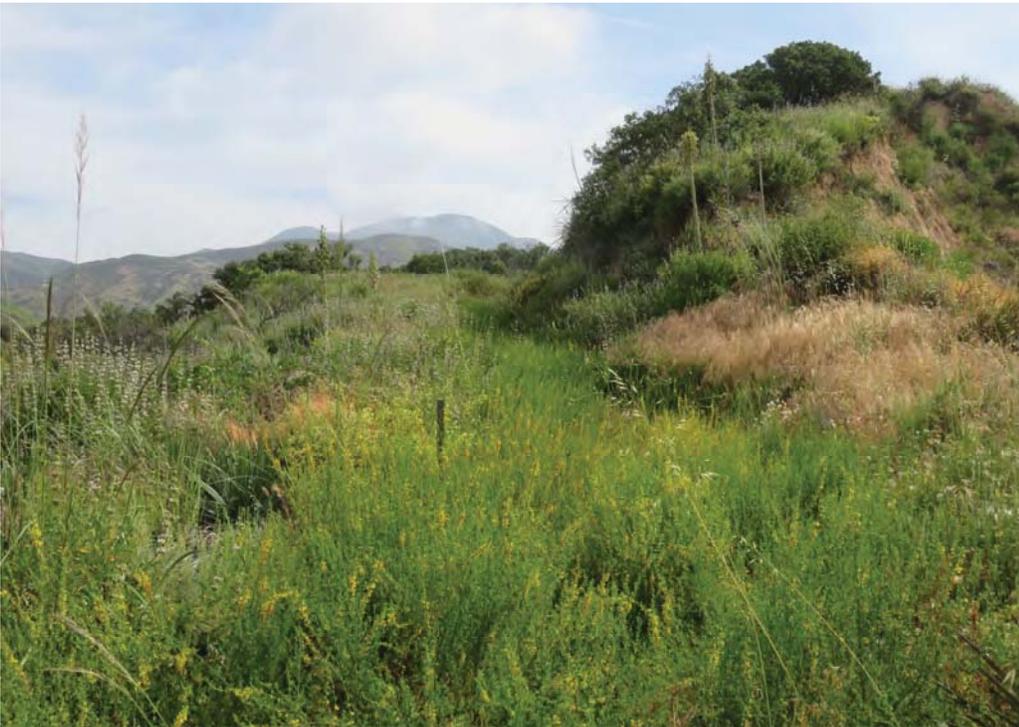
Photograph Location 4: Taken May 2, 2019 depicting significant growth of deerweed seedlings noted in 2018 and natural recruitment of California sagebrush, needle grass (*Stipa* sp.), black sage (*Salvia mellifera*).

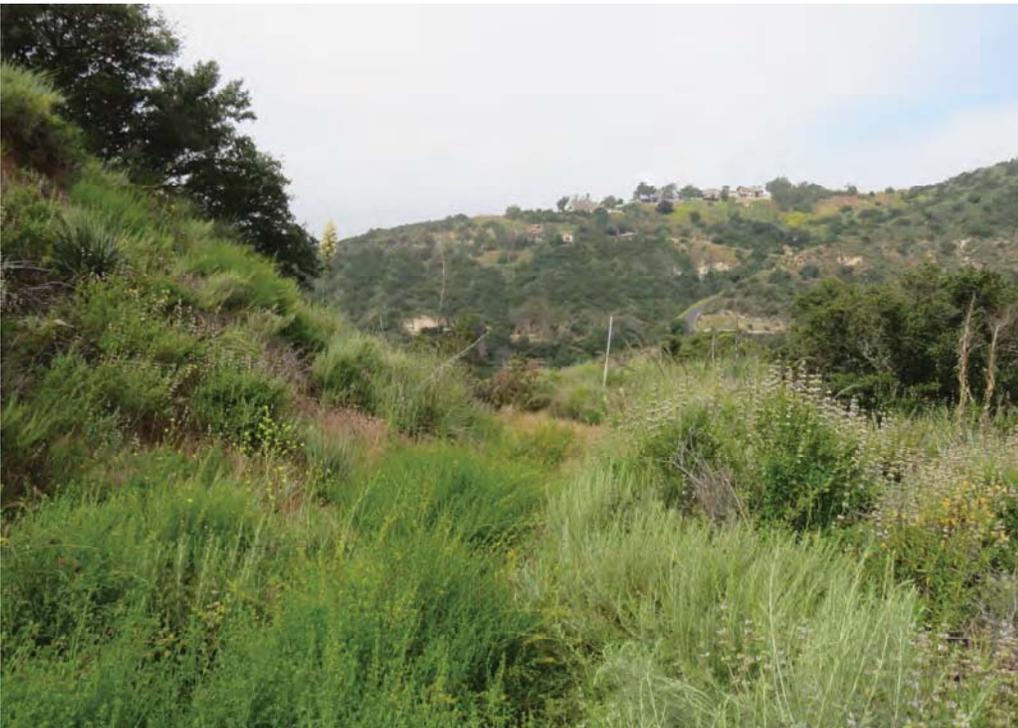
Photograph Location 5: Taken May 2, 2019, depicting significant growth of deerweed and California sagebrush noted in 2018.

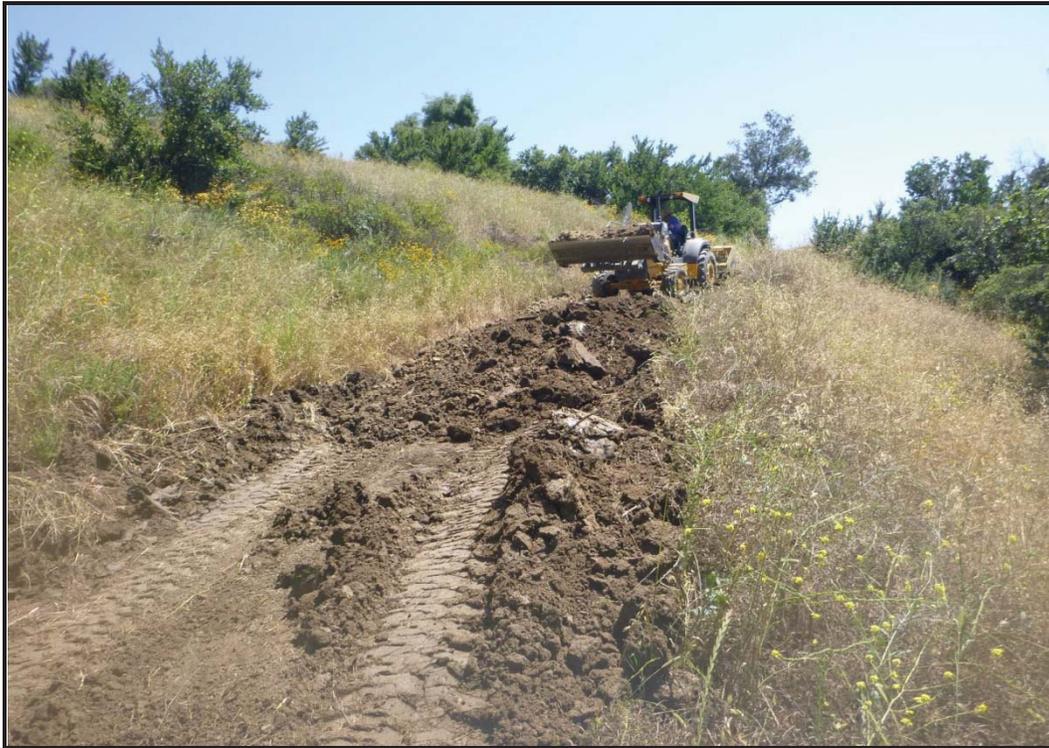
PHOTOGRAPH 16  
Reggrading of Fire Roads at Trabuco Rose Preserve to Repair Erosion,  
June 2019

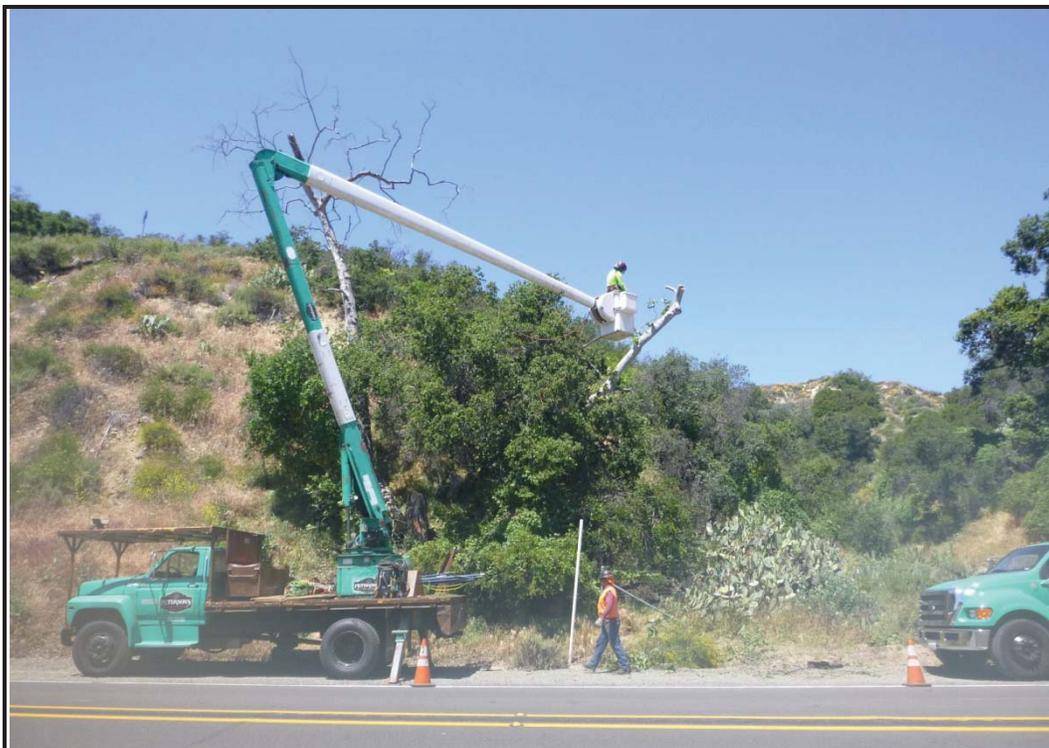
PHOTOGRAPH 17  
Sycamore Tree Removal along Trabuco Canyon Road Due to  
Invasive Shot Hole Borer Infestation, April 2019

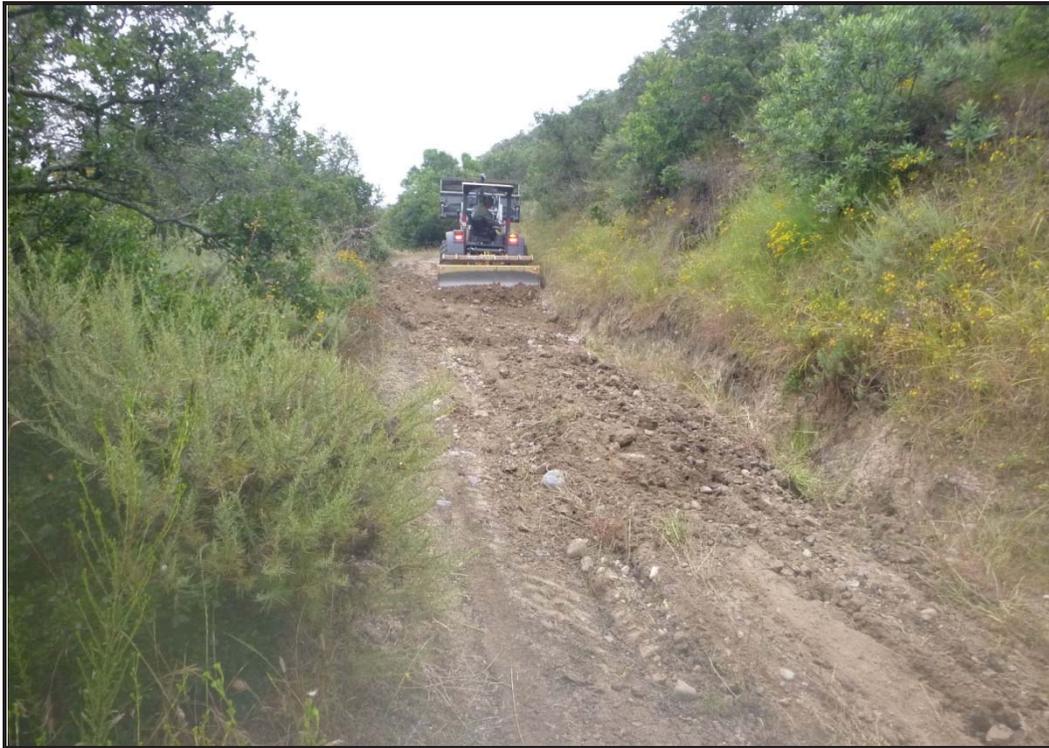
PHOTOGRAPH 22  
Regrading of Fire Road at Live Oak Creek Preserve to Repair Erosion,  
June 2019

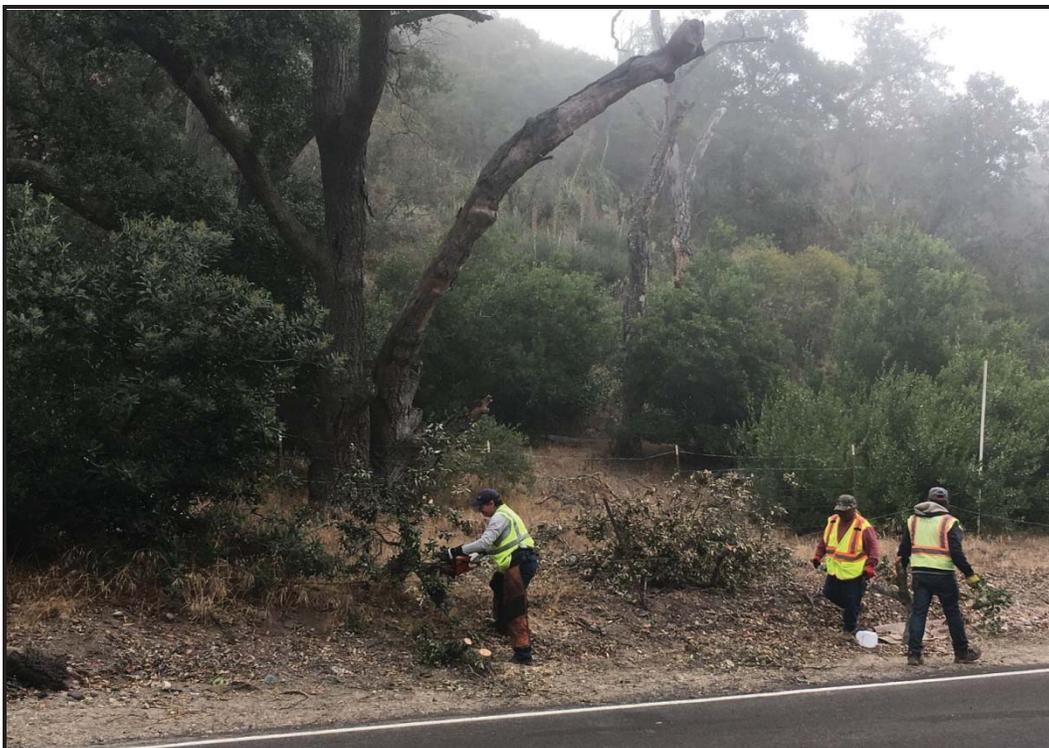
PHOTOGRAPH 23  
Removal of Fallen Oak Tree and Barbed Wire Fencing on Live Oak  
RECON Canyon Road at Bobcat Ridge Preserve, August 2019

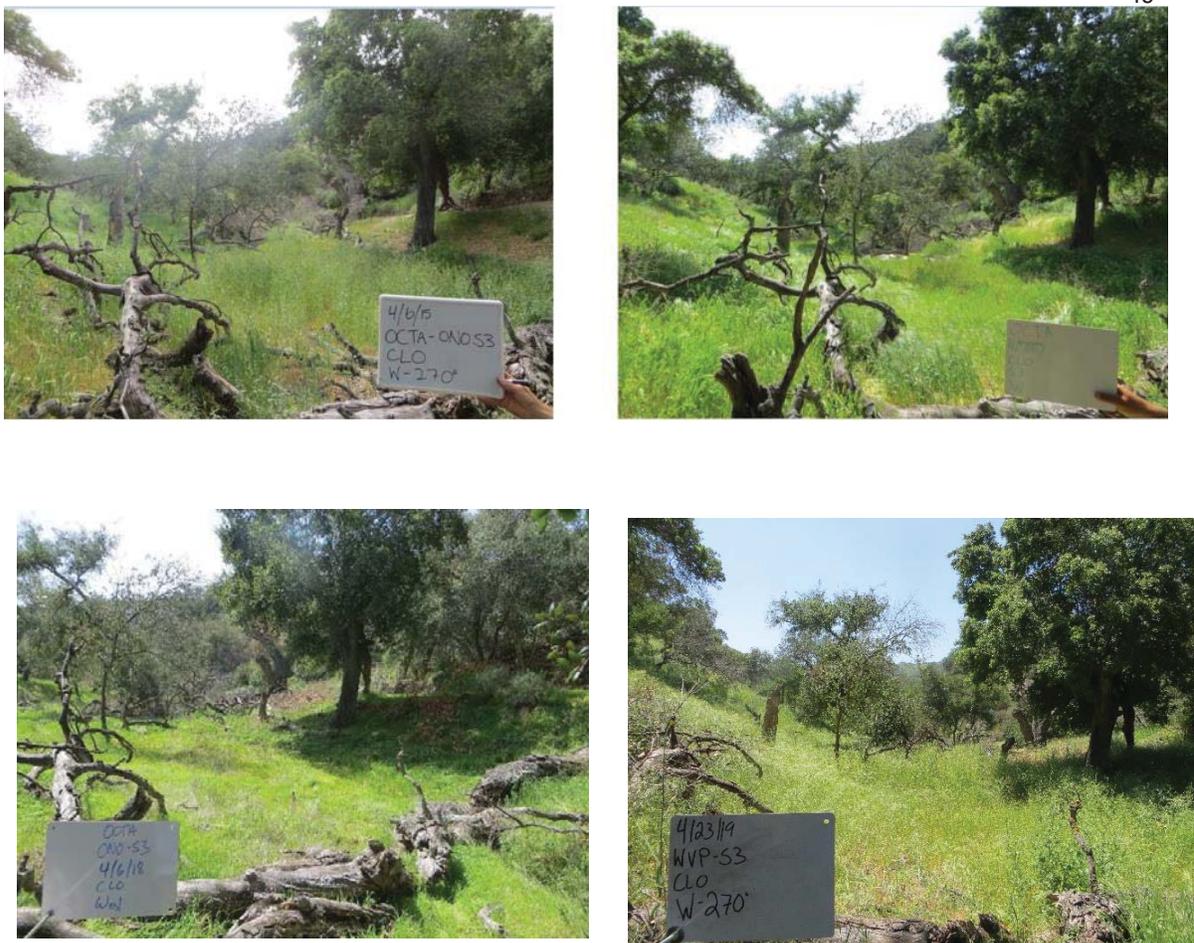
Fig. 35. Vantage point photos from 2016-19 of under and overstory of cattle-disturbed coast live oak woodland on Wren's View preserve.
