# Attachment A: Supplemental Information

## Critical San Clemente Railroad Protection Project – Area 1 (Mile Post 203.80 to Mile Post 203.90) and Area 2 (Mile Post 204.00 to Mile Post 204.40) (Areas 1 and 2)

### Block 19 – Description of Proposed Nationwide Permit Activity

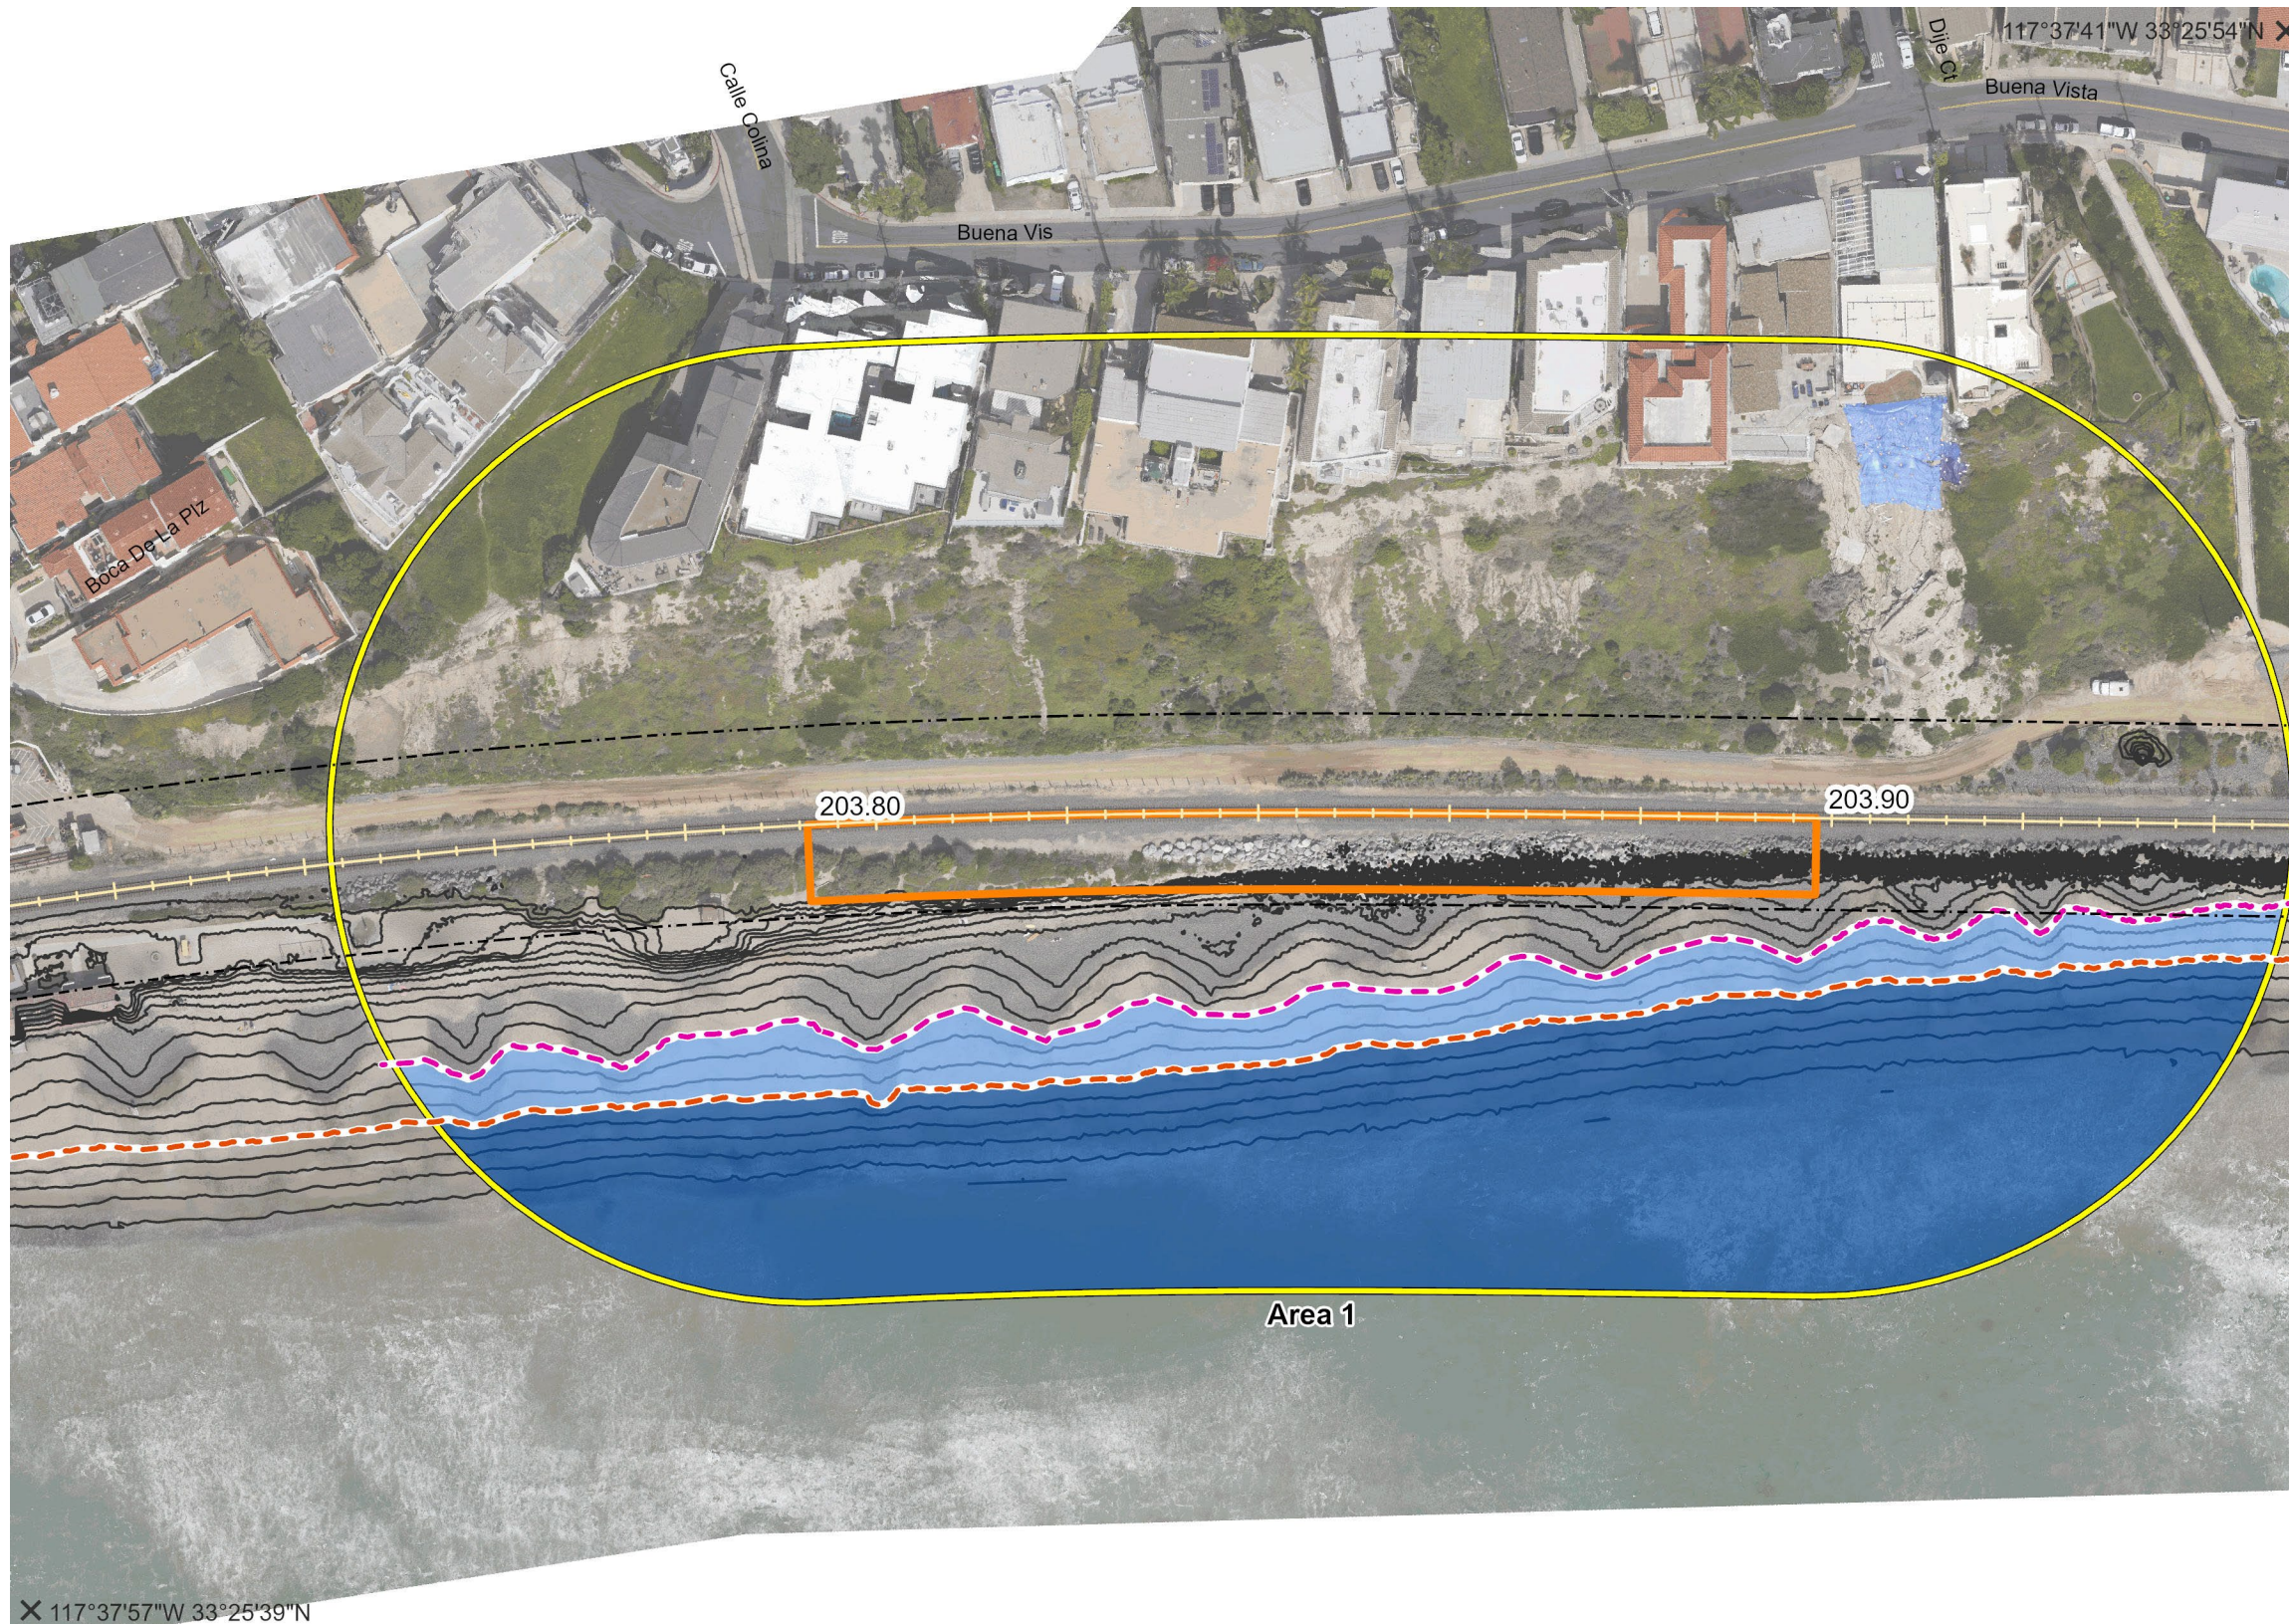
**USACE Jurisdictional Resources  
(Preliminary)  
Area 1&2 Map 1**

- Rail Alignment
- Preliminary Footprint
- Aquatic Resources Survey Area
- 4.06 ft MHW Contour
- 7.01 ft HAT Contour
- Aquatic Resources (field verified with USACE)
  - Section 404 Tidal Waters of the U.S
  - Section 404 & 10 Tidal Waters of the U.S
  - Contour 1ft
  - Rail Right-of-way

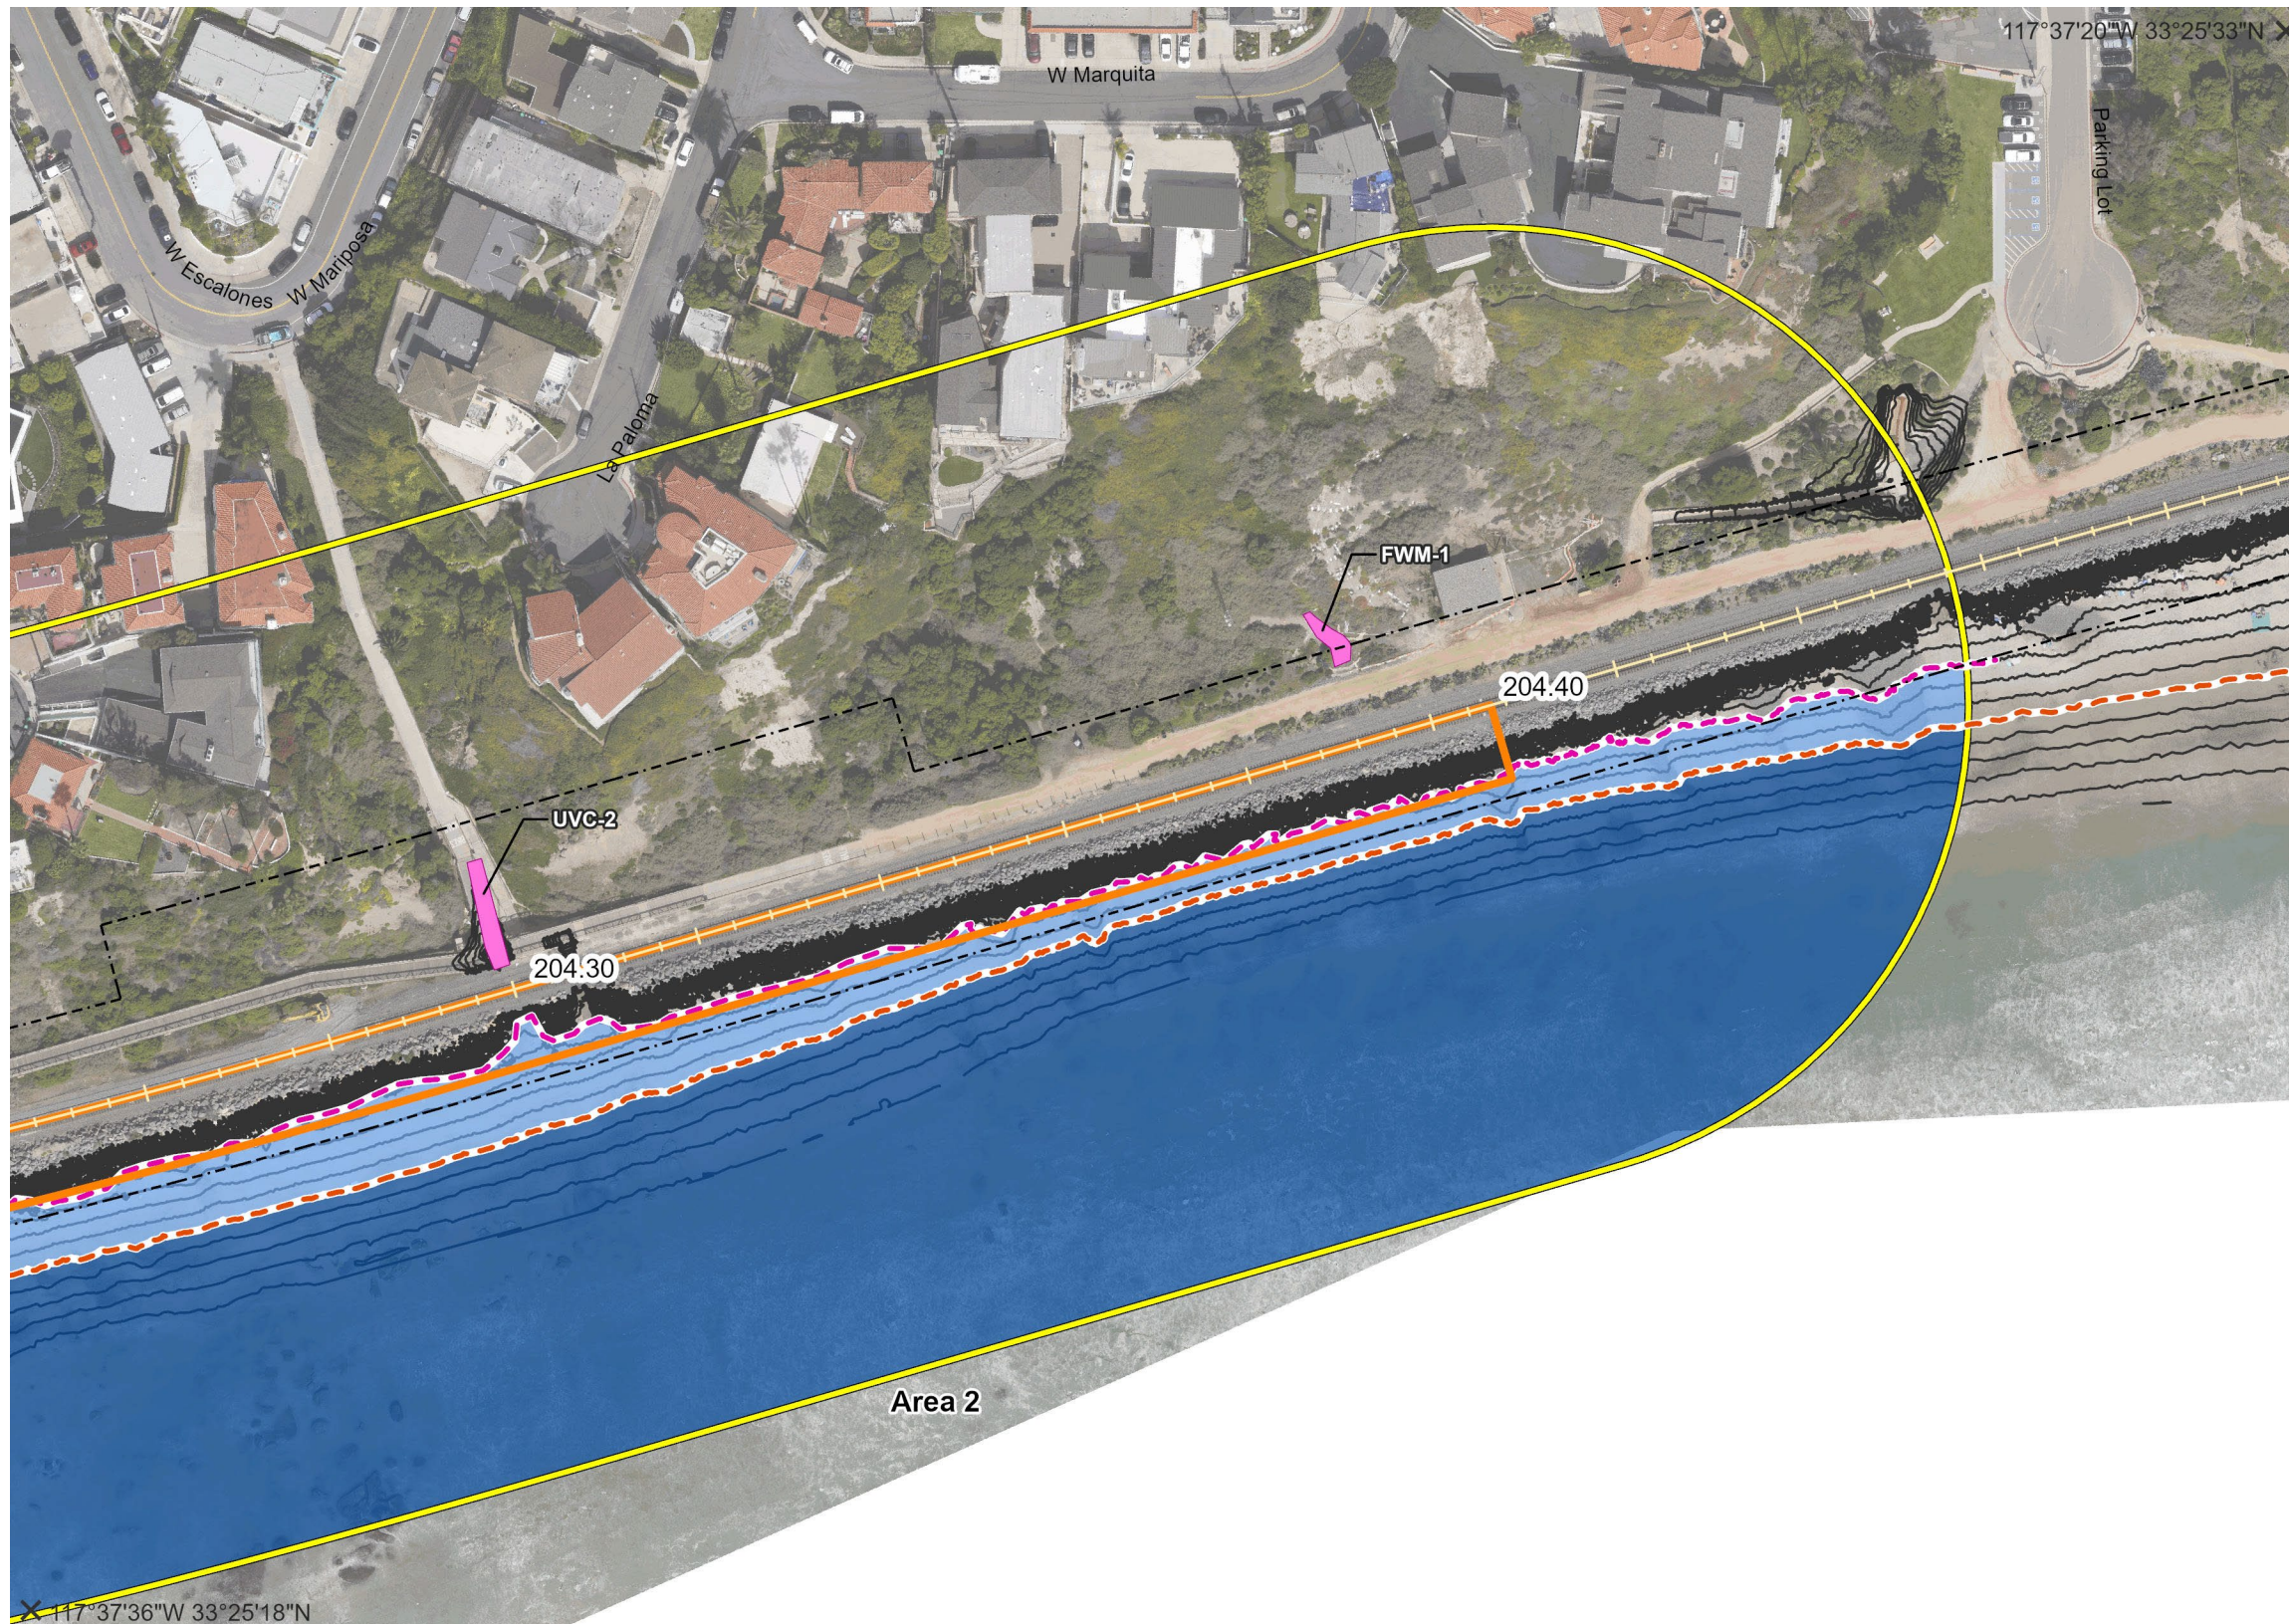
**USACE Jurisdictional Resources  
(Preliminary)  
Area 1&2 Map 4**

- Rail Alignment
- Preliminary Footprint
- Aquatic Resources Survey Area
- 4.06 ft MHW Contour
- 7.01 ft HAT Contour
- Aquatic Resources (field verified with USACE)
  - Section 404 Tidal Waters of the U.S
  - Section 404 & 10 Tidal Waters of the U.S
- Aquatic Resources (Unverified)
  - Potential Aquatic Resource
- Contour 1ft
- Rail Right-of-way

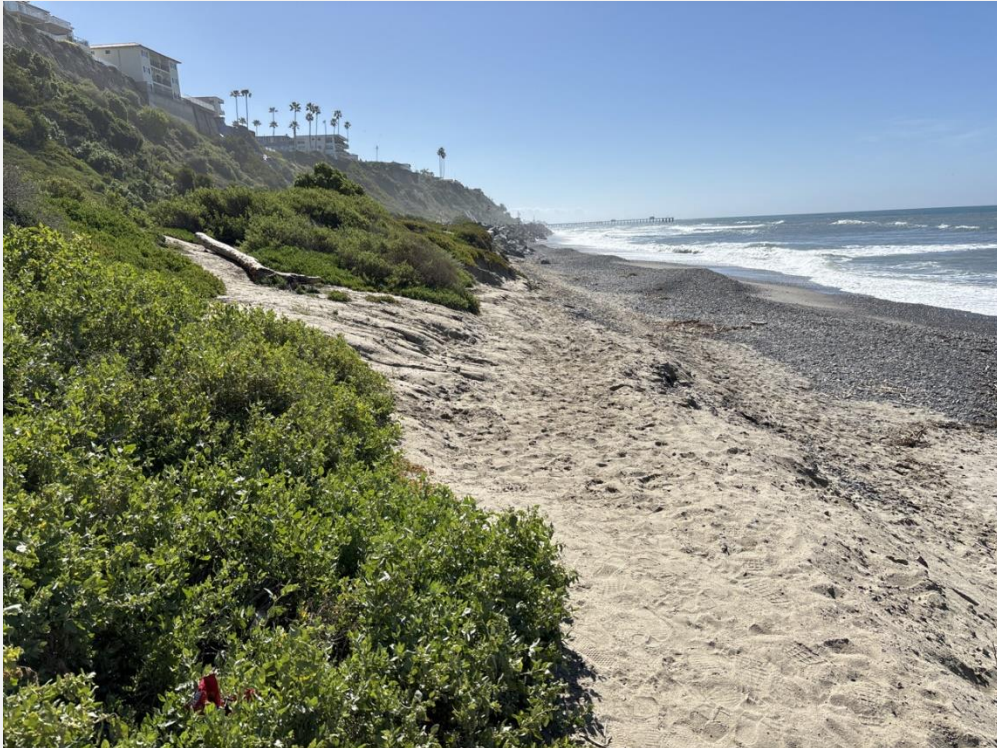
A wide-angle photograph showing a sandy beach. On the left, there is a dense area of green coastal vegetation. In the background, a cliffside rises with several buildings and palm trees. The ocean is visible on the right, with waves breaking onto the shore. The sky is clear and blue.	<p>Photograph #: 1</p> <p>Photo Date: 3/25/2024</p> <p>Location: 33.4299899, -117.6307980</p> <p>Direction: 140</p> <p>Notes: View of the Area #1 study area, riprap on slopes in background.</p>

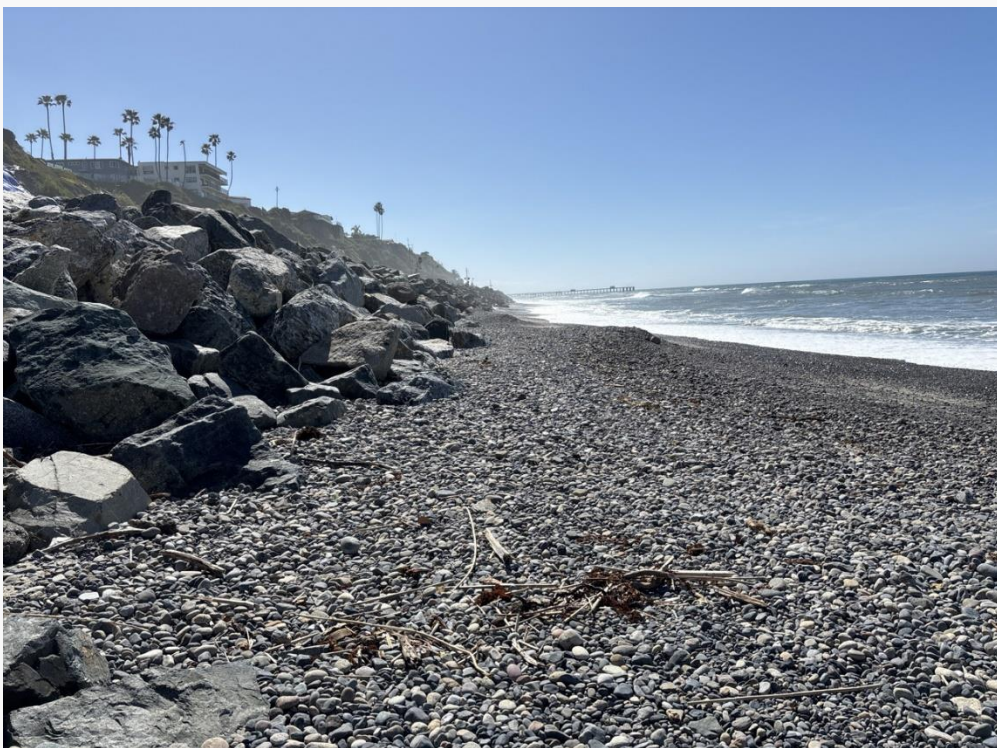
A photograph of a rocky beach. The foreground is filled with dark, smooth stones and pebbles. On the left, there is a large, structured pile of grey riprap. In the background, a cliffside with buildings and palm trees is visible under a clear blue sky. The ocean waves are breaking on the right side of the frame.	<p>Photograph #: 2</p> <p>Photo Date: 3/25/2024</p> <p>Location: 33.4293927, -117,6302882</p> <p>Direction: 140</p> <p>Notes: View of Area #1 study area, west of the railroad tracks. Riprap on slopes on the left.</p>

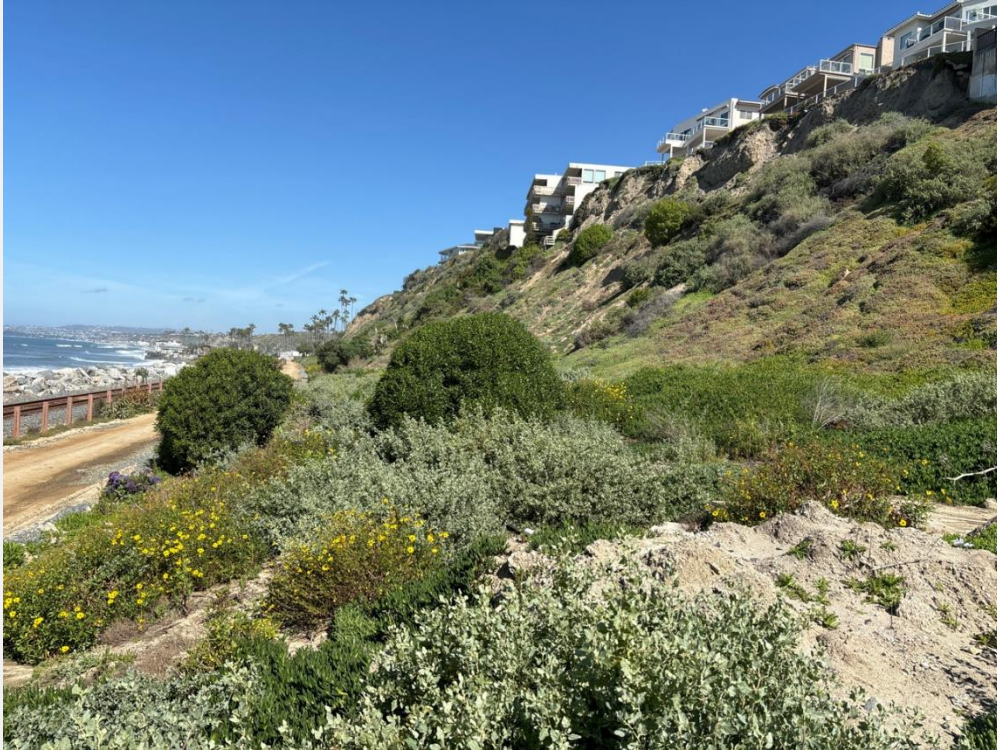
Photograph #: 3  
Photo Date: 3/25/2024  
Location: 33.4290212, -117.6294956  
Direction: 315  
Notes: View of Area #1 study area, big saltbush scrub (*Atriplex lentiformis* Shrub Alliance) on bluff slopes, east of railroad tracks and pedestrian trail.

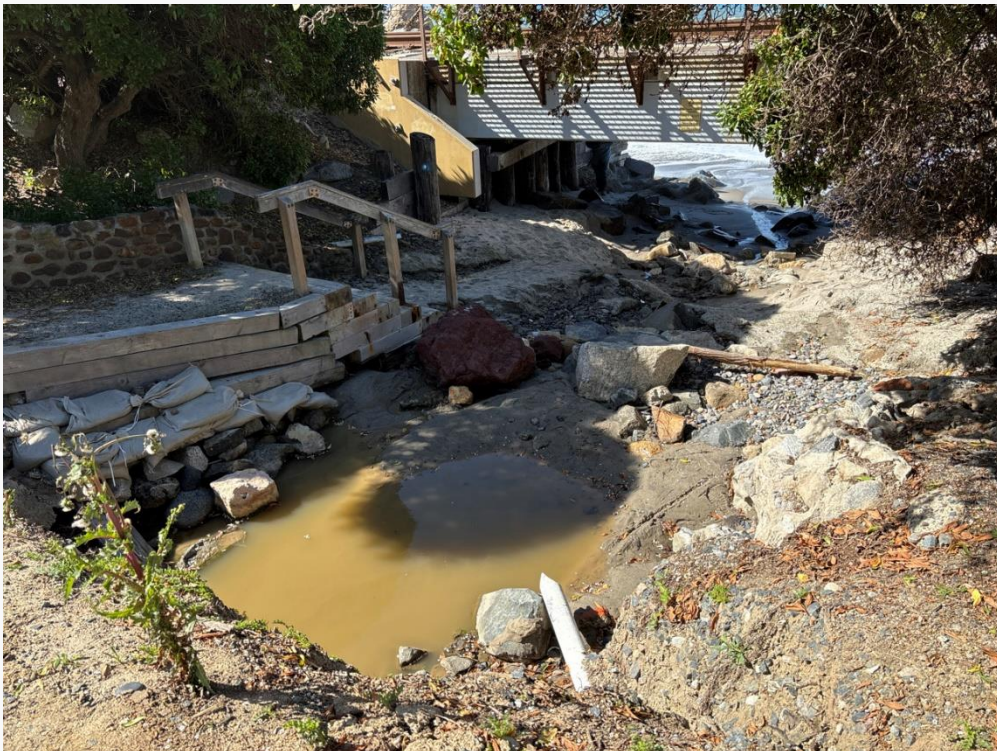
Photograph #: 4  
Photo Date: 3/25/2024  
Location: 33.427053, -117.628046  
Notes: View of UVC-1 west of pedestrian beach trail path within the Area #2 study area. View towards east.

UVC-1 consists of an unvegetated earthen channel located at the northern end of the Project study area. The channel also serves as a pedestrian pathway to access the Pacific Ocean under the railroad tracks. A concrete culvert was observed under the pedestrian pathway and a low flow channel, approximately 6-inches deep, was observed flowing the culvert through UVC-1, west towards the Pacific Ocean. UVC-1 exhibits an OHWM ranging from 10 feet near the concrete culvert to 18 feet near the railroad tracks. The channel consists of compact sand with larger boulders throughout the middle of the channel.

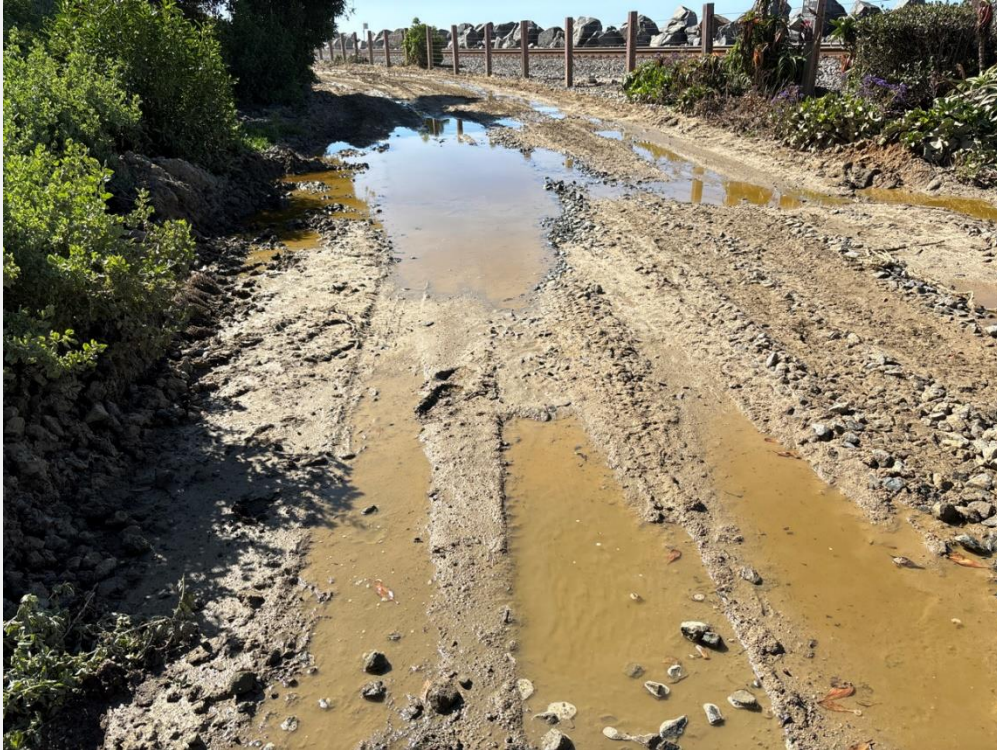
Photograph #: 5  
Photo Date: 3/25/2024  
Location: 33.426951, -117.627965  
Notes: View of Road Rut A and B with standing water along pedestrian beach trail path within the Area #2 study area. View towards south.

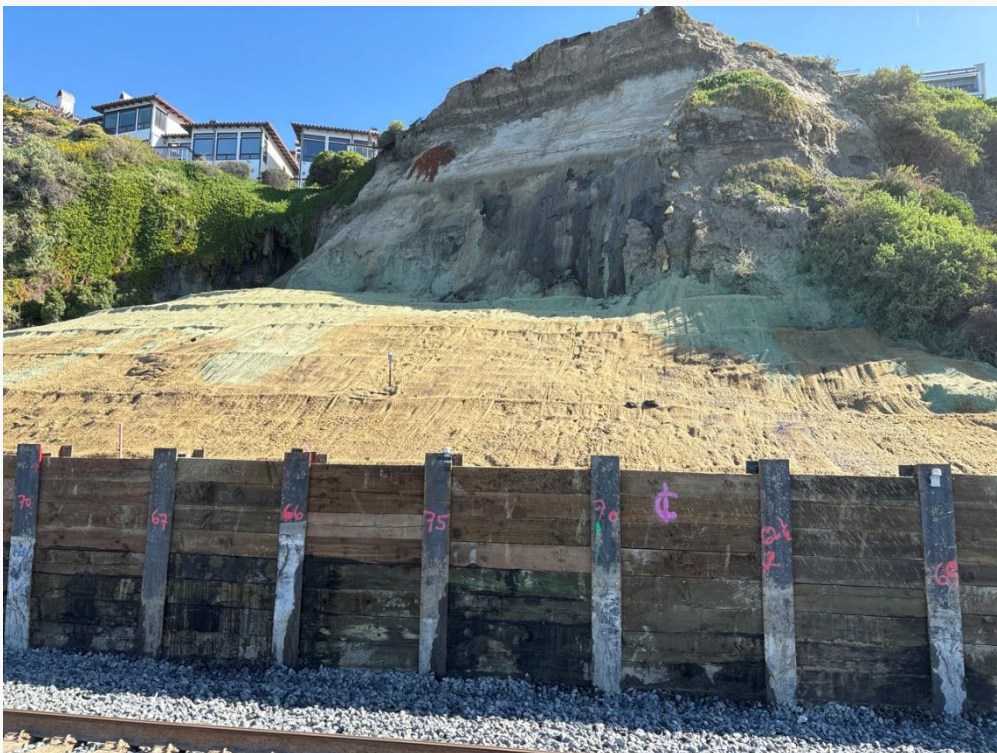
Photograph #: 6  
Photo Date: 3/25/2024  
Location: 33.425299, -117.626639  
Direction: 30 degrees  
Notes: View of landslide area at the Mariposa Pedestrian Bridge with retaining wall in place within the Area #2 study area.

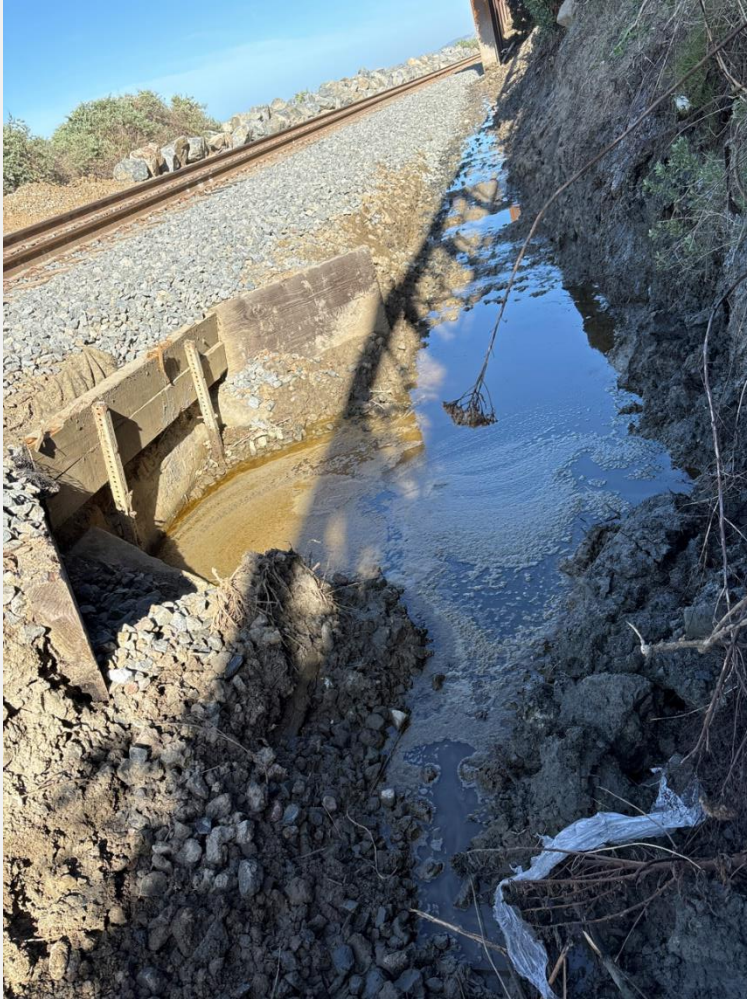
Photograph #: 7

Notes: View of Road Rut C along railroad with water pooling from seeps in bluffs within the Area #2 study area. Culvert filled in with sediment causing water to pool.

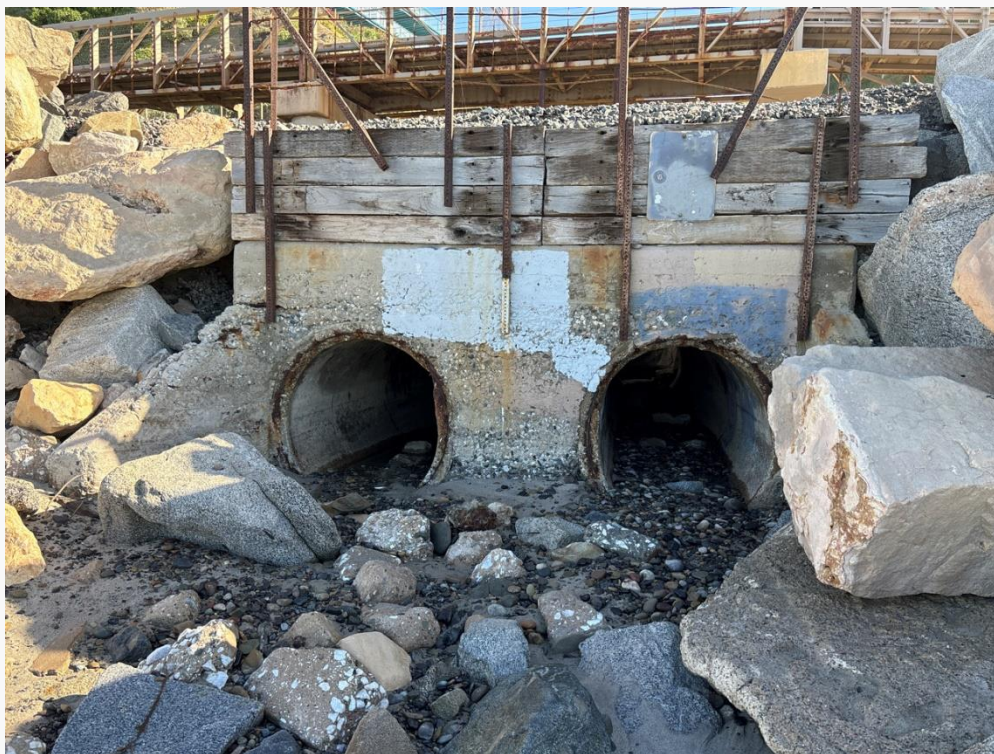
Photograph #: 8

Notes: View of double three-foot concrete culverts which outlets to ocean within the Area #2 study area. View towards east.

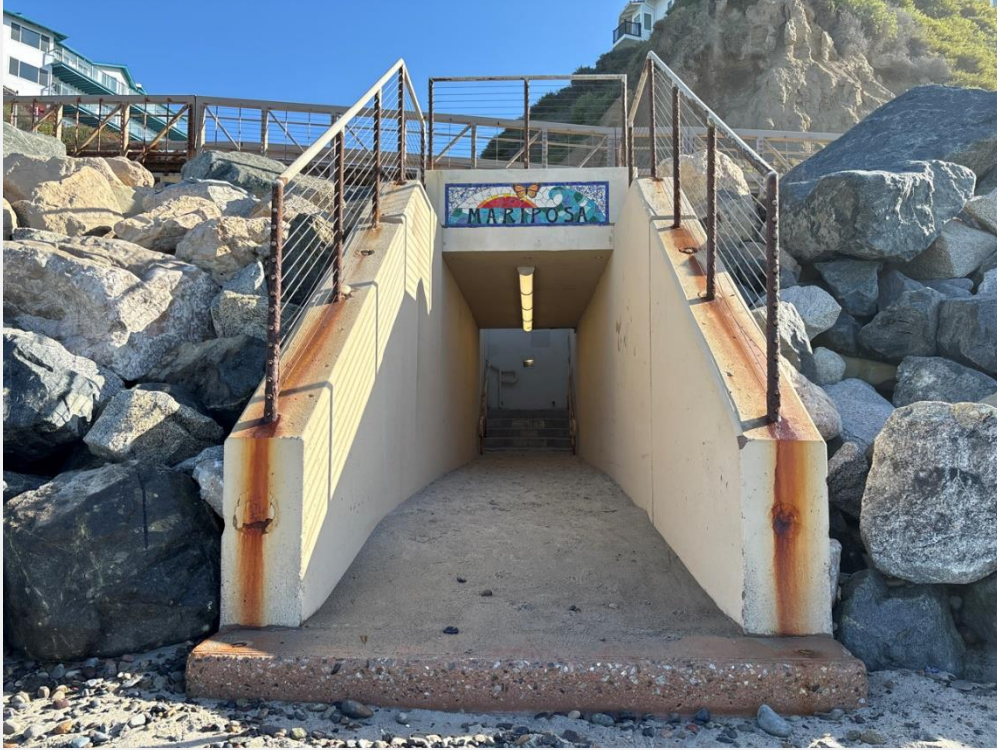
Photograph #: 9  
Photo Date: 3/25/2024  
Location: 33.424211, -117.625244  
Direction: 40 degrees  
Notes: View of stairway from pedestrian bridge to beach within the Area #2 study area. View towards east.

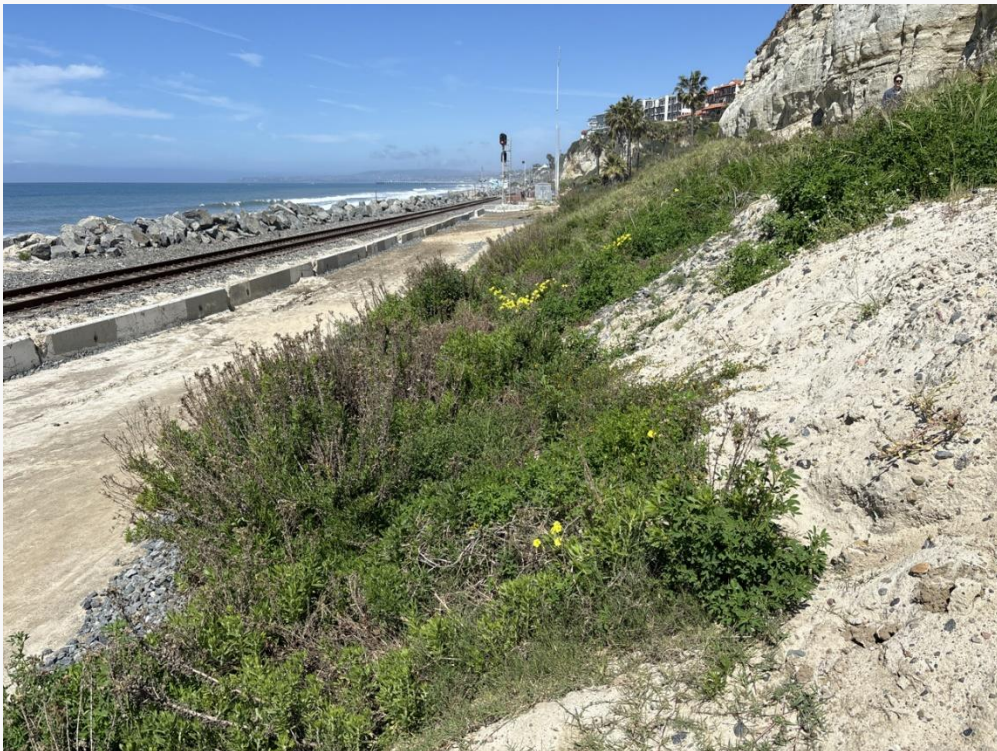
Photograph #: 10  
Photo Date: 3/25/2024  
Location: 33.4046556, -117.6059474  
Direction: 315  
Notes: View of California brittlebush (*Encelia California*) east of rail ROW along pedestrian trail within the Area #4 study area. View towards north.

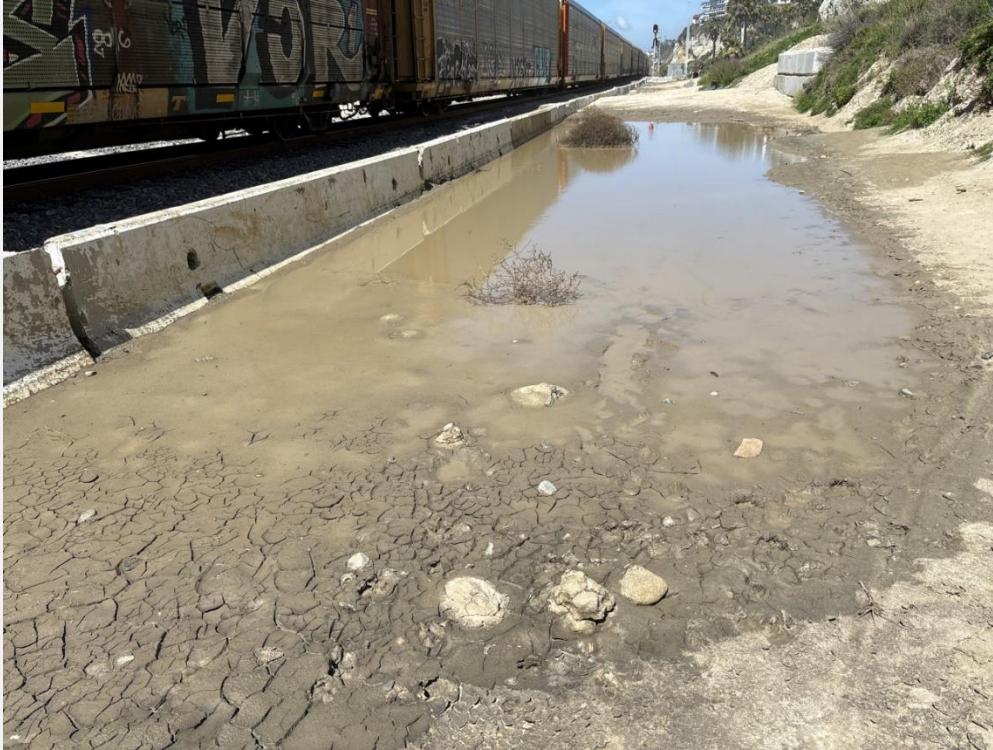
Photograph #: 11  
Photo Date: 3/25/2024  
Location: 33.4039563, -117.6054610  
Direction: 340  
Notes: Photo of Road Rut D within the Area #4 study area. Railroad tracks on left and coastal bluffs on right.

Road Rut 4 is an unvegetated road rut located at the base of the coastal bluffs along the pedestrian trail within the northern portion of the Area #4 study area. Road Rut 4 is approximately 115 feet long and 15 feet wide. Water was observed within the road rut with some observations of flow from the coastal bluff immediately northeast of the feature. The feature abuts railroad barriers.

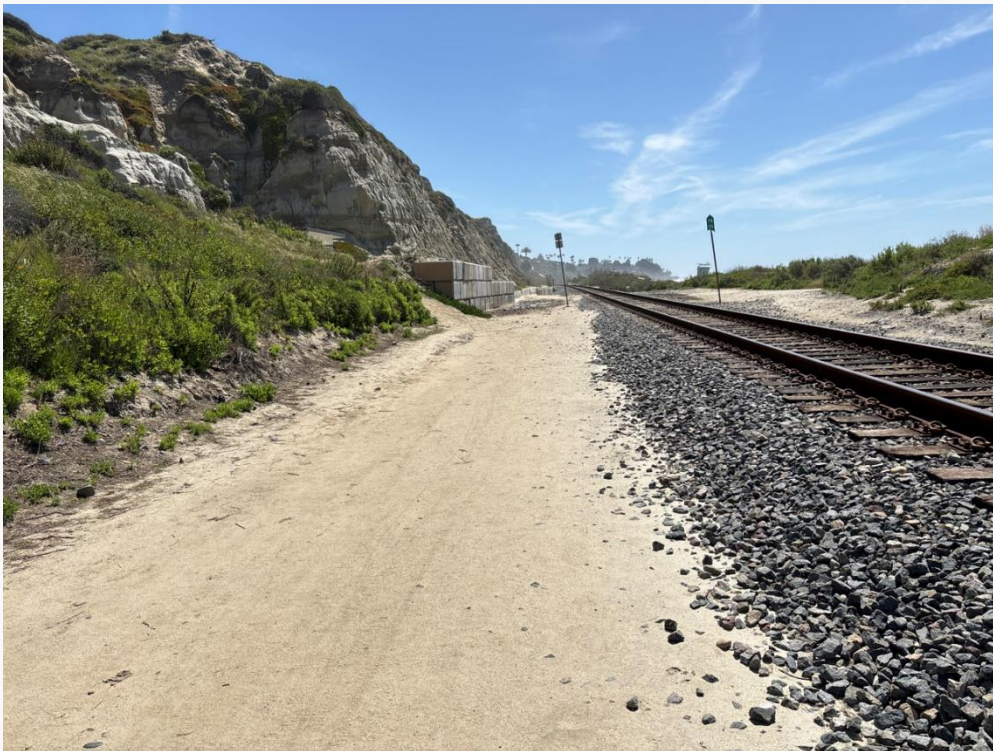
Photograph #: 12  
Photo Date: 3/25/2024  
Location: 33.4025713, -117.6043916  
Direction: 135  
Notes: Photo of the Area #4 study area. California brittlebush scrub below unvegetated coastal bluffs on left and railroad tracks on right.

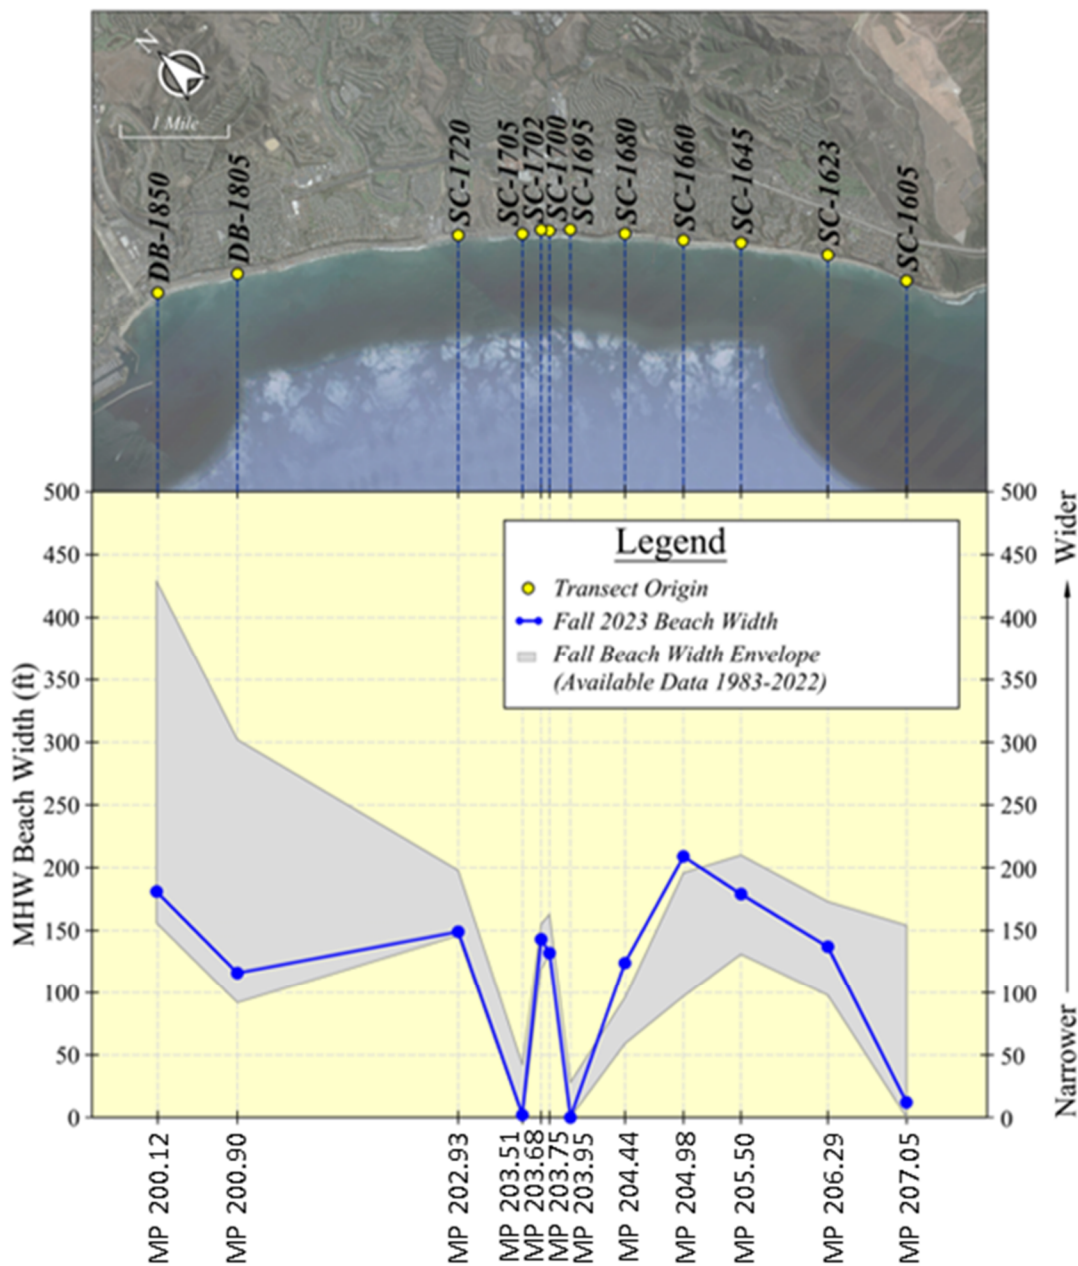
Figure 4 Fall 2023 Beach Widths Relative to Historic Shoreline Position per Survey Comparisons Conducted by Coastal Frontiers

Figure 4 includes the fall 2023 beach width and illustrates relatively little change compared to the fall 2022 shoreline position.

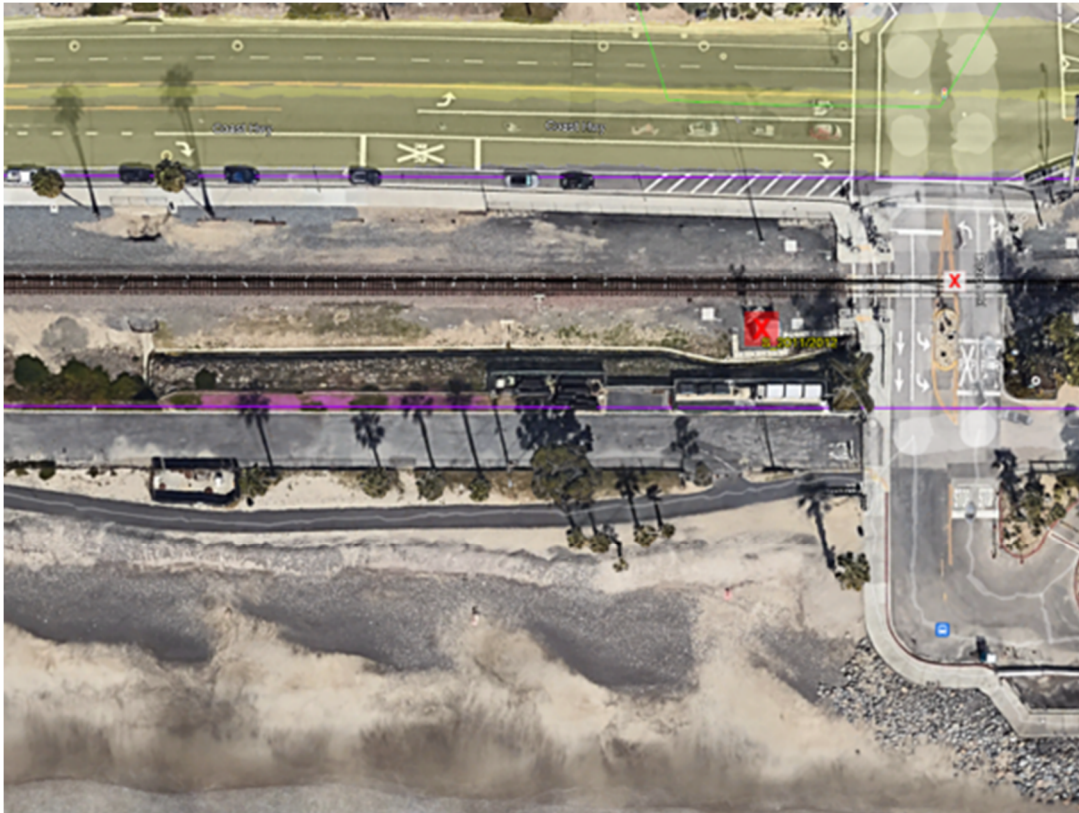
**Figure 6. Monitoring Site 1: South Doheny Beach Erosion near Parking Lot**

The adjacent shoreline infrastructure at Doheny State Beach (see Figure 6) to the west and Capistrano Beach Park to the east have experienced erosion, and erosion control measures have been implemented. The project team recommends shoreline monitoring in this area where beach has not yet eroded to the point of imminent threat to the rail but may do so in the future. Semi-annual monitoring concurrent with spring/fall beach monitoring is recommended.

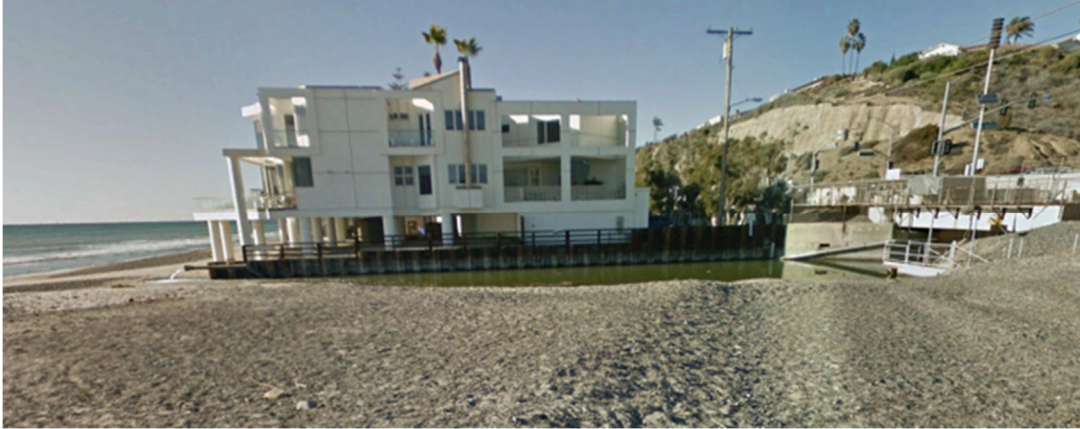
**Figure 7. Monitoring Site 2: MP 202.70, Poche Beach Outfall and Pedestrian Underpass**

Outfalls and drainages allow waves to propagate inland, and in combination with ongoing beach erosion may erode the rail ROW in future. Quarterly monitoring is recommended. See Figure 7.

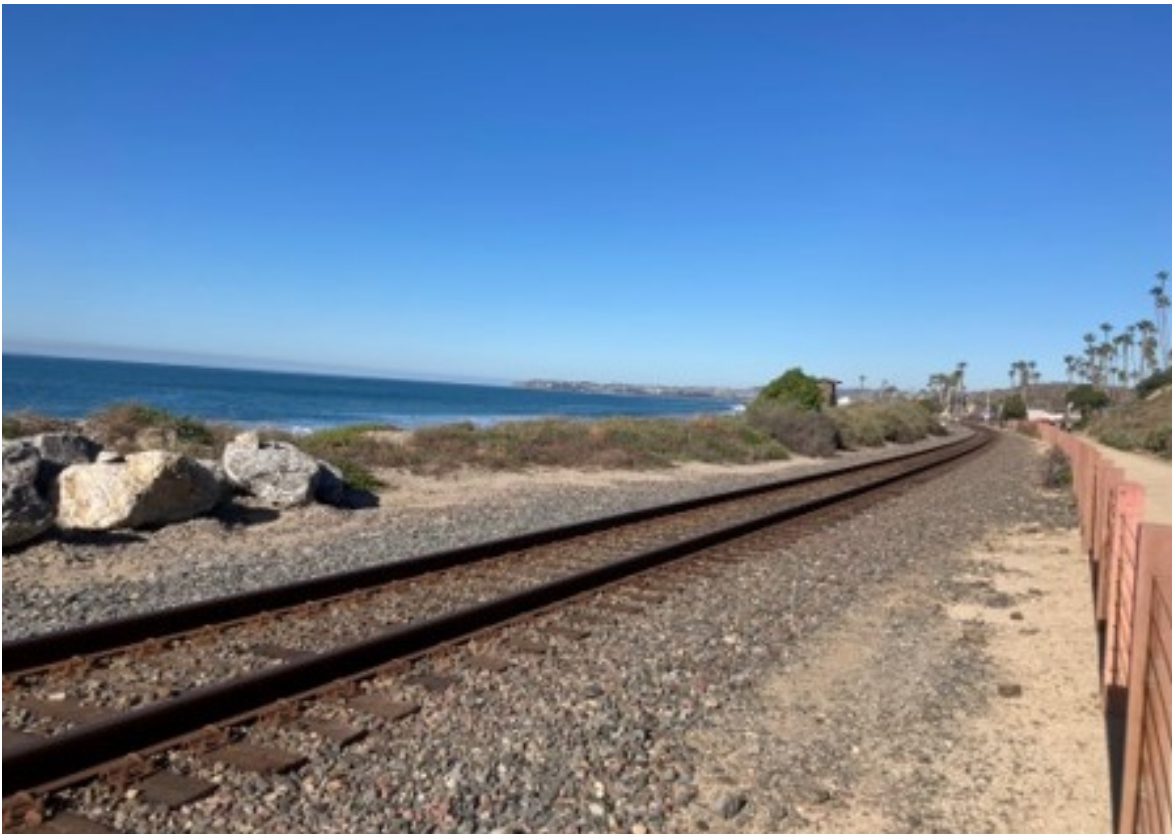
**Figure 8. Monitoring Site 3: MP 203.65, North Beach**

There is ongoing coastal erosion at the base of the riprap slope causing stone to be undermined and dislodged downslope. This reach should be monitored as part of the coastal shoreline monitoring program. See Figure 8.

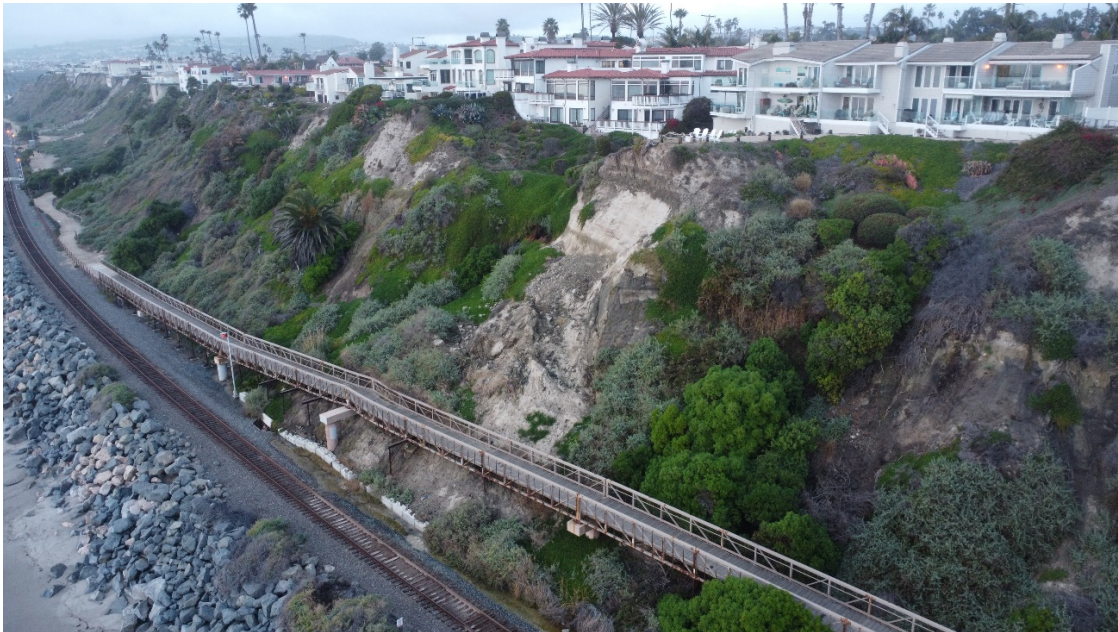
**Figure 9. Monitoring Sites 4 and 5: MP 204.1–204.3, Mariposa Pedestrian Bridge – January 21, 2024.**

There is ongoing coastal (beach) erosion along the base of riprap slopes causing stone to be undermined and dislodged seaward. This reach should be monitored as part of the coastal shoreline monitoring program. See Figure 9.
