# Attachment A: Supplemental Information

## Critical San Clemente Railroad Protection Project – Area 1 (Mile Post 203.80 to Mile Post 203.90) and Area 2 (Mile Post 204.00 to Mile Post 204.40) (Areas 1 and 2)

### Block 19 – Description of Proposed Nationwide Permit Activity

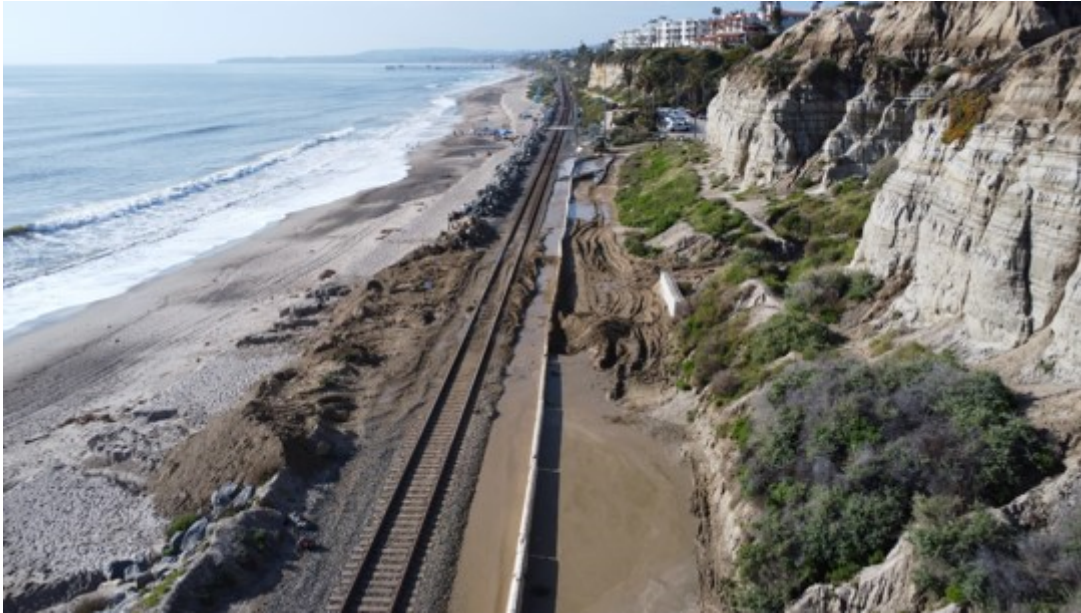
**Figure 10. Monitoring Site #6: MP 206.1, Calafia State Beach**

The face of the sea cliff is entrenched by several small to large size re-entrant canyons generating periodic sediment discharge into low-lying terrain along the landward Rail Corridor margin. Impacts have included flooding, blocking of drainage structures, and deposition of sediment within the Rail Corridor during larger storm events. See Figure 10. Frequent post-storm maintenance efforts have been required to preserve train service, including removal of sediment and ponded water, restoration of surface flow, and installation of concrete blocks at the mouth of canyons in attempt to restrain sediment transport.

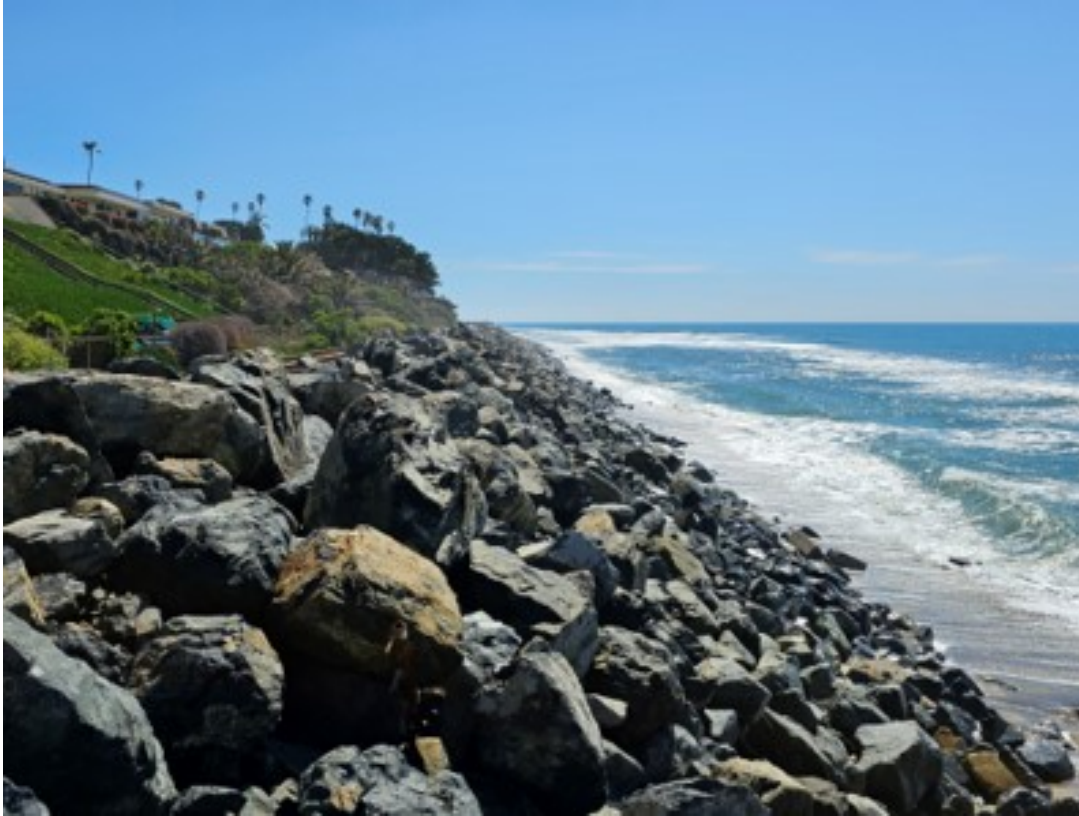
**Figure 11. Monitoring Site 7: MP 206.7–207.25, Cyprus Shore to County Line**

This reach (see Figure 11) should be monitored as part of the coastal shoreline monitoring program to ensure that the riprap section is stable and withstanding wave and weather conditions.

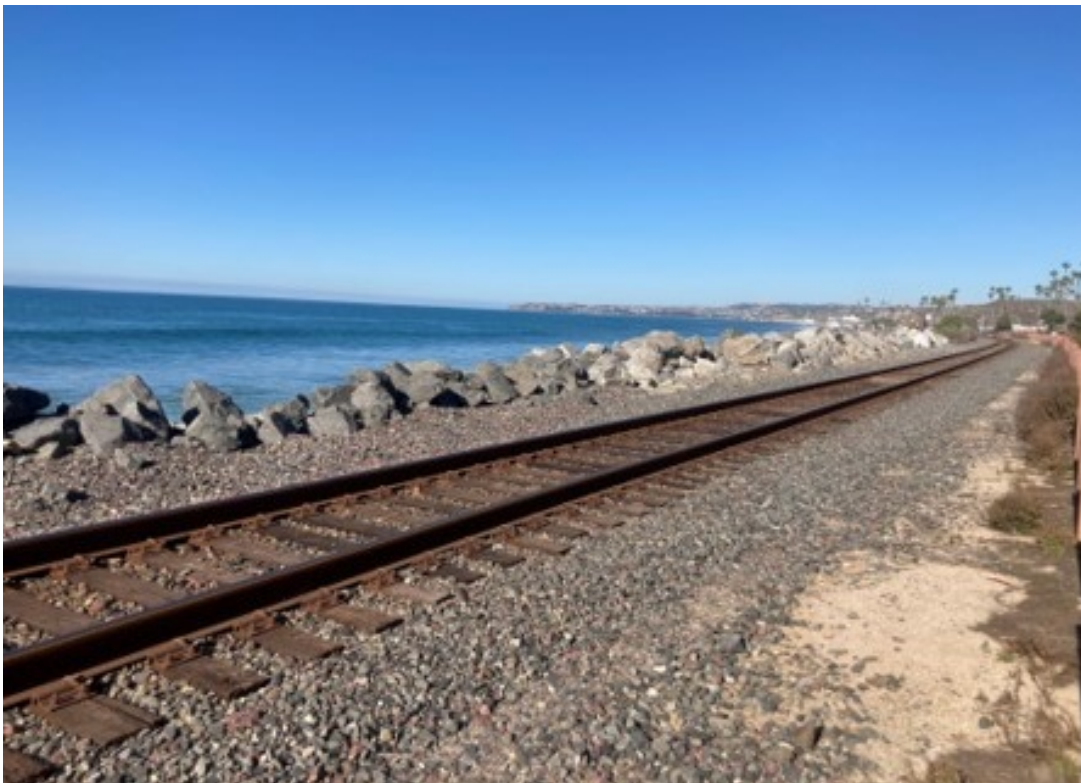
Figure 12. Potential Reinforcement Area 1: MP 203.85 to MP 203.90

Place new rock and/or rework existing rock that has fallen out of section to restore the structure slope and crest elevation, thereby providing beach erosion protection and reduction in wave overtopping. Where possible, place new, larger rock and/or rework existing rock in a way that reduces the slope, thereby improving the stability of the rocks. See Figure 12 and Figure 13.

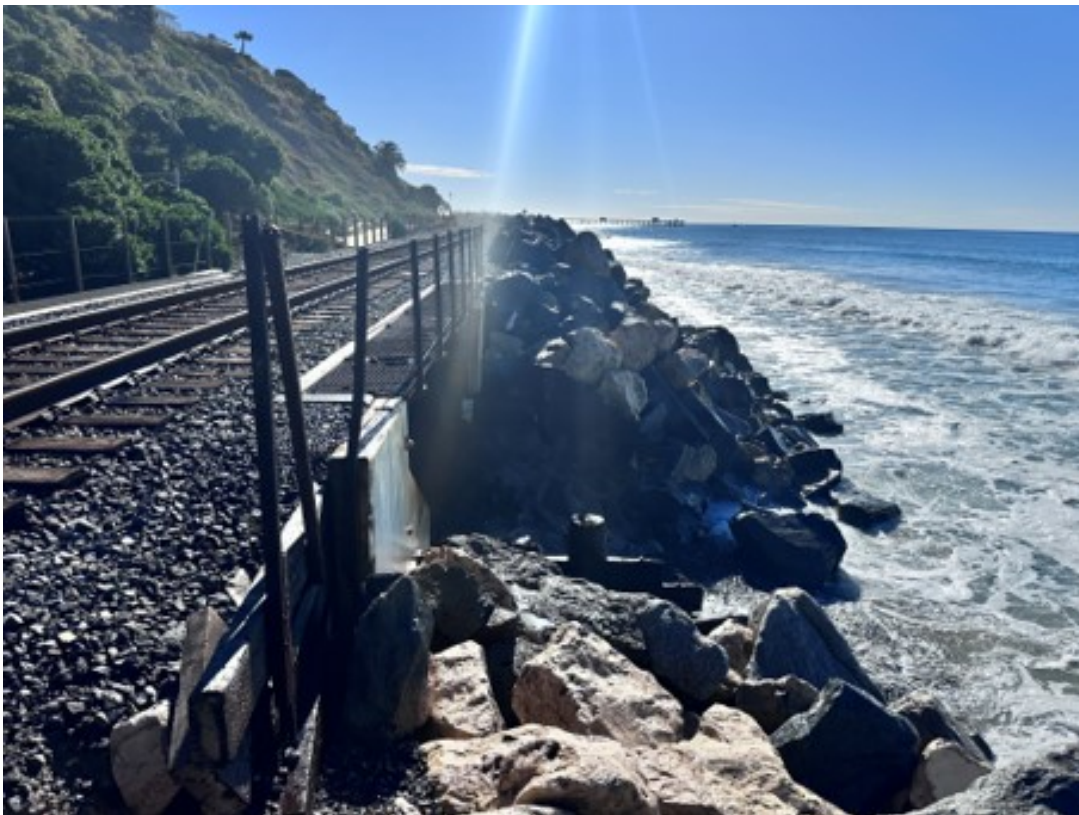
Figure 14. Potential Reinforcement Site 2: MP 204.00 to MP 204.40

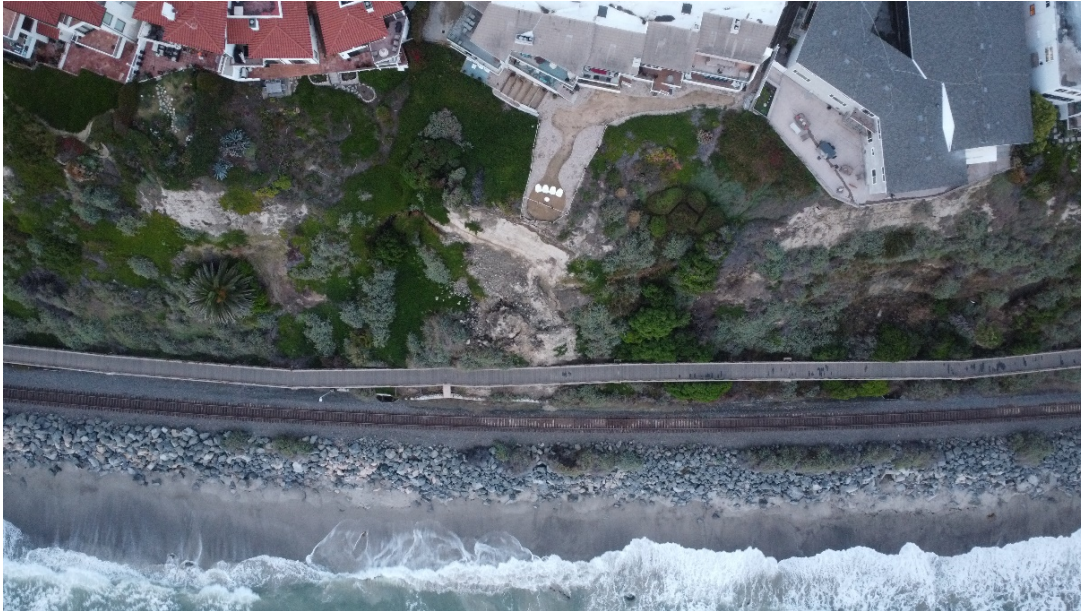
Figure 15. Potential Reinforcement Site 3: MP 204.00 to 204.50, steep bluffs, potential to impact tracks, poor track-side drainage with potential for liquefaction – January 21, 2024

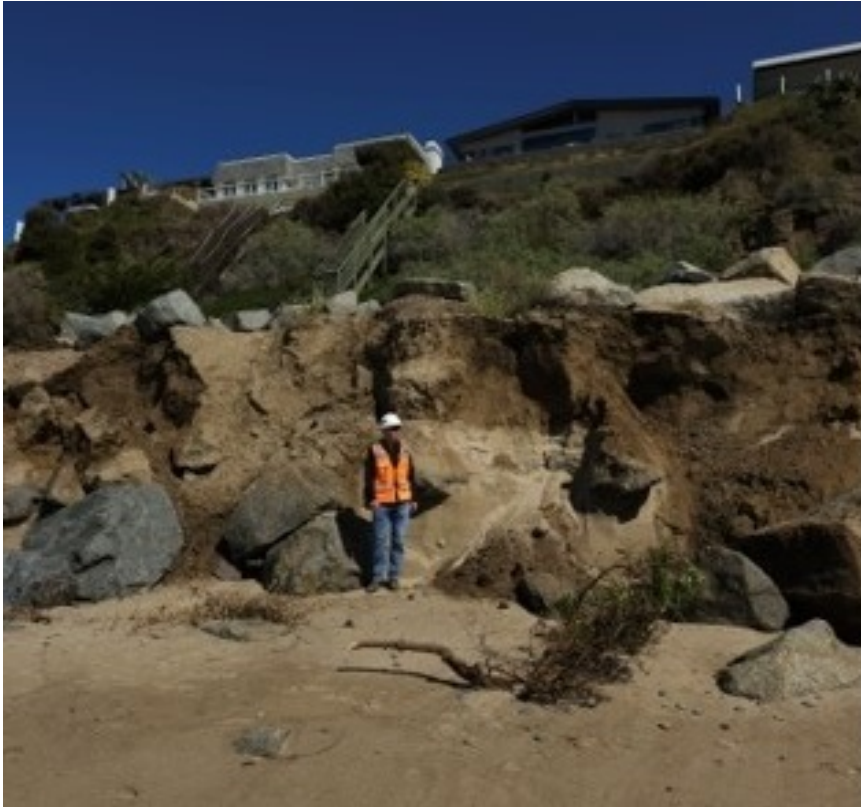
Figure 17. Potential Reinforcement Site 4: MP 206.00 to 206.67, North End of Cyprus Shore Project.
