# M2 Natural Community Conservation Plan/Habitat Conservation Plan– 2019 Annual Report

Prepared by  
**Orange County Transportation Authority**  
550 S. Main Street  
Orange, CA 92863

April 2020

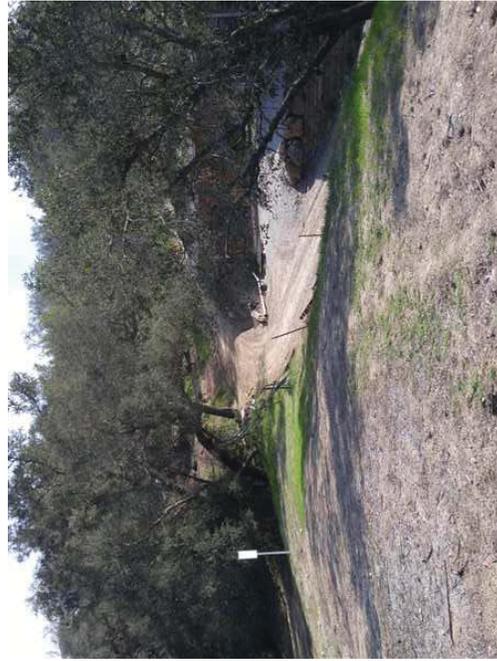
Photograph 11: Slanted fence line observed during fence line monitoring. Photo taken January 30, 2019.

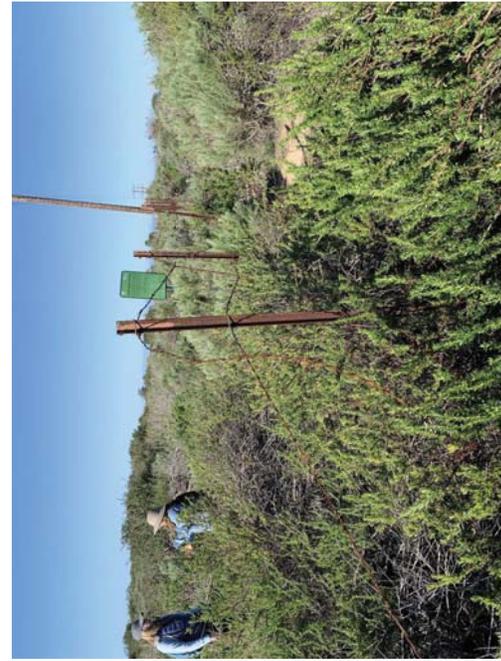
Photograph 1: View of rusted barbed wire fence to be repaired. Photo taken March 14, 2019.

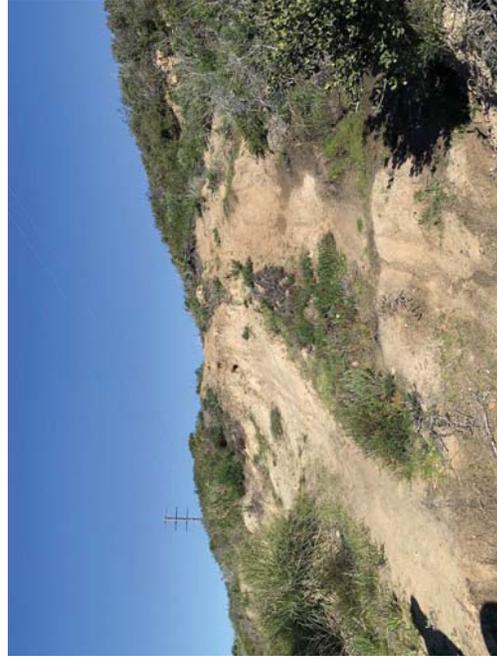
Photograph 2: View of mountain bike disturbance area to be restored. Photo taken March 14, 2019.

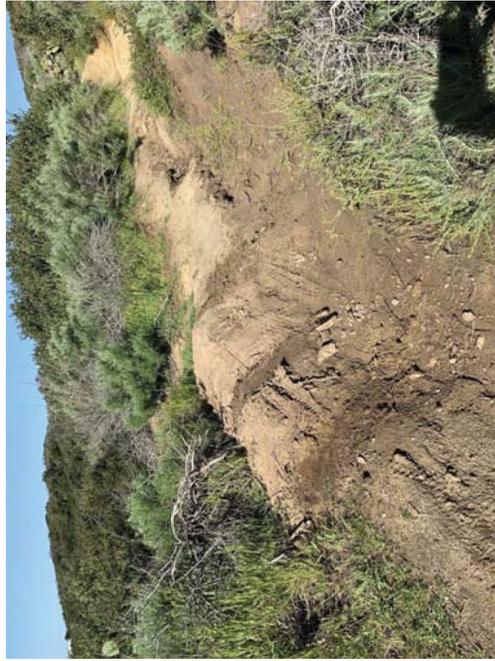
Photograph 3: View of berm created for mountain biking. Area to be restored. Photo taken March 14, 2019.

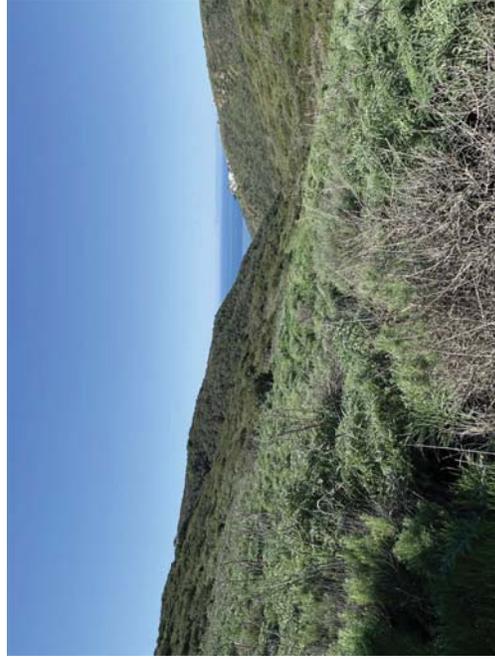
Photograph 4: View of artichoke field to be treated. Photo taken March 14, 2019.

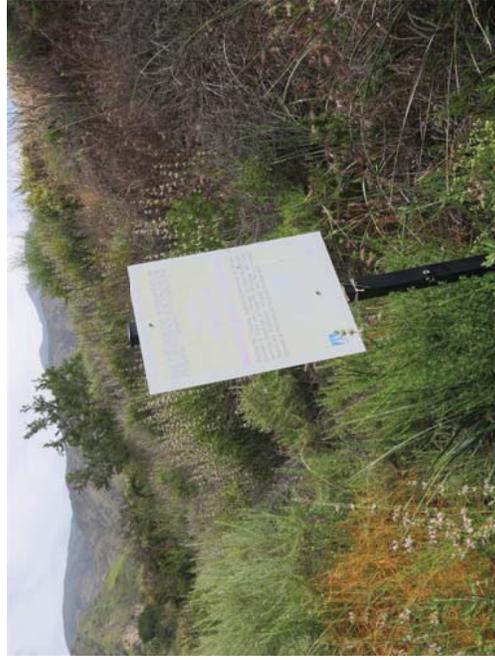
Photograph 4: View of faded sign recommended for replacement. Photo taken May 2, 2019.

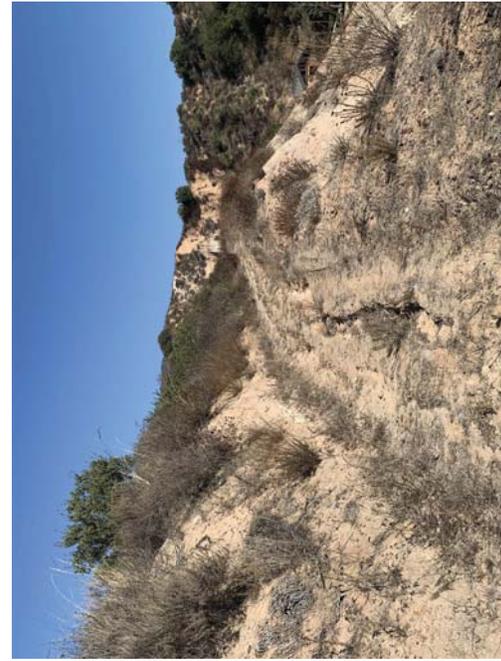
Photograph 5: View of the unauthorized grading along the southern Preserve boundary looking east. Photo taken November 4, 2019.

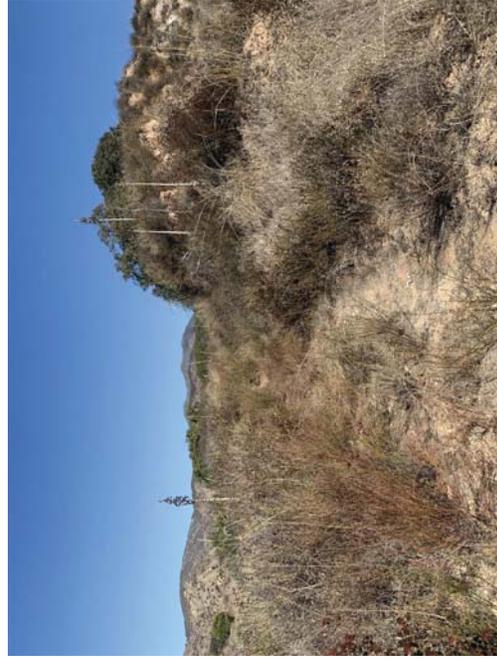
Photograph 6: View of the unauthorized grading along the southern Preserve boundary looking northeast. Photo taken November 4, 2019.

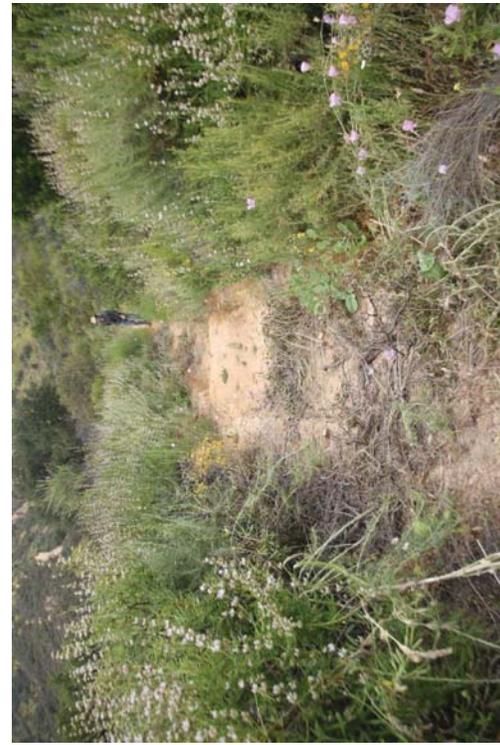
Photograph 1: View of unauthorized trail modification for mountain bike use. Photo taken May 2, 2019.

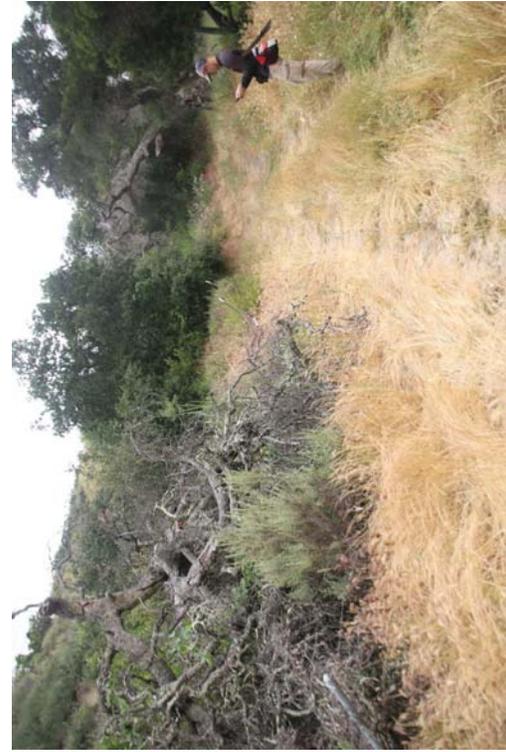
Photograph 1: View of downed oak tree on interior fence. Photo taken May 9, 2019.

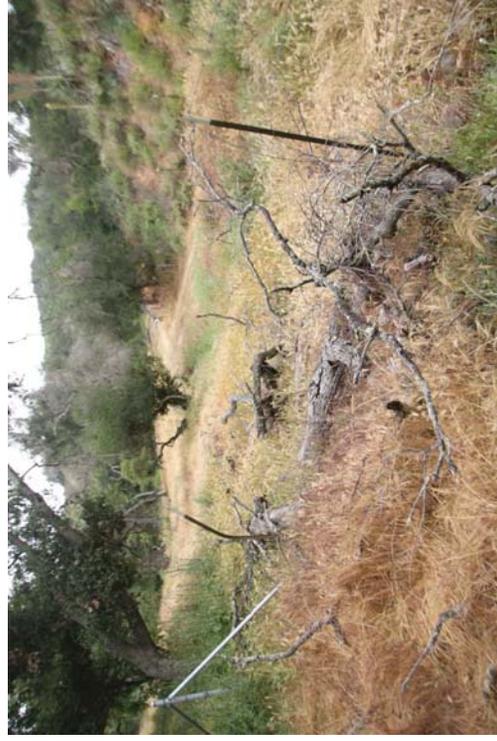
Photograph 2: View of downed oak tree on perimeter fence. Photo taken May 9, 2019.

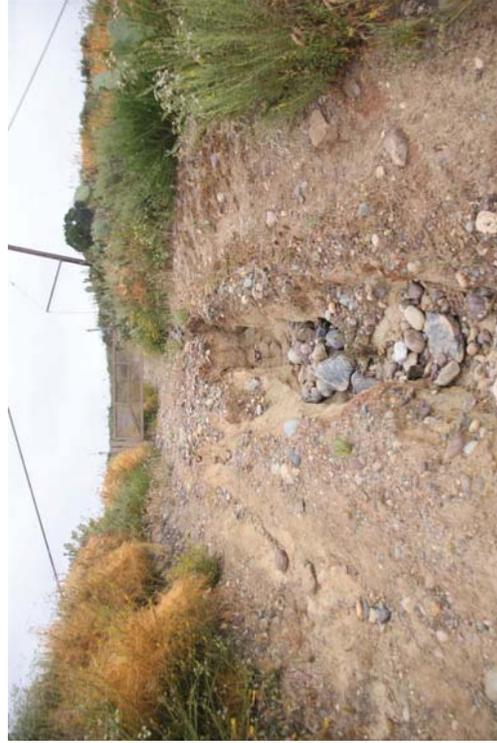
Photograph 3: Ongoing erosion issue leading up to main gate. Photo taken May 9, 2019.

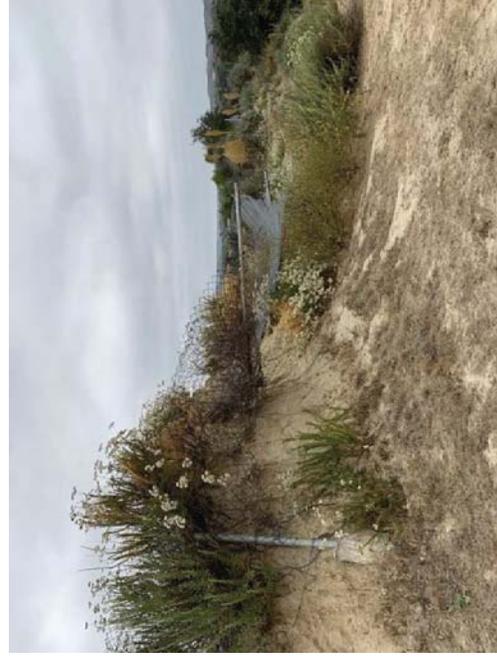
Photograph 4: View of downed interior chain link fence. Photo taken June 14, 2019.

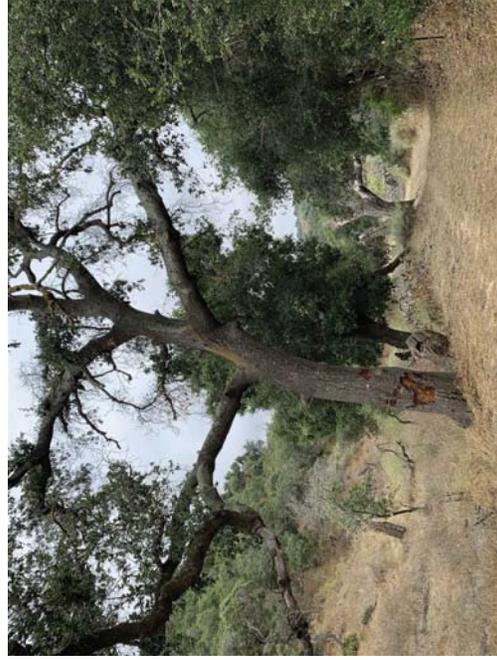
Photograph 6: View of oak tree infested with Goldspotted Oak Borer, which was subsequently removed. Photo taken June 26, 2019.

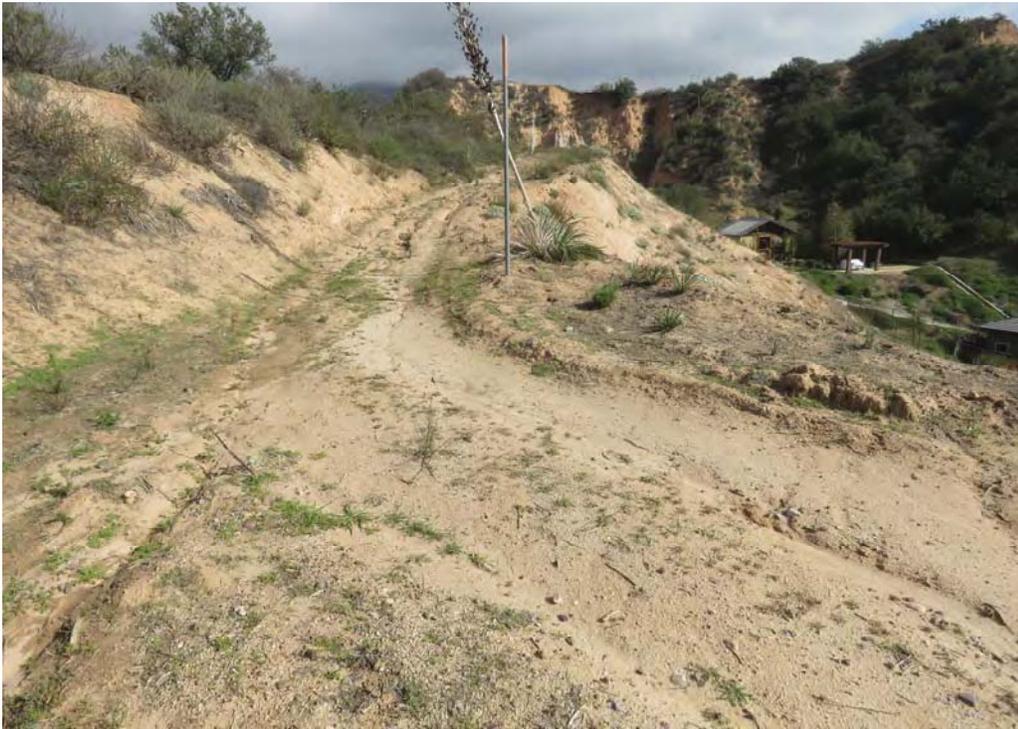
Photograph Location 1: Taken December 18, 2018, depicts the above area, downslope at the preserve boundary and facing northeast. Detected species include non-native longbeak stork's bill (*Erodium botrys*) and smooth cat's ears (*Hypochaeris glabra*) and bare ground.

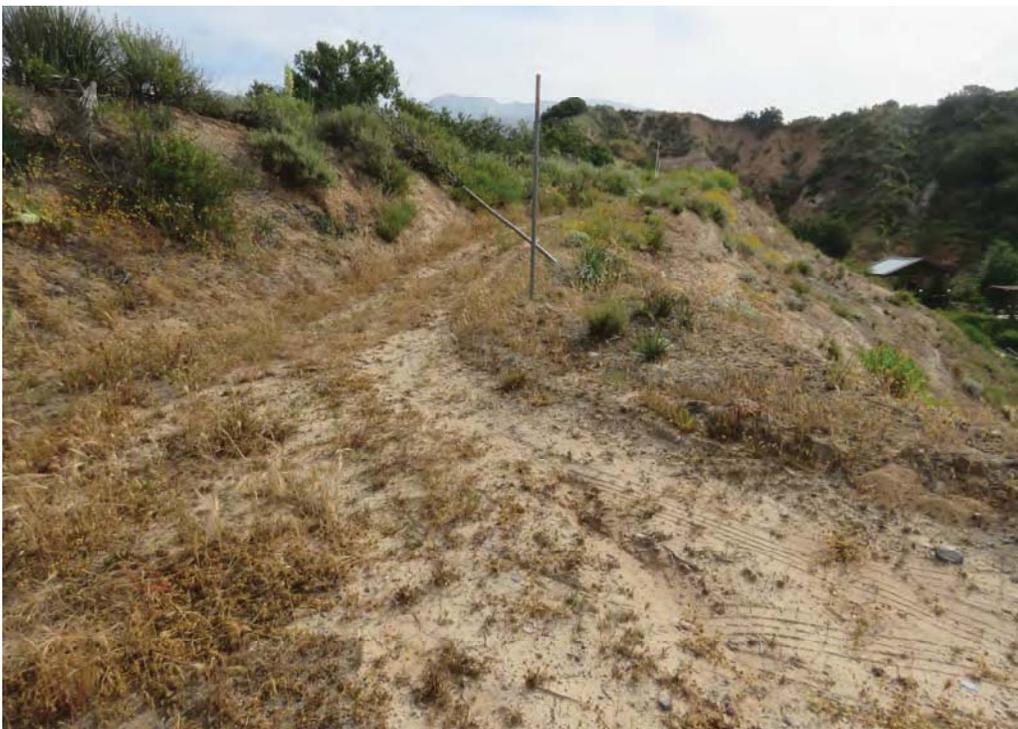
Photograph Location 1: Taken May 2, 2019 depicting bare areas and non-native species dominated with crete weed (*Hedypnois cretica*), red brome (*Bromus madritensis ssp. rubens*), and ripgut brome (*Bromus diandrus*).

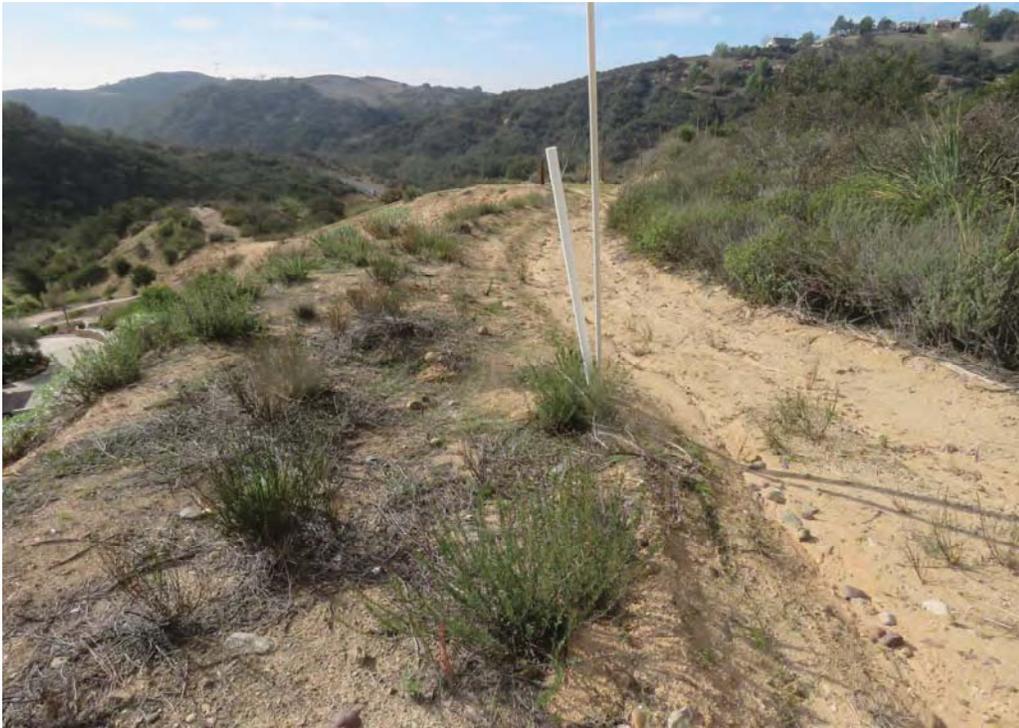
Photograph Location 2: Taken December 18, 2018. Species recruitment includes deerweed (*Acmispon glaber*) within road and California buckwheat (*Eriogonum fasciculatum*) along road at center.

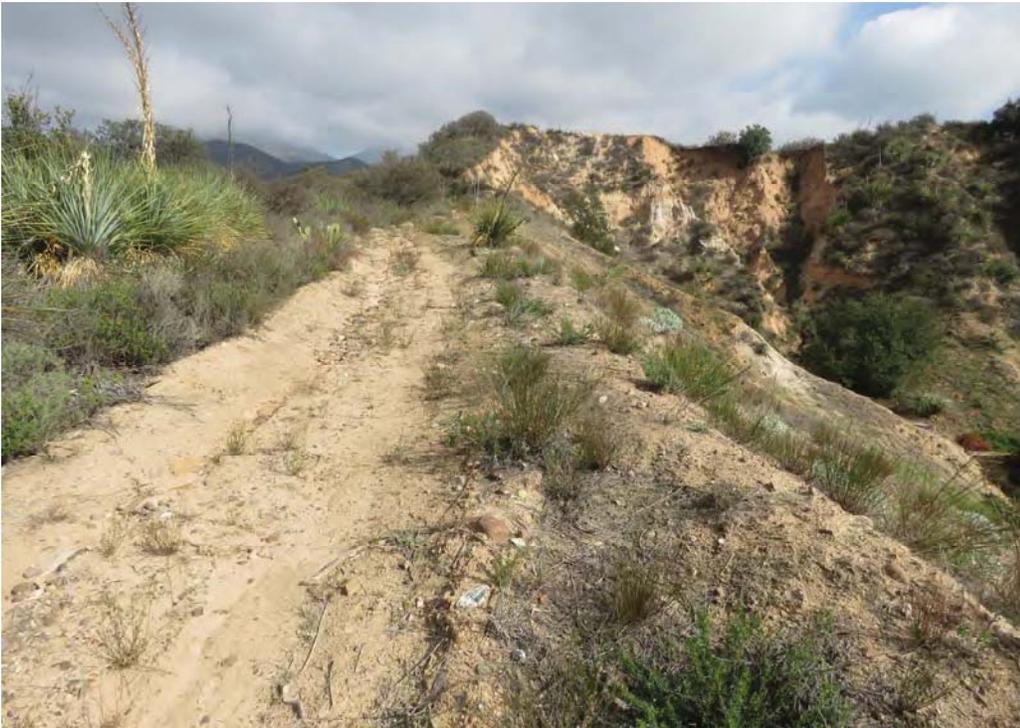
Photograph Location 3: Taken December 18, 2108, depicts native recruits including deerweed, and lupine (*Lupinus sp.*) and chia (*Salvia columbriæ*) seedlings within the road.

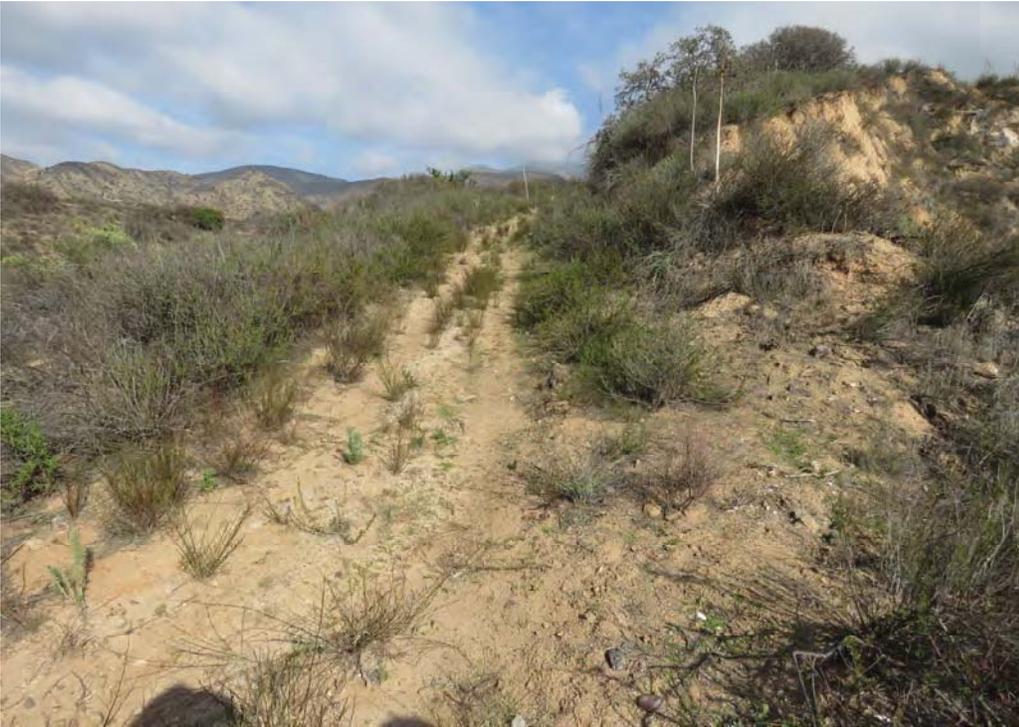
Photograph Location 4: Taken December 18, 2018, depicting the area above, down slope and facing northeast. The road remains generally bare with deerweed continues to be the dominant species.

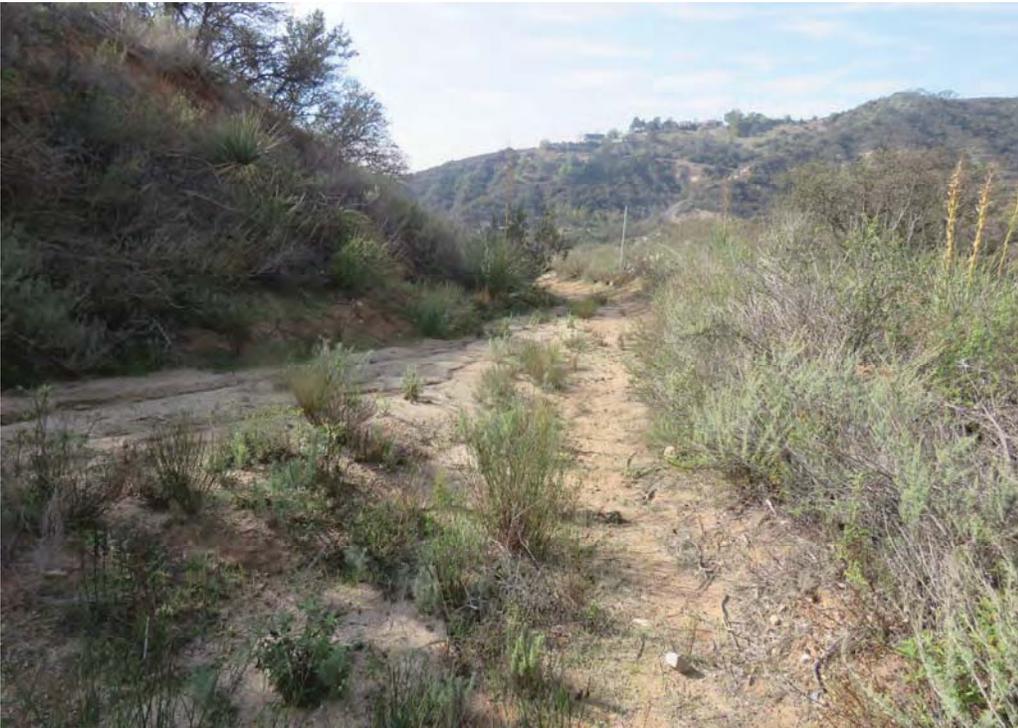
Photograph Location 5: Taken December 18, 2018, depicting the area with an increase in native species cover. Deerweed and California sagebrush continue to be the dominant species within the road area.

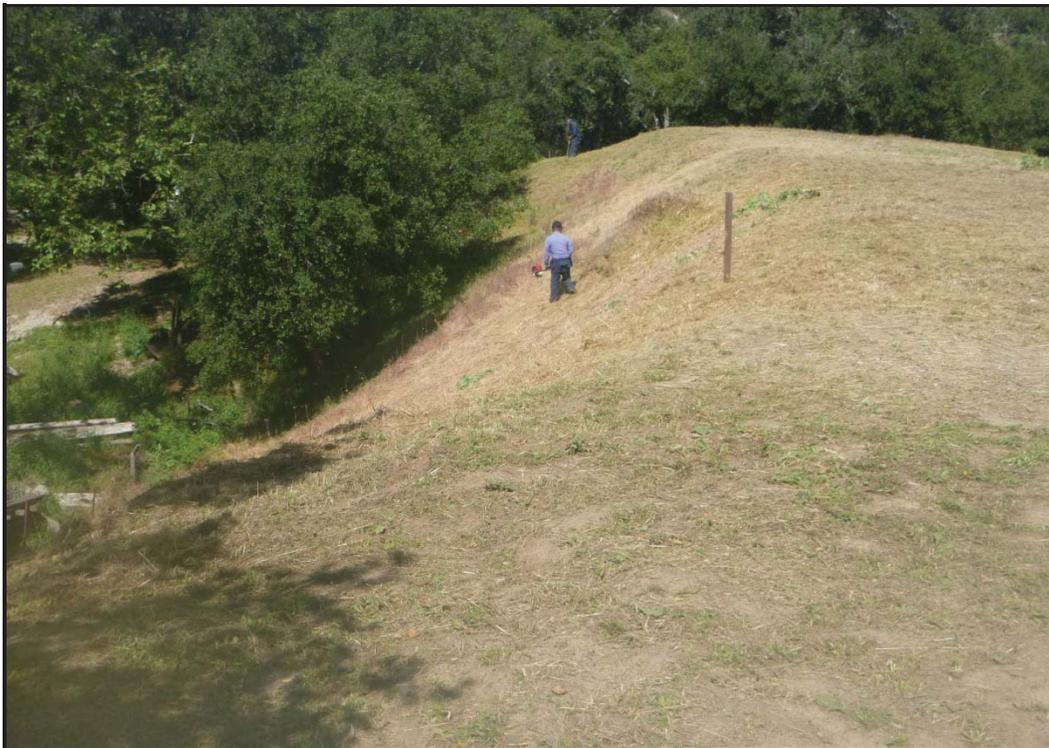
**PHOTOGRAPH 2**  
Vegetation Removal within Trabuco Rose A Fuel Modification Zone,  
April 2019

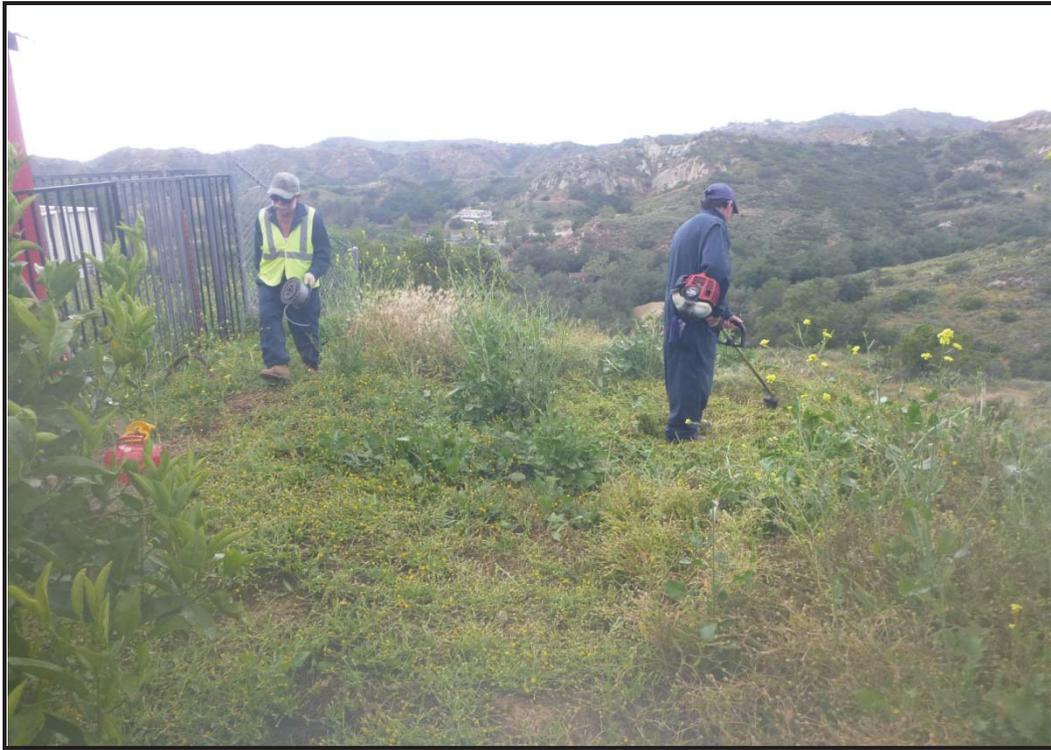
PHOTOGRAPH 3  
Vegetation Removal within Trabuco Rose B Fuel Modification Zone,  
April 2019

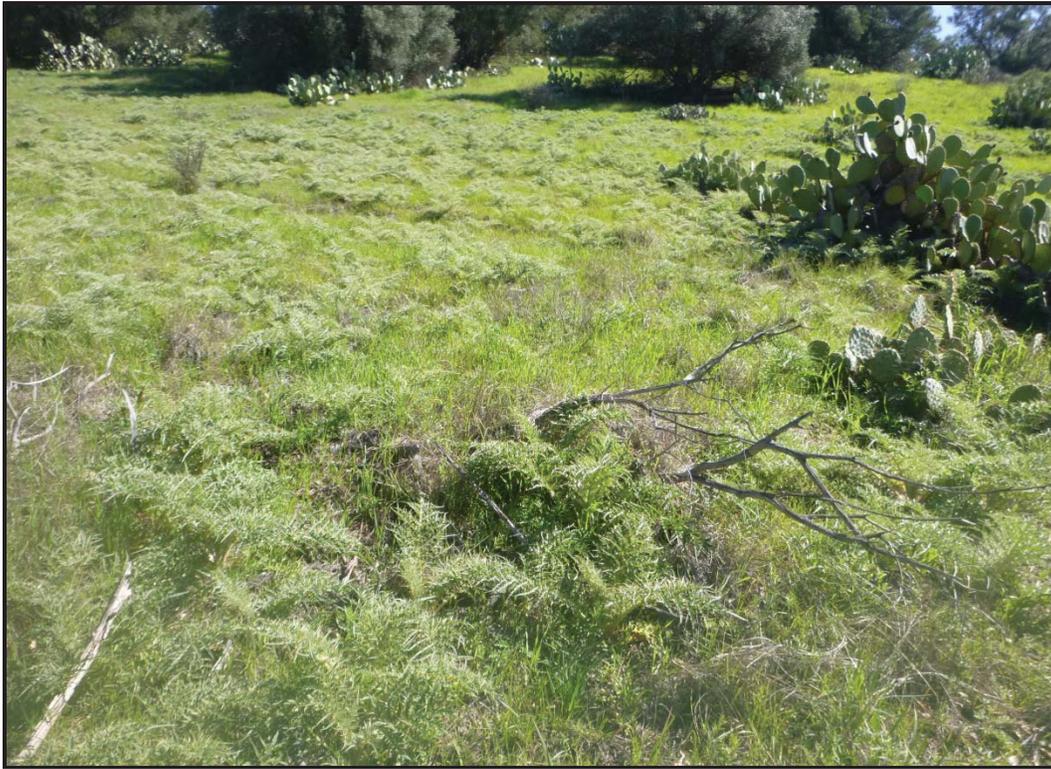
PHOTOGRAPH 4  
Trabuco Rose, Area 17, Before Herbicide Application, February 2019

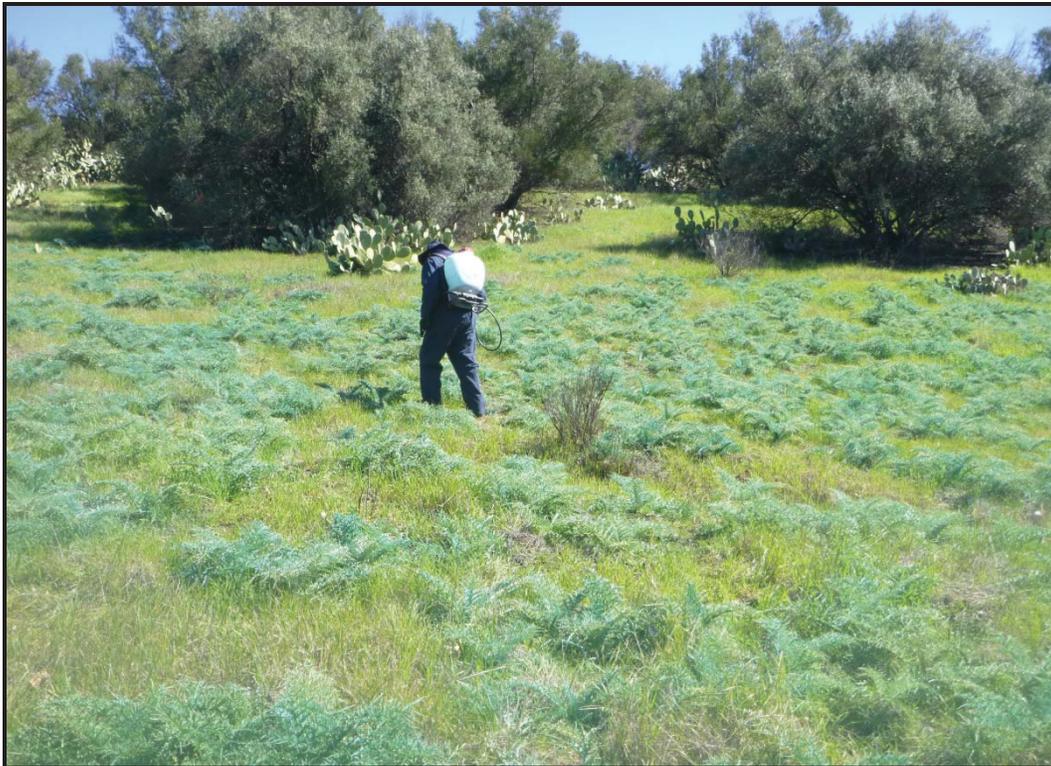
PHOTOGRAPH 5  
Trabuco Rose, Area 17, During Herbicide Application, February 2019

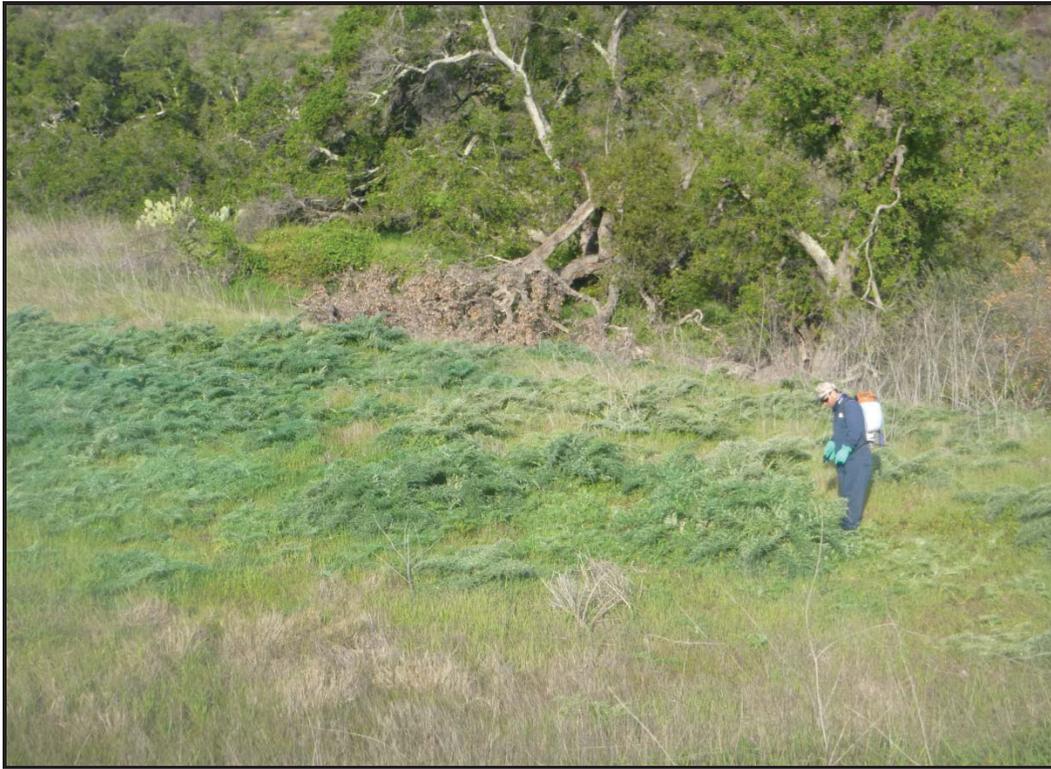
**PHOTOGRAPH 6**  
Trabuco Rose, Area 24, During Herbicide Application, February 2019

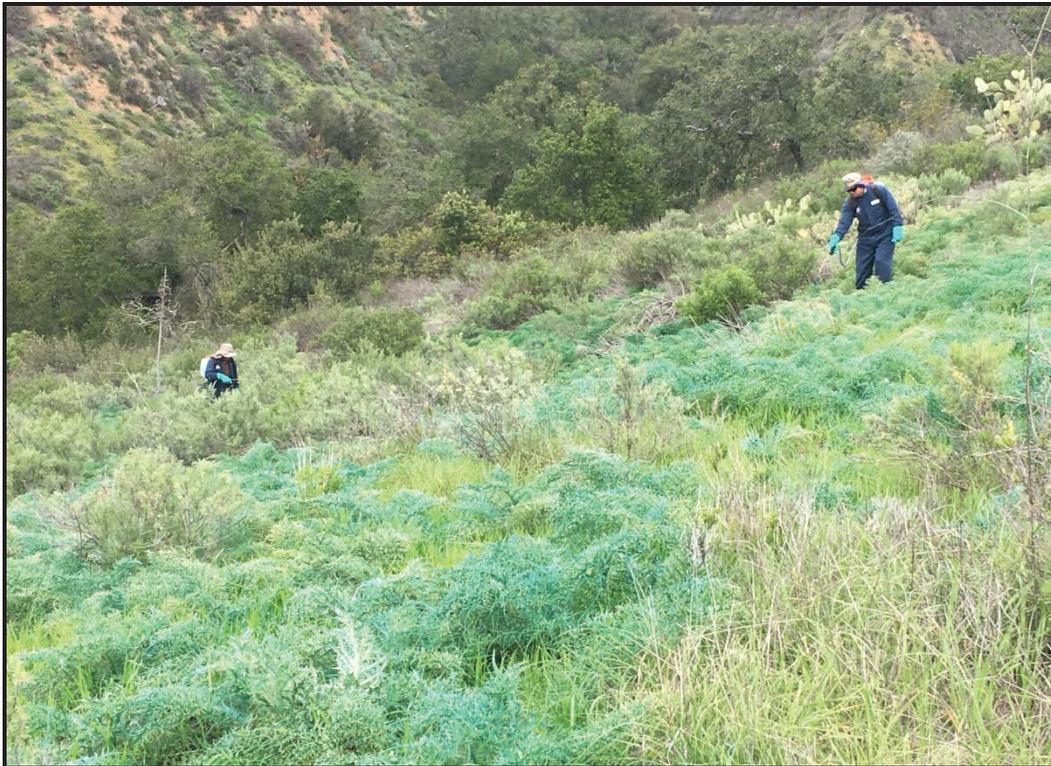
**PHOTOGRAPH 7**  
Trabuco Rose, Area 25, During Herbicide Application, March 2019

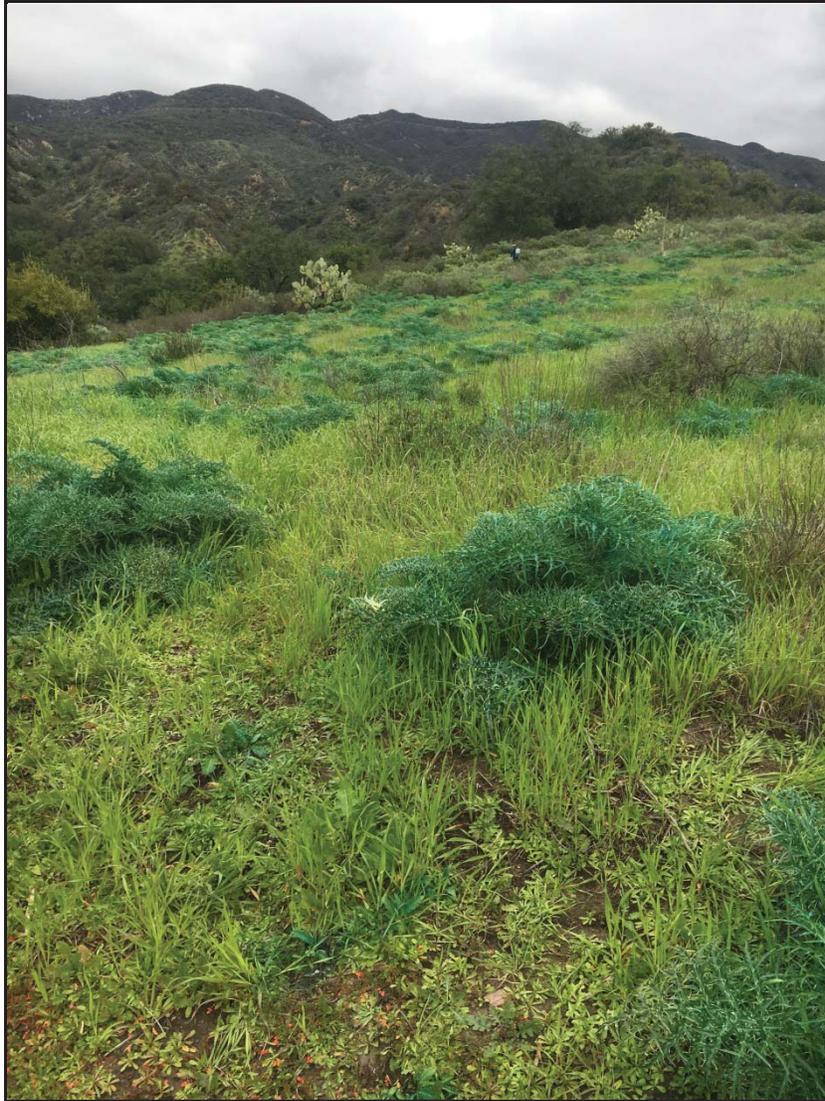
PHOTOGRAPH 8  
Trabuco Rose, Area 25, Following Herbicide  
Application, March 2019

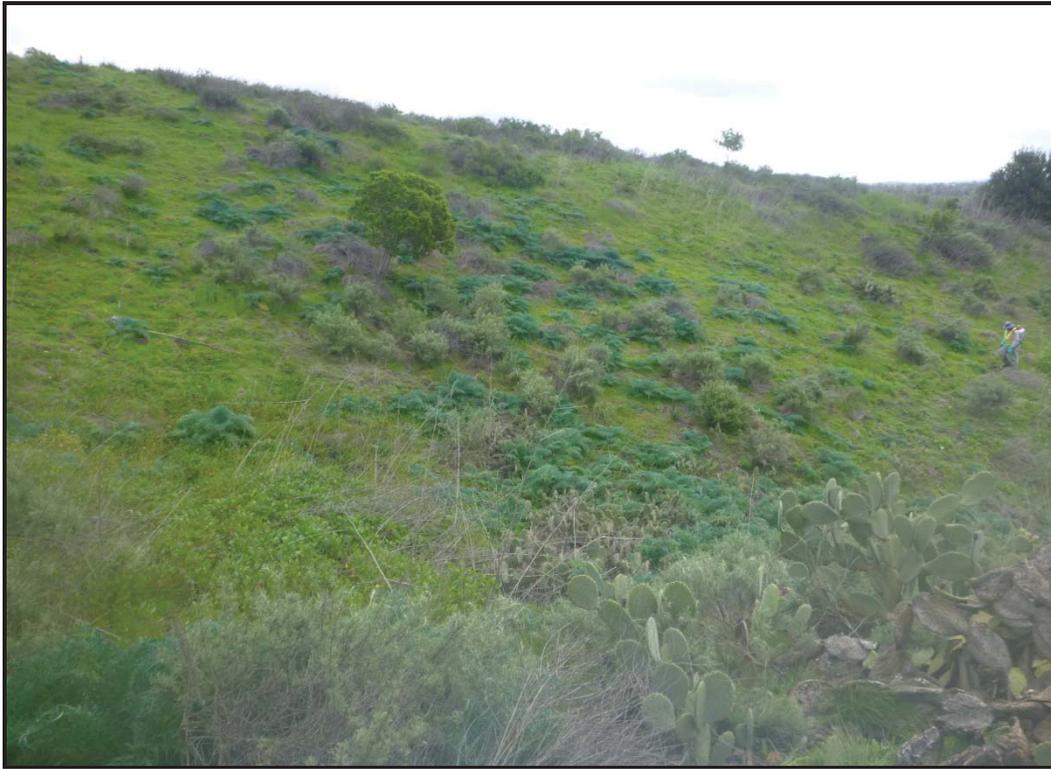
**PHOTOGRAPH 9**  
Trabuco Rose, Area 32, During Herbicide Application, March 2019

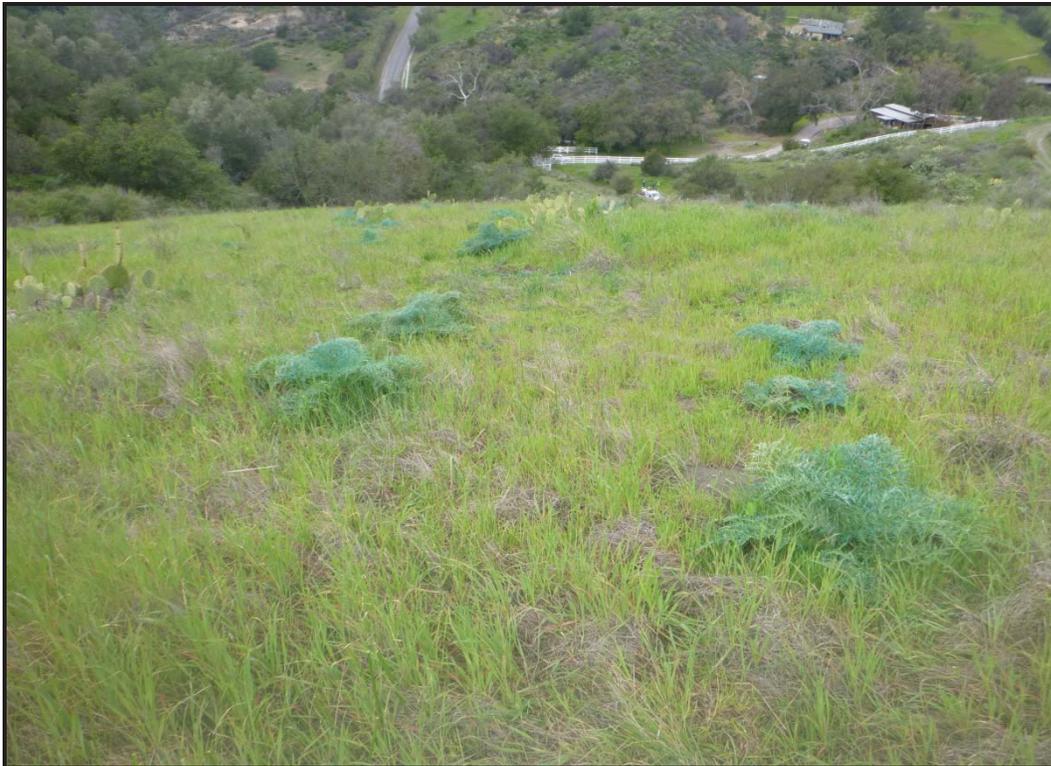
**PHOTOGRAPH 10**  
Trabuco Rose, Area 35, Following Herbicide Application, March 2019

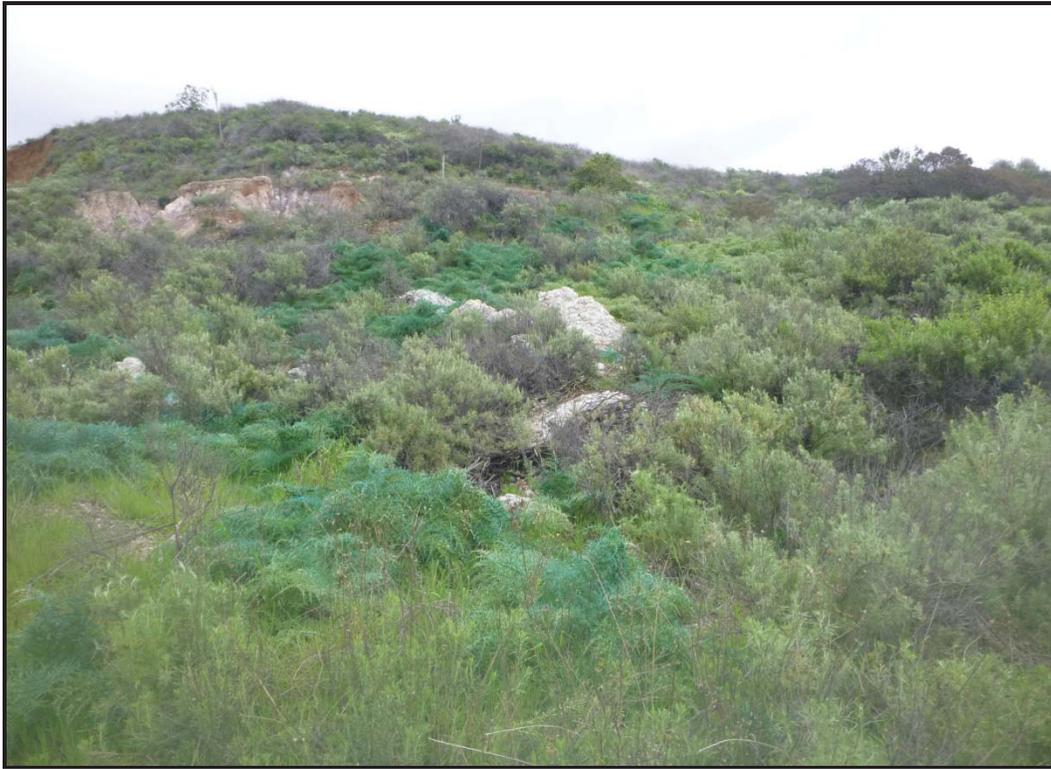
PHOTOGRAPH 11  
Trabuco Rose, Area 37, Following Herbicide Application, March 2019

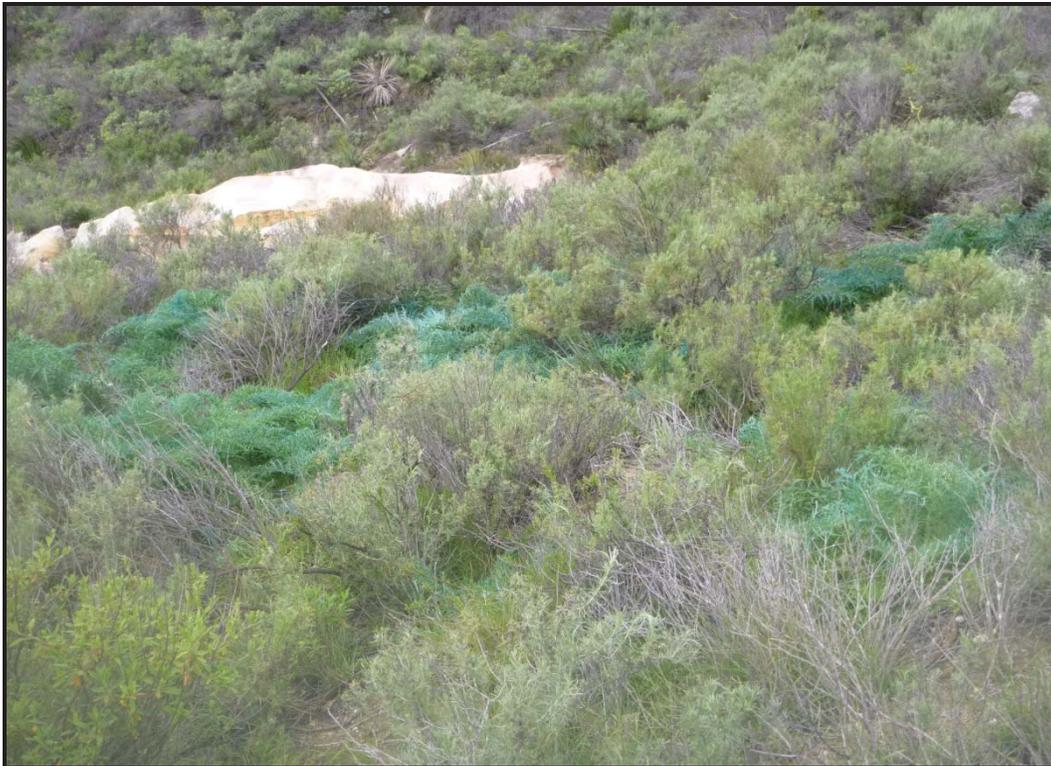
PHOTOGRAPH 12  
Trabuco Rose, Area D, Following Herbicide Application, March 2019

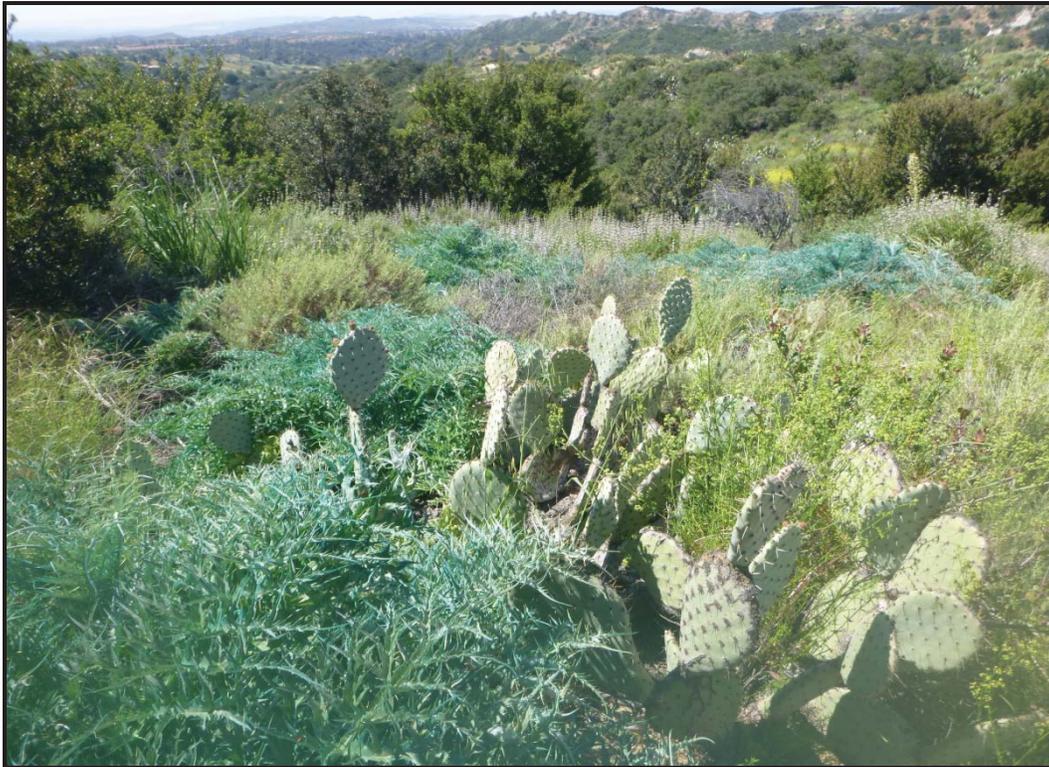
PHOTOGRAPH 13  
Trabuco Rose, Area B, Following Herbicide Application, April 2019

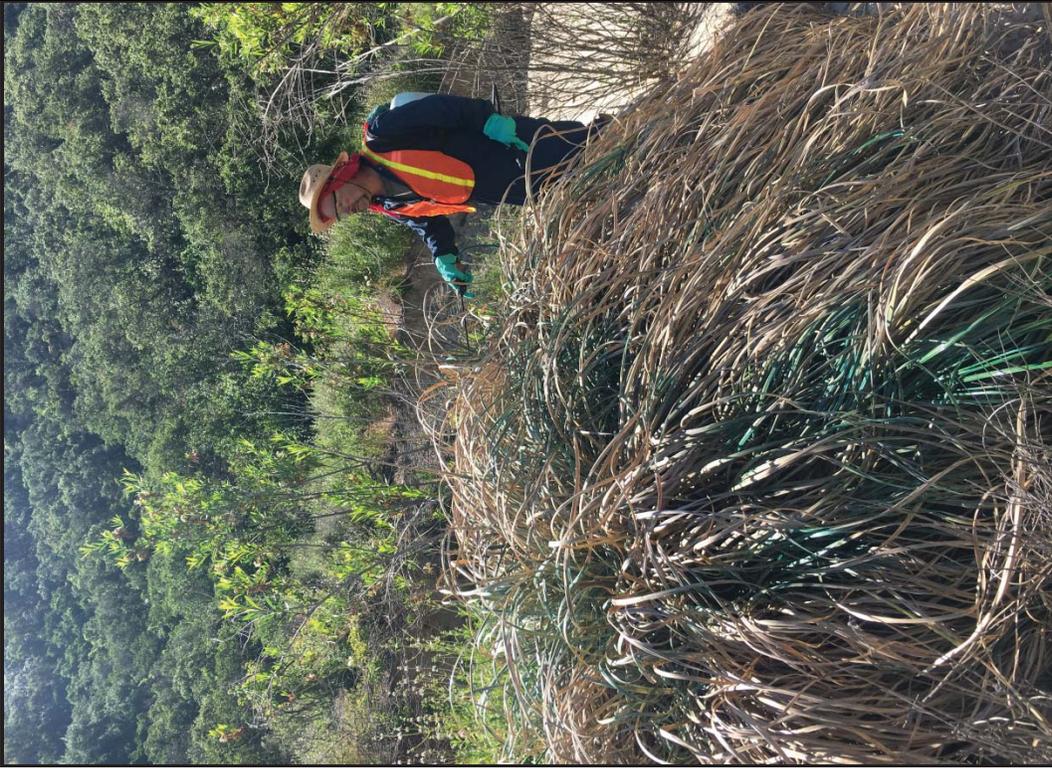
**PHOTOGRAPH 14**  
Trabuco Rose, Area 47, During Herbicide  
Application, April 2019

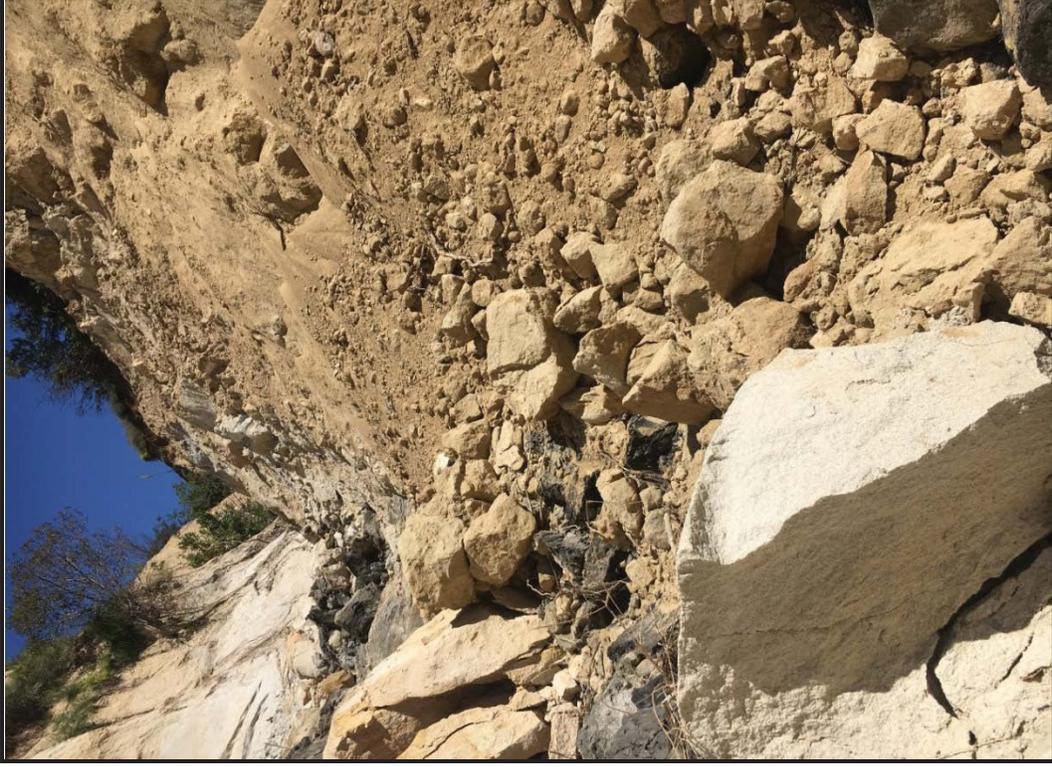
**PHOTOGRAPH 15**  
Trabuco Rose, Erosion within Canyon, Looking  
Upstream, Following Winter Storms, April 2019

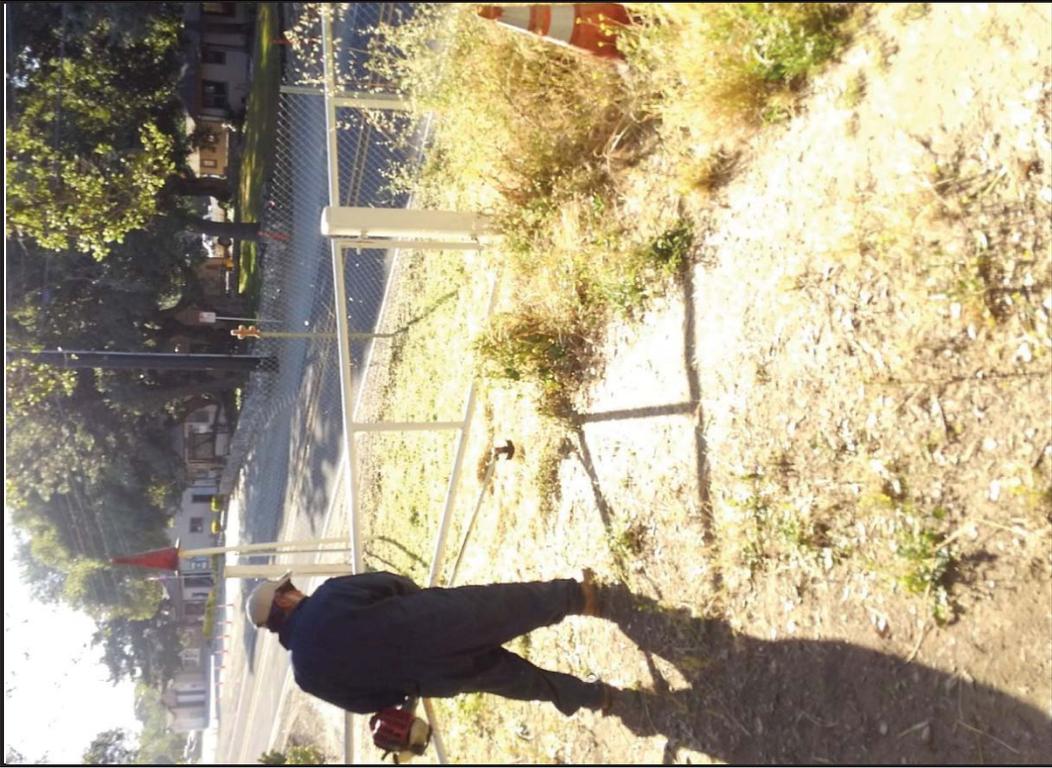
For vegetation removal along the fire roads/access roads, there were several mapped locations of intermediate mariposa lily located within or adjacent to the roads. Therefore, special care was taken in these areas to detect the plant and avoid any disturbances while vegetation removal occurred. Vegetation was removed along Trabuco Canyon Road and the entrance to Wren’s View, as well as on all fire roads (Photographs 18 and 19). A summary of the work completed at Wren’s View has been included in Table 2.

**PHOTOGRAPH 18**  
Vegetation Removal along Trabuco Canyon Road  
and Entrance to Wren's View Preserve, June 2019
