# M2 Natural Community Conservation Plan/Habitat Conservation Plan– 2019 Annual Report

Prepared by  
**Orange County Transportation Authority**  
550 S. Main Street  
Orange, CA 92863

April 2020

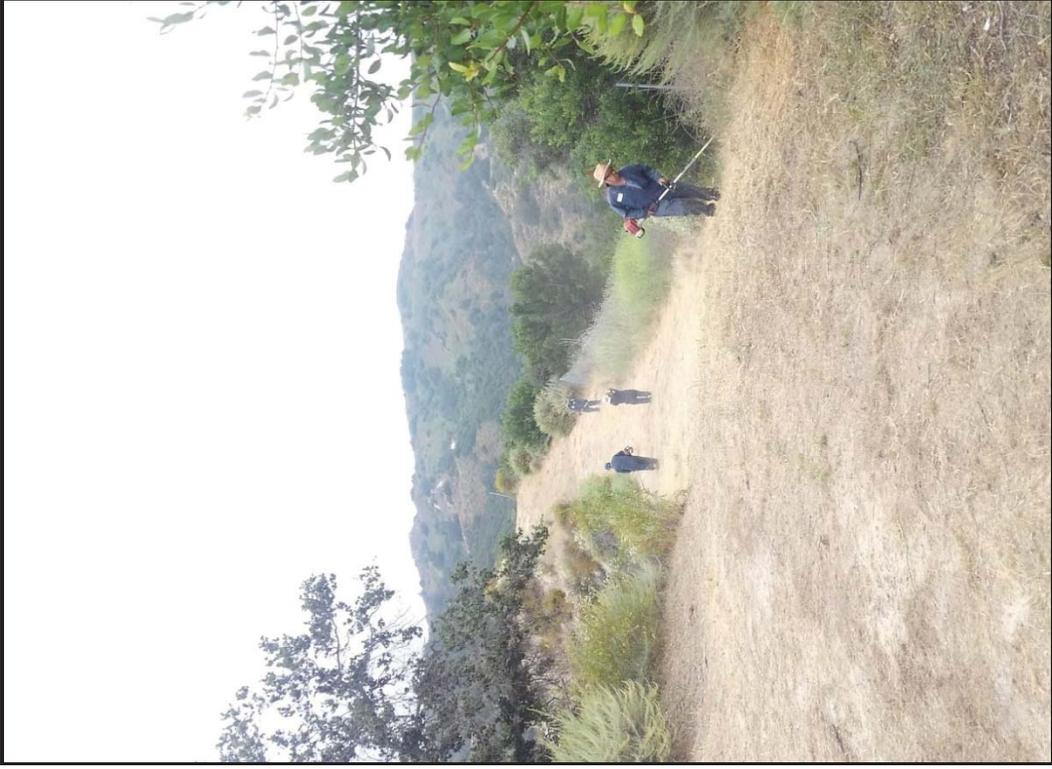
For vegetation removal along the fire roads/access roads, there were several mapped locations of intermediate mariposa lily located within or adjacent to the roads. Therefore, special care was taken in these areas to detect the plant and avoid any disturbances while vegetation removal occurred. Vegetation was removed along Trabuco Canyon Road and the entrance to Wren’s View, as well as on all fire roads (Photographs 18 and 19). A summary of the work completed at Wren’s View has been included in Table 2.

**PHOTOGRAPH 19**  
Vegetation Removal on Fire Roads at  
Wren's View Preserve, June 2019

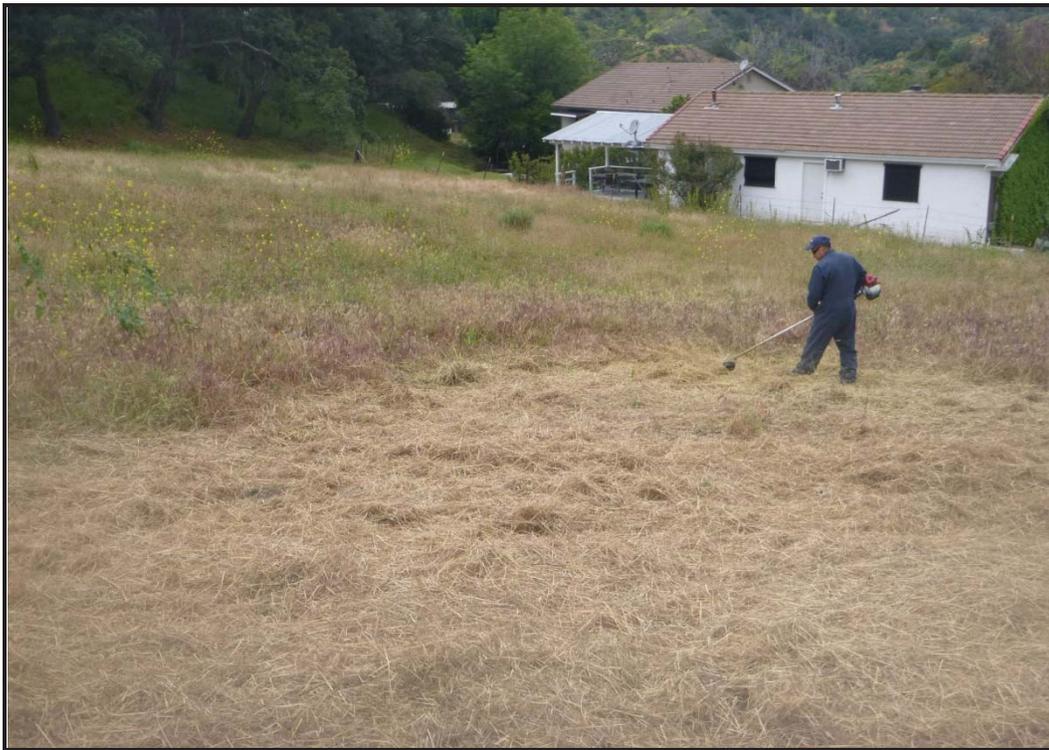
PHOTOGRAPH 20  
Vegetation Removal within Live Oak Creek A Fuel Modification Zone,  
May 2019

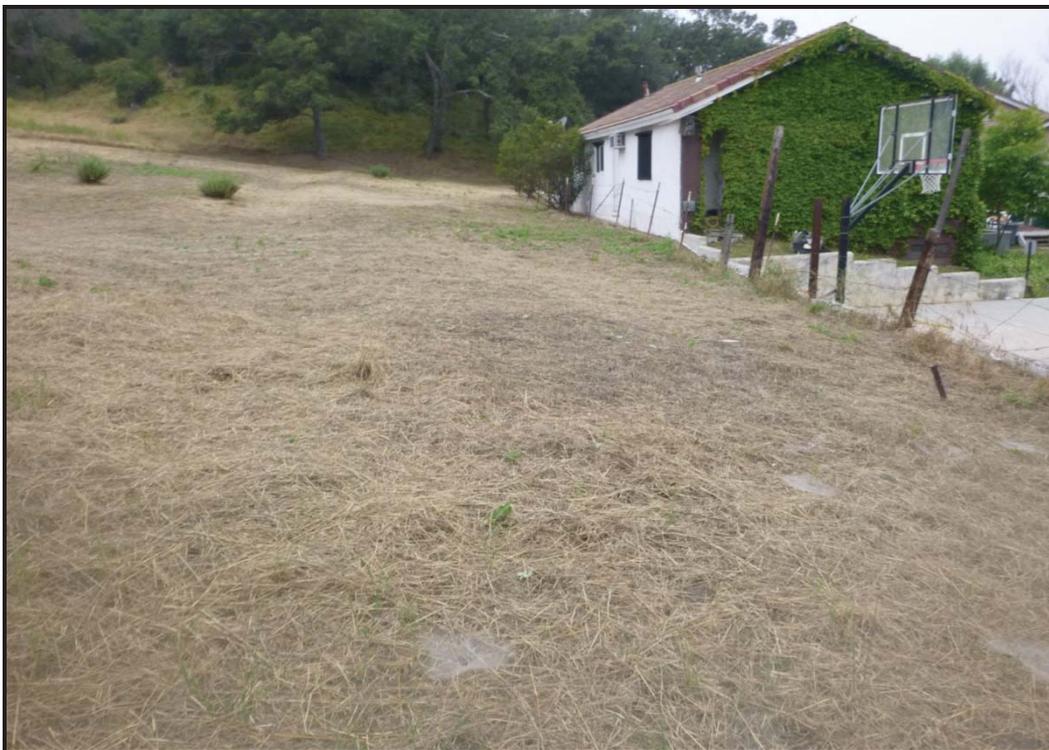
PHOTOGRAPH 21  
Live Oak Creek A Fuel Modification Zone, Following Vegetation  
RECON Removal at Live Oak Creek, June 2019

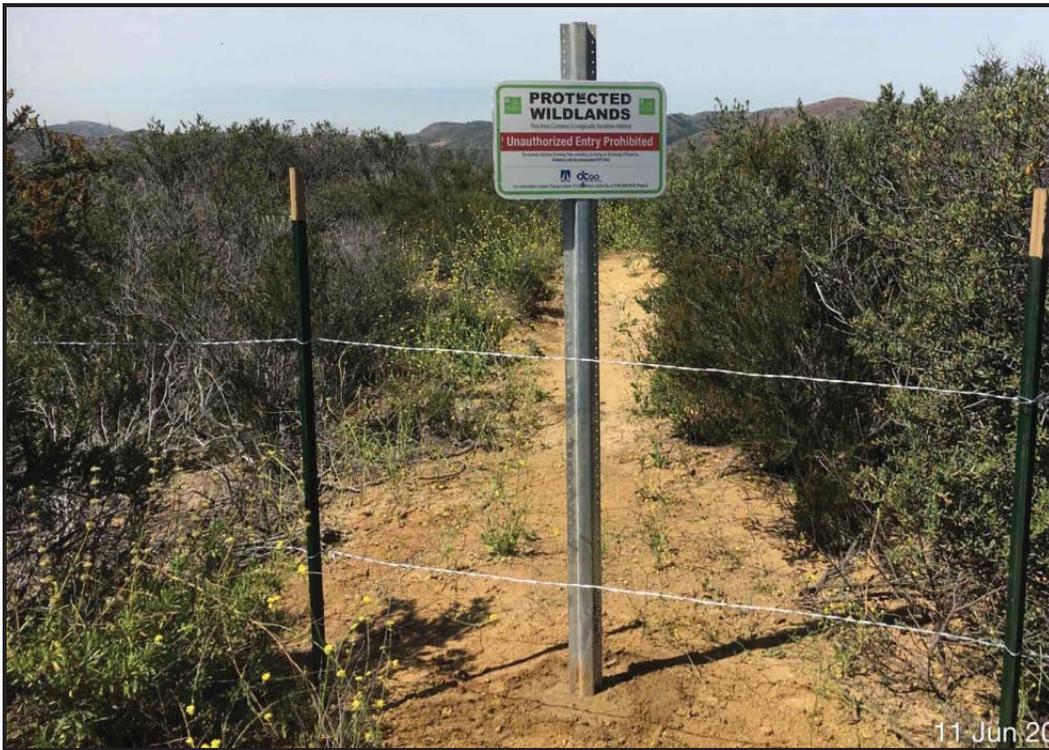
Maintenance tasks performed at the Silverado Chaparral Preserve included the installation of Preserve signs and wildlife-friendly fencing in select locations (Photographs 24 and 25). The installation of fencing included barbless wire 3-strand fencing, with the lowest strand of fencing at least 18 inches from the ground to allow for the safe passage of wildlife (i.e., deer). Fencing was installed in three separate locations at access points along the perimeter of the Preserve’s property (Figure 5), for a total of approximately 140 linear feet of new fencing. Additionally, six Preserve signs were installed at four separate locations (see Figure 5). A summary of the work completed at the Silverado Chaparral Preserve has been included in Table 5.

PHOTOGRAPH 24  
Installation of Signage and Fence at Silverado Chaparral Preserve  
(northeastern perimeter location), June 2019

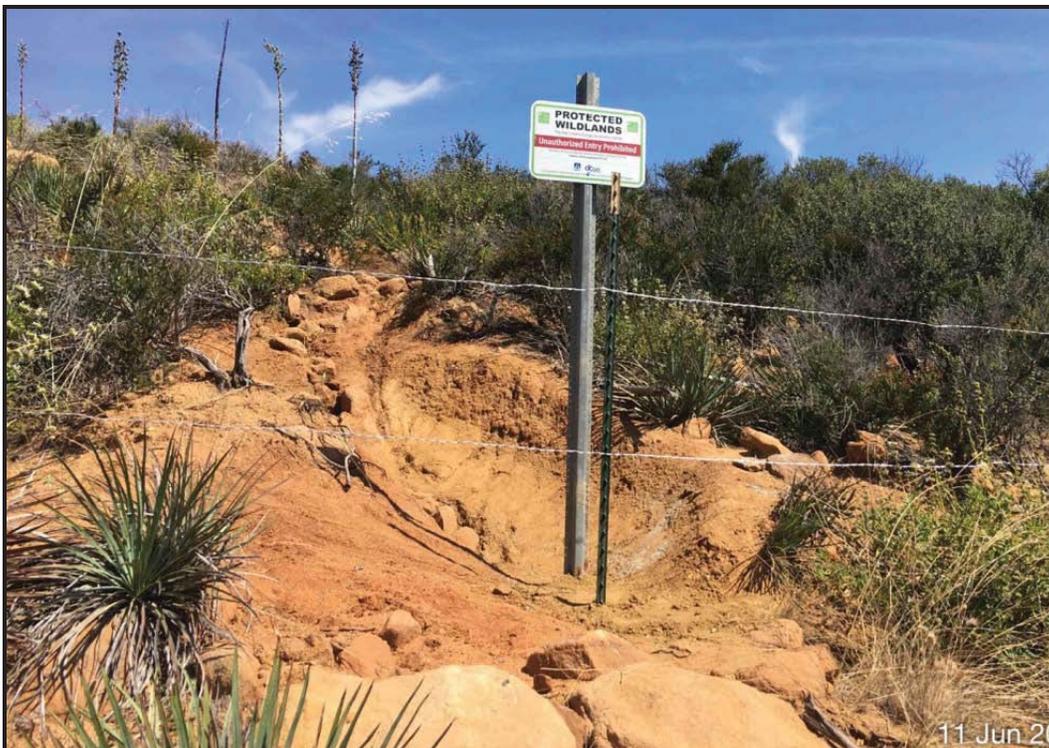
PHOTOGRAPH 25  
Installation of Signage and Fence at Silverado Chaparral Preserve  
(southeastern perimeter location), June 2019

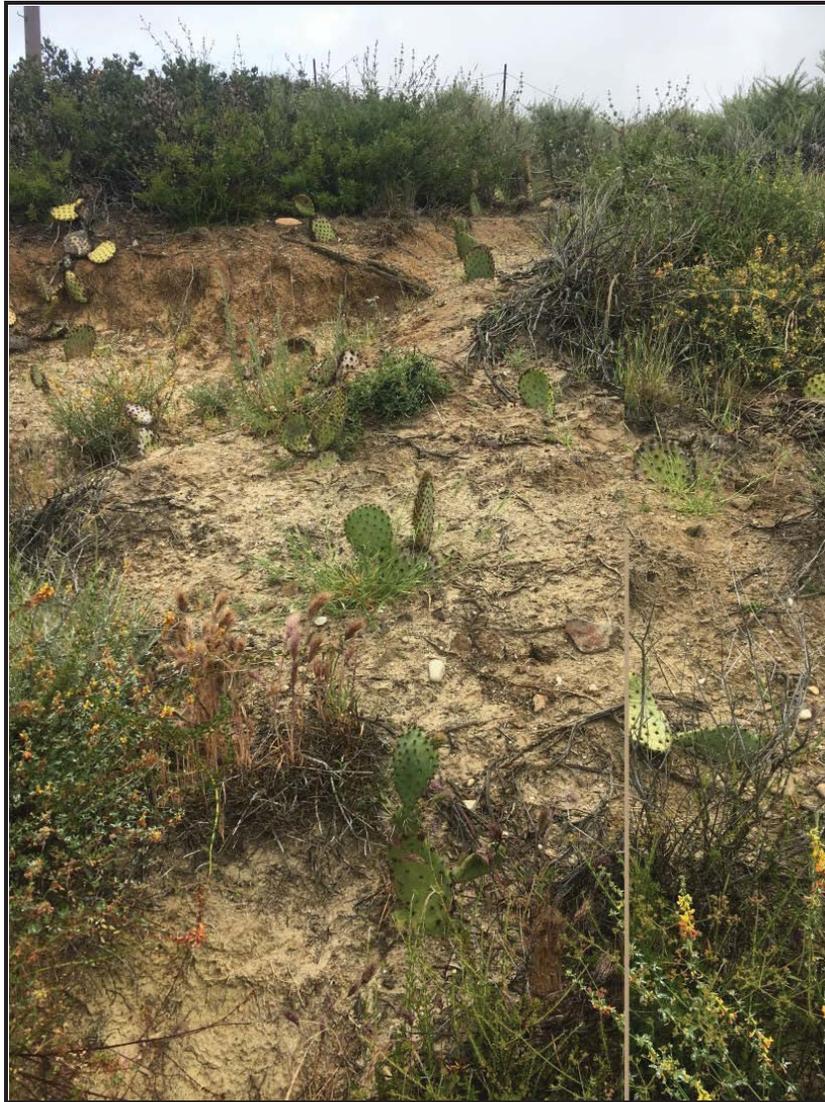
Work associated with the removal of the bike jumps consisted of using non-mechanized hand tools to remove all soil piles. The disturbed areas were recontoured to match the surrounding areas; all soil was balanced on-site. In previously disturbed areas, prickly pear cactus pads (*Opuntia* spp.) were collected from surrounding areas and installed within the unauthorized bike trails to prevent future off-road use. Only a small percentage of cuttings were salvaged from numerous plants in the vicinity, so as to not negatively impact any prickly pear cactus patches. During the April 2019 site visit, it was observed that these plantings are doing well and no additional disturbances have been made in areas where trails were closed (Photograph 26).

PHOTOGRAPH 26  
Pacific Horizon Preserve, Cactus Plantings on  
Closed Trail, April 2019

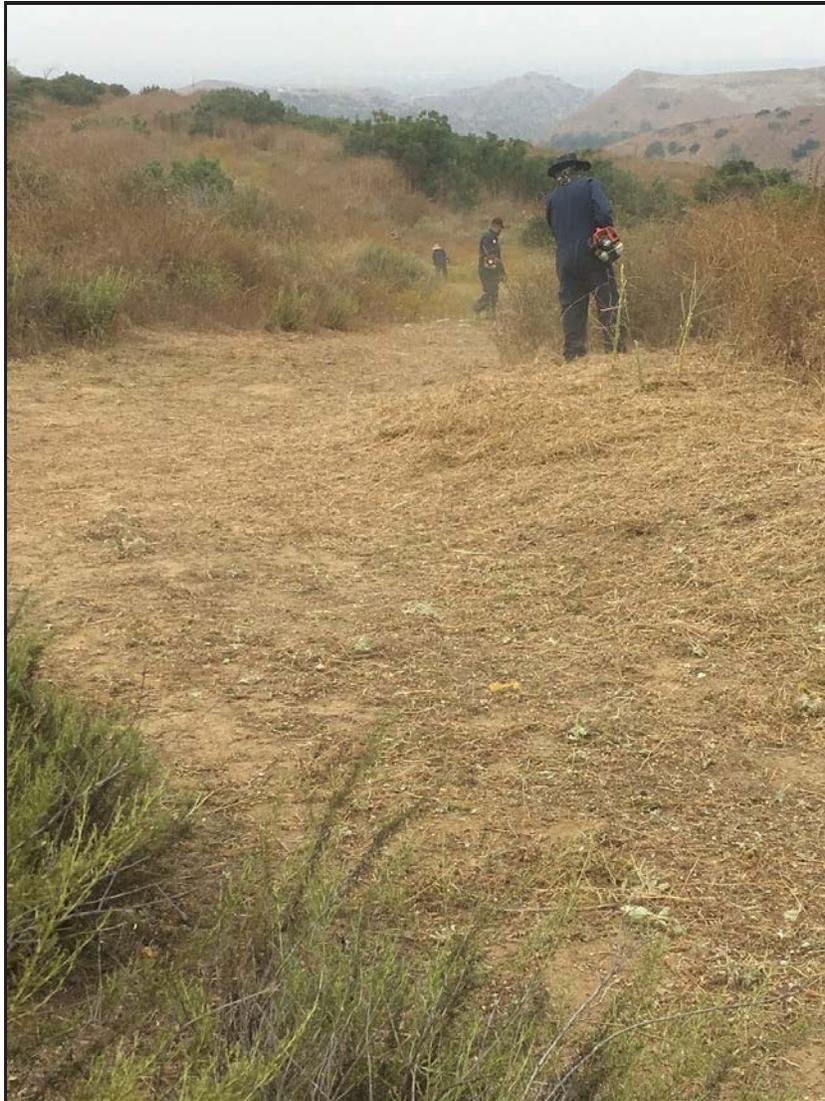
For the Eagle Ridge Preserve (Figure 7), maintenance tasks included vegetation removal along the primary fire road that traverses through the property (Photograph 27). It is unknown when the last time this road was maintained, making it inefficient for line trimmers or hand tools to remove the vegetation. Therefore, a skid steer with a mower attachment was used to cut down vegetation on about half of the road. For fire prevention, a water truck was also stationed on-site during all days the skid steer was on-site. A summary of the work completed at Eagle Ridge has been included in Table 7.

PHOTOGRAPH 27  
Vegetation Removal on Ridge Road/  
Fire Road at Eagle Ridge Preserve

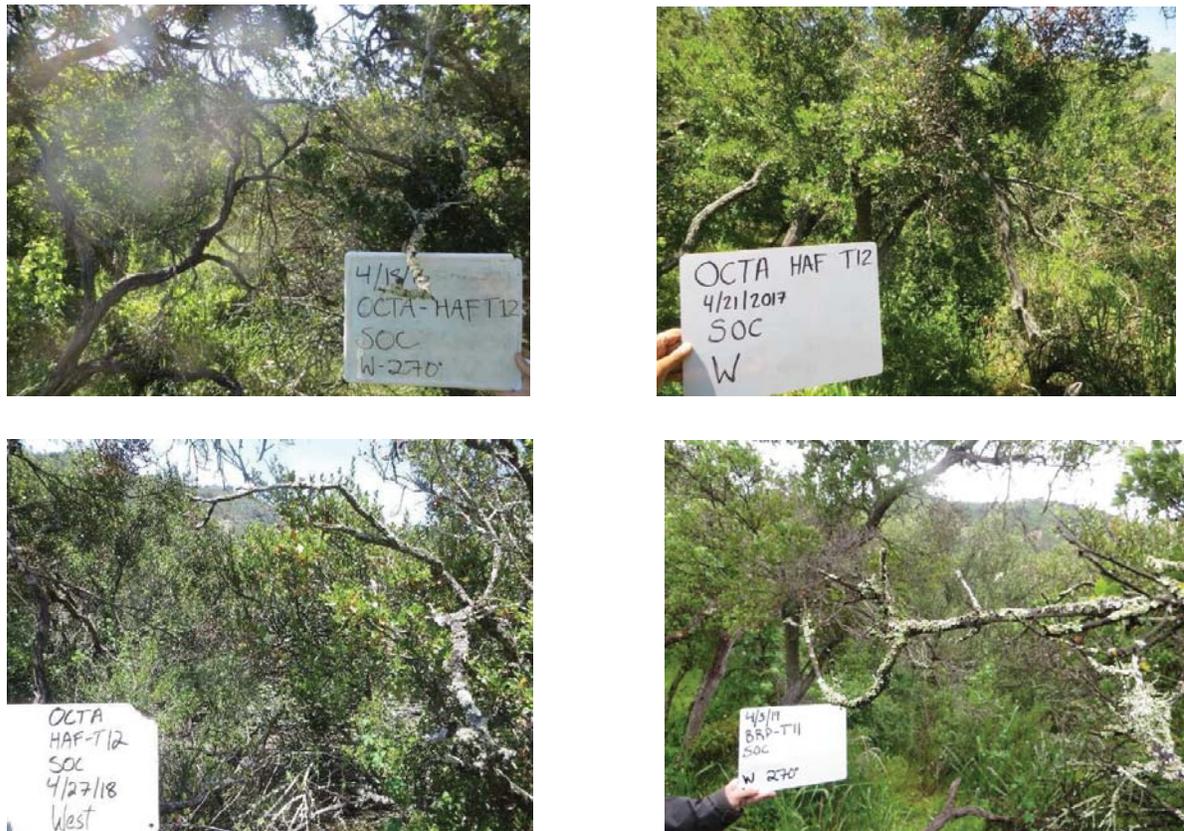
In the 30.6 acres of scrub oak chaparral on the 47.9 acre Bobcat Ridge preserve, the dominant canopy species continued to be *Quercus berberidifolia* (Figs. 3 - 4). Only one species of non-native grass (*Bromus diandrus*) was observed in lower cover classes (< 40%). The diversity of shrubs and understory herbaceous species was back up to 2017 levels, presumably related to the higher than average rainfall of both seasons (2016-17 precipitation was 17 inches, 432 mm at Starr Ranch). Other native species in 2019 observations and similar to 2016 - 2018 were shrubs typical of pristine chaparral understories: *Rhus integrifolia*, *Mimulus aurantiacus*, *Salvia apiana*, *S. mellifera*, and *Artemisia californica* but not *Eriogonum fasciculatum*. Also present at low cover were the natives *Nolina cismontana*, *Claytonia perfoliata*, *Euchrypta chrysanthemifolia*, and *Marah macrocarpus* paralleling observations in the wetter 2017 spring. Bare ground was at low (<10%) cover, typical of Southern CA chaparral (Fig. 5).

Fig. 4. Photos taken in April 2016-19 of the same transect (T12West) on the Bobcat Ridge preserve. The 2019 photo sign should read BRP – T12W.

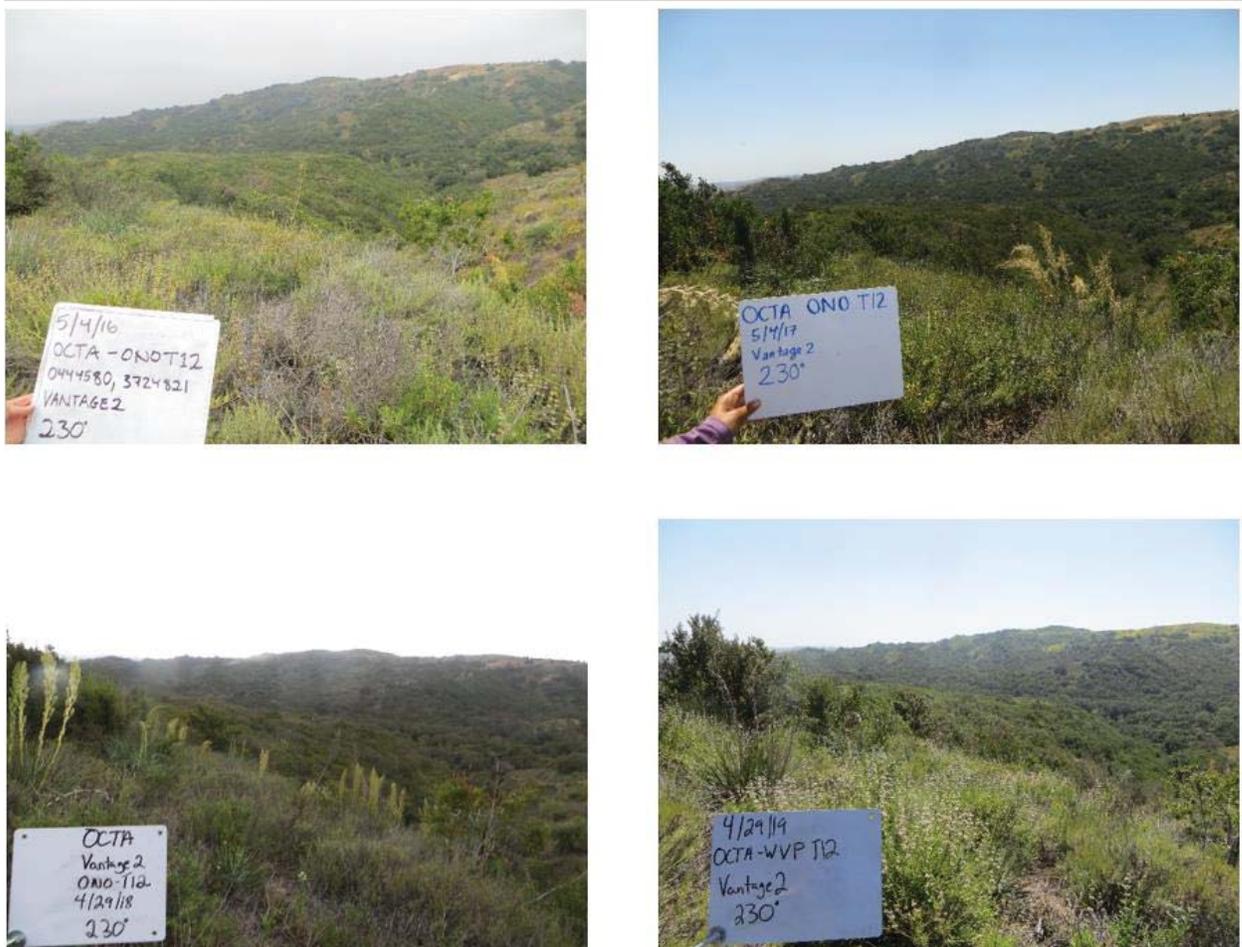
In the 61.5 acres of chaparral on the 119 acre Wren’s View preserve, two non-native annual grass species , *Bromus diandrus* and *B. madritensis* were concentrated in high cover in 2019 in a relatively limited number of transect areas that were adjacent to the (formerly)cattle disturbed oak woodland (Figs. 6,7). As in 2016 - 2018, this area near the cattle disturbed woodland appeared more open and disturbed as evidenced by the relatively high cover of especially *Bromus diandrus* (Fig. 6). More common native species (> 10 – 70%) similar to 2016 and 2017 observations were the evergreen shrubs (*Adenostoma fasciculatum* (not in the 2018 graph since average cover class was close to but less than one), *Quercus berberidifolia*, and *Rhus integrifolia* and drought deciduous shrubs *Artemisia californica* and *Salvia mellifera*. Also present was the native *Nolina cismontane*. Abiotic factors such as low cover of bare ground (Fig. 8) were typical of chaparral (low).

Fig.7. Photos taken in April 2016-19 of scrub oak (*Quercus berberidifolia*) chaparral on the Wren's View preserve in the same transect (T12)

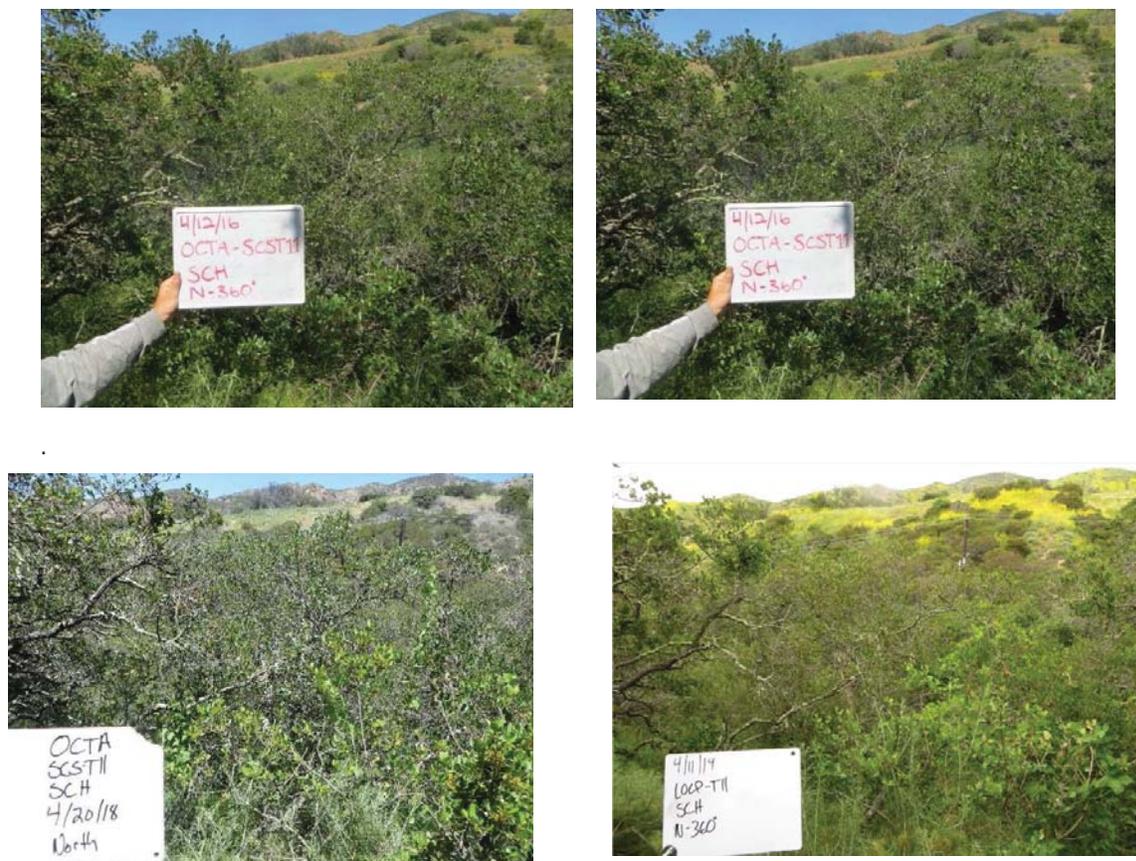
*Quercus berberidifolia* dominated the 36 acres of tall, dense chaparral on 83 acre Live Oak Creek preserve (Figs. 9 -10). *Marah macrocarpus* and *Rhus ingetrifolia* were observed at low cover in the area around most transects. No non-native grasses and forbs were present in the understory but natives (*N. cismontana* and coastal sage scrub (CSS) shrubs *Salvia apiana*, *S. mellifera*, and *Mimulus aurantiacus* were observed at low to moderate (10-40%) cover throughout. Also present in the herbaceous understory were natives *Claytonia perfoliata* (a native forb) and *Marah macrocarpa* (a native vine). Life forms on all three preserves generally reflect species discussed but with single individuals of the non-native shrub, *Nicotiana glauca*, observed in Wren's View and Live Oak Creek (Figs. 11). Bare ground cover, typical of chaparral, was low (Fig. 12).

Fig. 10. Photos taken in April 2016-19 of scrub oak (*Quercus berberidifolia*) chaparral on the Live Oak Creek preserve and in the same transect (T11 North).

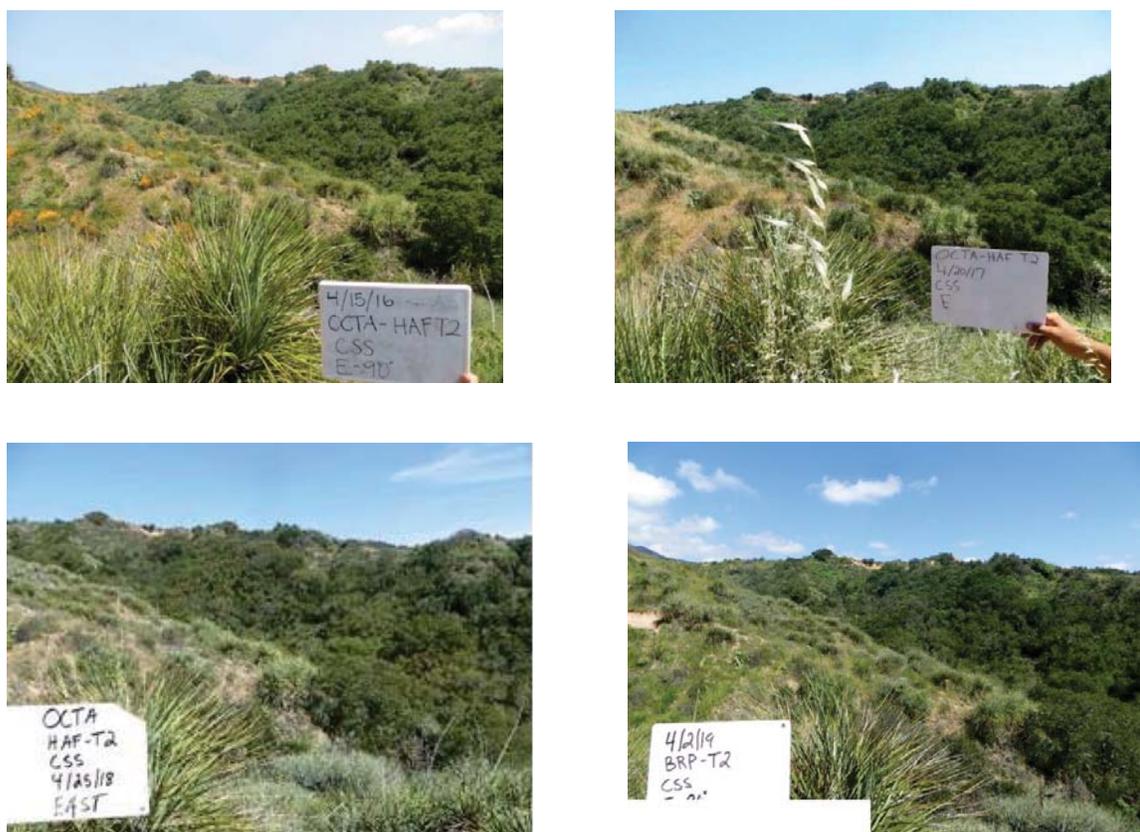
In the 11.6 acres of coastal sage scrub on the 47.9 acre Bobcat Ridge preserve in 2019, although overall the CSS appeared in good condition (Fig. 14), non-native species occurred in relatively higher cover: two non-native grass species in the *Bromus* genus and the forb, *Hirschfeldia incana* (Fig. 13). This was in contrast to much lower annual grass cover in the dry 2018 spring (Fig.13). Commensurately, bare ground was lower in 2019 (1-10%) (Fig. 15) than in the much drier 2018 spring (5-40% range). The native shrub *Nolina cismontana* was commonly observed in all four seasons, 2016-19. Cover of the most abundant species of Southern California coastal sage scrub, *Artemisia californica*, as in previous seasons was widespread as were other native species typical of CSS (shrubs *Salvia mellifera*, *Acmispon glaber*, *Eriogonum fasciculatum* (Figs. 13-14). The wet winter brought higher cover of understory natives such as *Dichelostemma capitatum*, *Caulanthus heterophyllus*, and *Phacelia minor* (Fig. 13).

Fig. 14. Coastal sage scrub on the Bobcat Ridge preserve in 2016-2019 (T2 East).

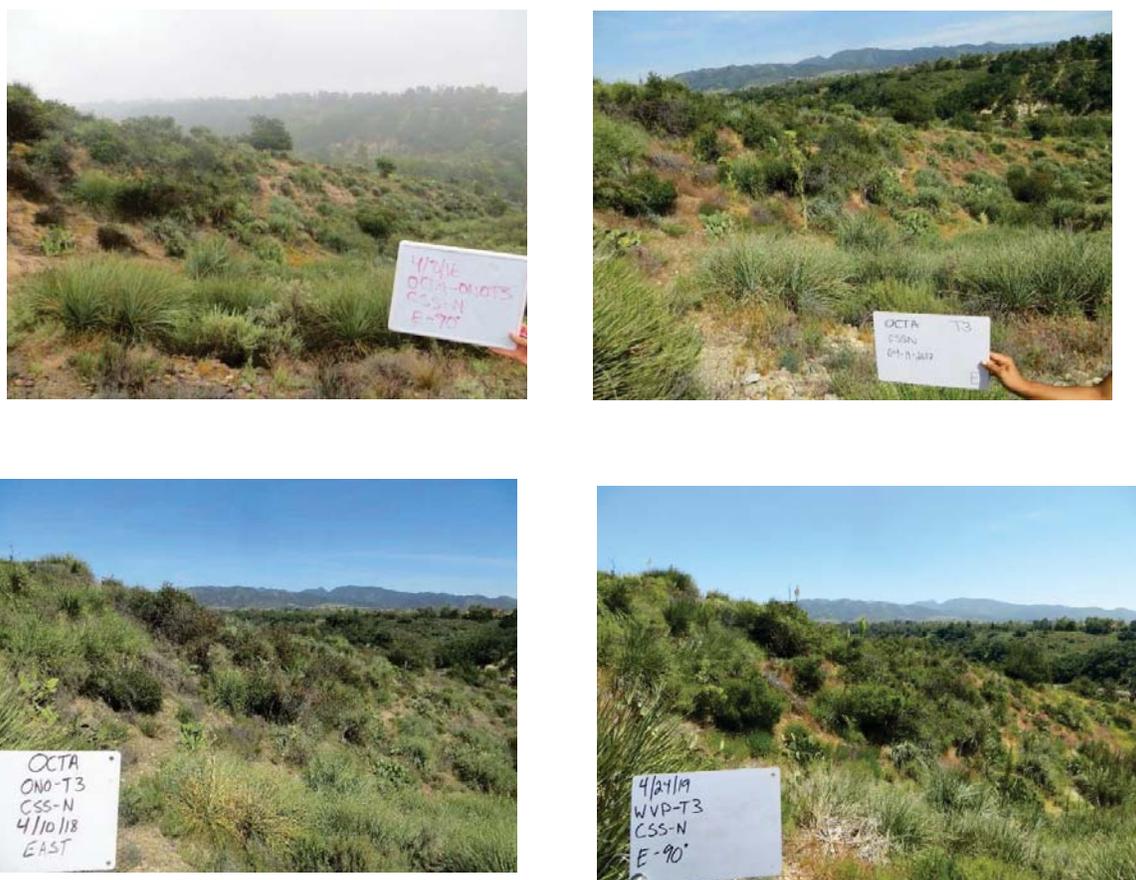
In the 39 acres of coastal sage scrub on the 119 acre Wren’s View preserve non-native cover was relatively higher in 2019 than in the previous year. In 2018, the non-native annual grass *Bromus madritensis* and non-native forb *Hirschfeldia incana* were widespread but observed mostly in lower cover classes; whereas in 2019, cover ranged 1-40%. As observed in 2016 -18, species typical of Southern California coastal sage scrub dominated the canopy in higher cover classes: *Artemisia californica*, *Salvia mellifera*, and *Eriogonum fasciculatum* at mostly > 10%. The sage scrub appears in excellent condition, with only the previously mentioned nonnative annual grass and mustard at relatively higher cover. *Nolina cismontane* and succulent *Opuntia littoralis* were also present and in good condition (note that it is difficult to identify cactus species in Orange County since several native species hybridize in the Southern California region (Mark Dodero, RECON senior biologist personal communication) (Figs. 16-17). Bare ground was at relatively lower cover in 2019 than in the drier previous season, presumably due to non-natives’ response to winter rains (Fig. 18).

Fig. 17. Photo taken in April 2016-19 of coastal sage scrub on the Wren's View preserve (T3 East)

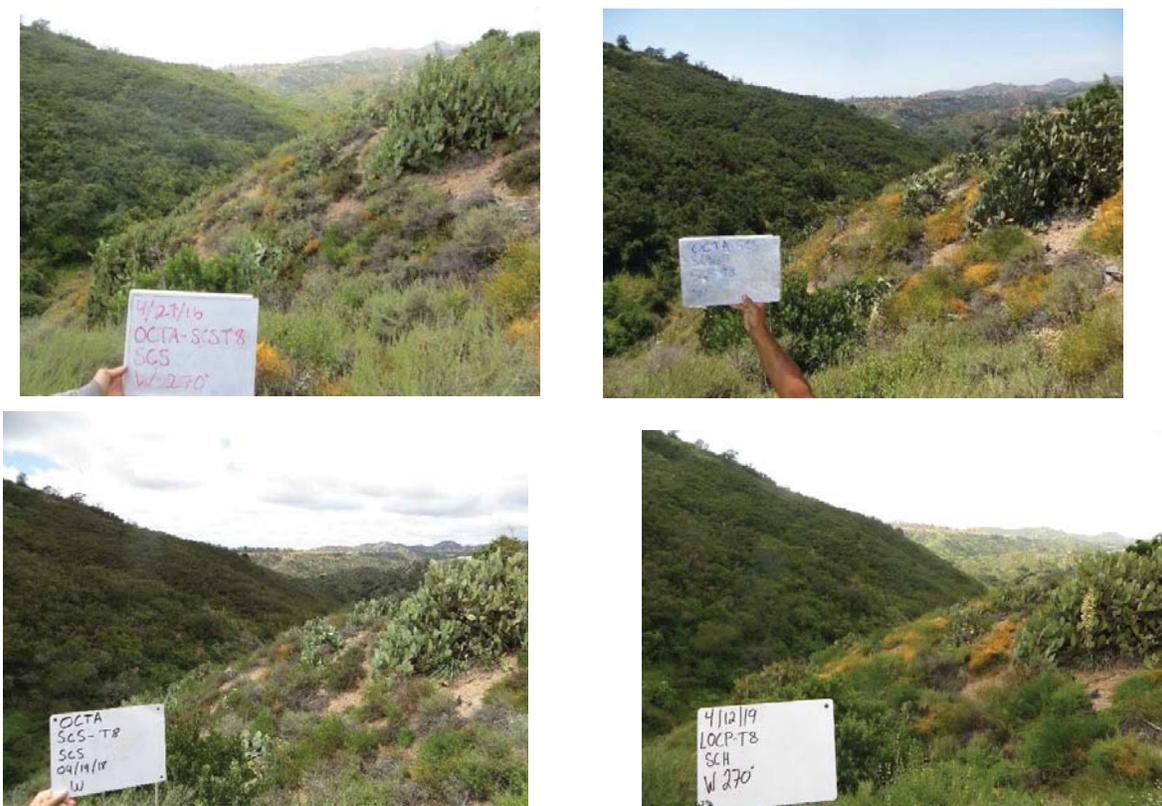
In the approximately 10 acres of coastal sage scrub on 83 acre Live Oak Creek preserve *A. californica* continued to dominate the canopy (present in all transects and in most transects at the highest two cover classes). The crew again observed distinct differences in non-native annual grass cover between the two subtypes of CSS on the preserve. The non-native annual grass *Bromus diandrus* was again, as in 2018, in higher cover classes but almost exclusively in the white sage subtype polygons and not in the singular California sagebrush subtype polygon (Fig. 19, 20). In the CA sagebrush prickly pear subtype, there was very low cover of non-native annual grasses in 2018. Bare ground was at relatively higher cover classes in the drier 2018 spring than in 2019 (Fig. 21). The non-native annual grass *Bromus diandrus* was at similar cover in 2019 as in 2017-18 in the understory in open areas in the white sage subtype shrub canopy. Other subshrubs in 2019 remained stable at lower cover (*E. fasciculatum*, *S. apiana*, and *S. mellifera*). As in previous years, *Opuntia littoralis*, a common native cactus that provides habitat for species such as the San Diego Cactus Wren, was most commonly observed in extensive patches in the California Sagebrush polygon in the north of the preserve (Figs. 19-20).

Fig. 20. Photos taken in April 2016-19 of coastal sage scrub on the Live Oak Creek preserve and in the same transect (T8 West).

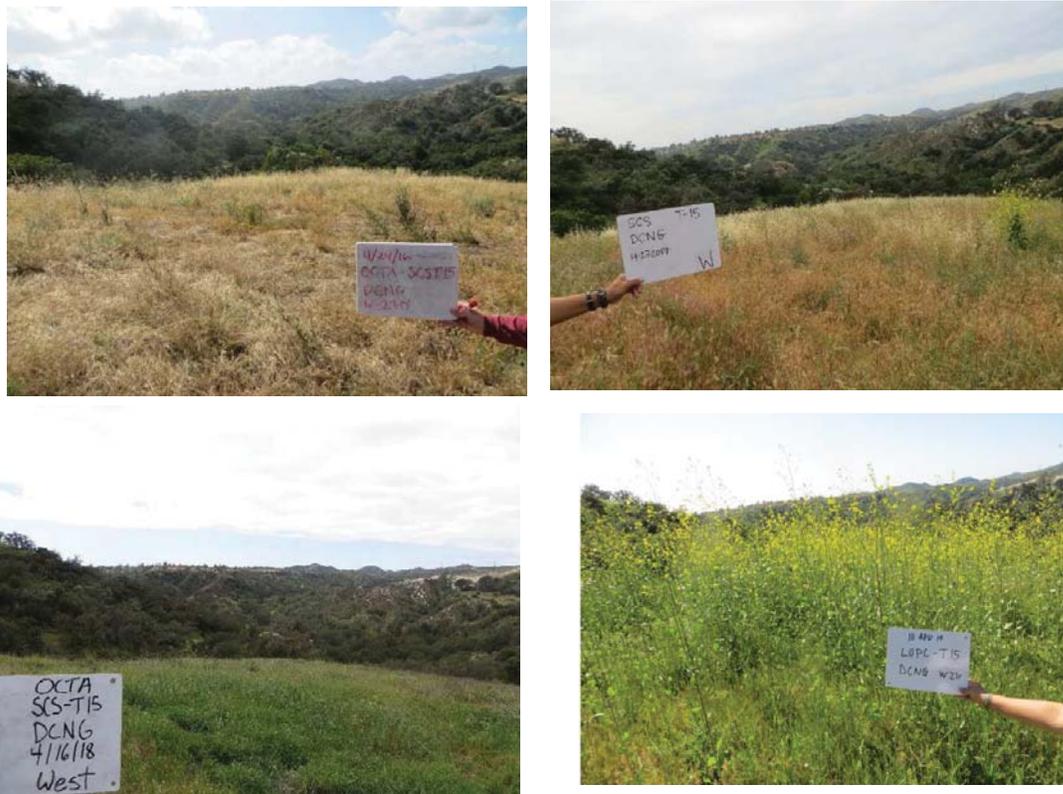
As in 2016 -18, large areas of the 15.3 acres of grasslands on the 83 acre preserve in 2019 were dominated by non-native annual grasses and forbs (Figs. 23-24). The nonnative biomass was so high that, in this qualitative survey, very low cover (< 10%) of the native bunchgrass, *Stipa pulchra*, was observed, even in the small patch identified as a native perennial grassland. Annual grasses dominating in 2016-19 were *B. diandrus*, *B. hordeaceous*, *B. madritensis*, and *A. fatua*. The forb *Brassica nigra*, up to 10 feet tall, dominated the canopy. (Figs. 23, 24). As in previous years, in April 2019 there was low cover of bare ground (Fig. 25).

Fig. 24. Photo taken in April 2016-19 of a native perennial grassland on the Live Oak Creek preserve (T15 West).

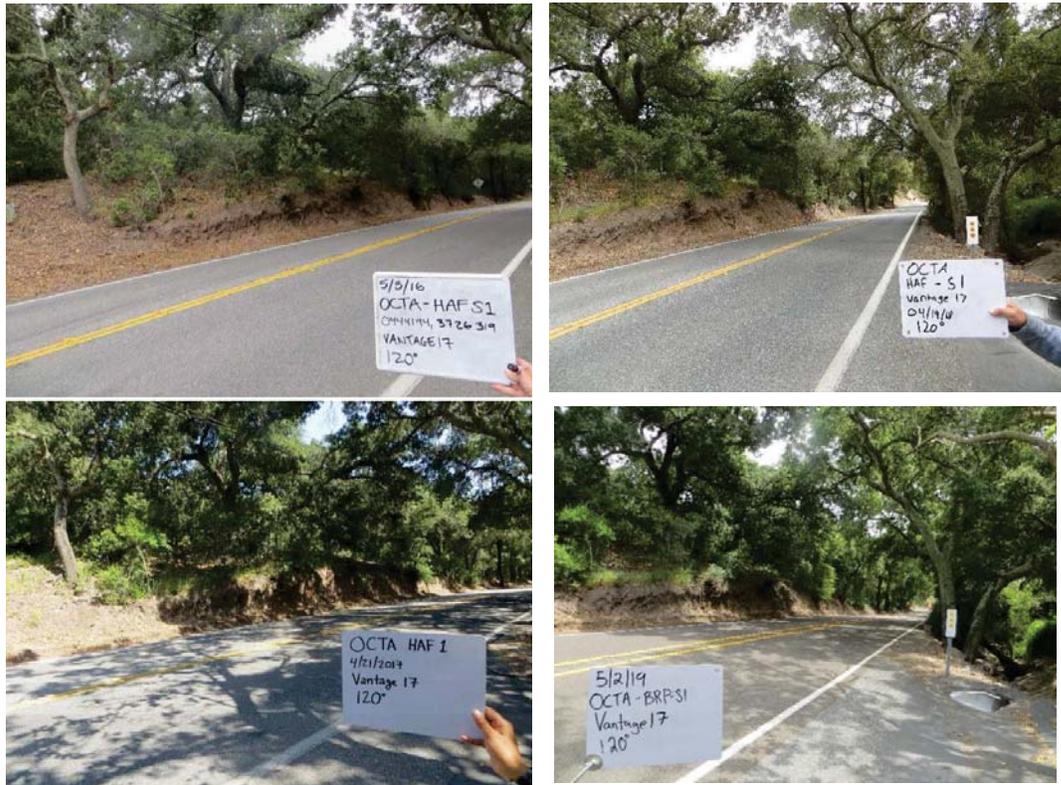
Woodlands at the Bobcat Ridge preserve are not extensive and include one riparian woodland polygon and a coast live oak woodland polygon. With the exception of thinning sycamore canopies, both woodlands otherwise continue to appear intact and healthy (Fig. 26-29). As is often observed in Southern Californian oak woodland understories, there was moderate cover of the non-native annual grass *B. diandrus* and low cover of Italian thistle, *C. pycnocephalus* (Fig. 26). Native evergreen and drought deciduous shrubs were at low to moderate cover in the understory (top Bobcat Ridge figure from 2019 data Fig. 26).

Fig. 28. Vantage point 17 photo of coast live oak woodland from 2017 on Bobcat Ridge preserve (V 17)

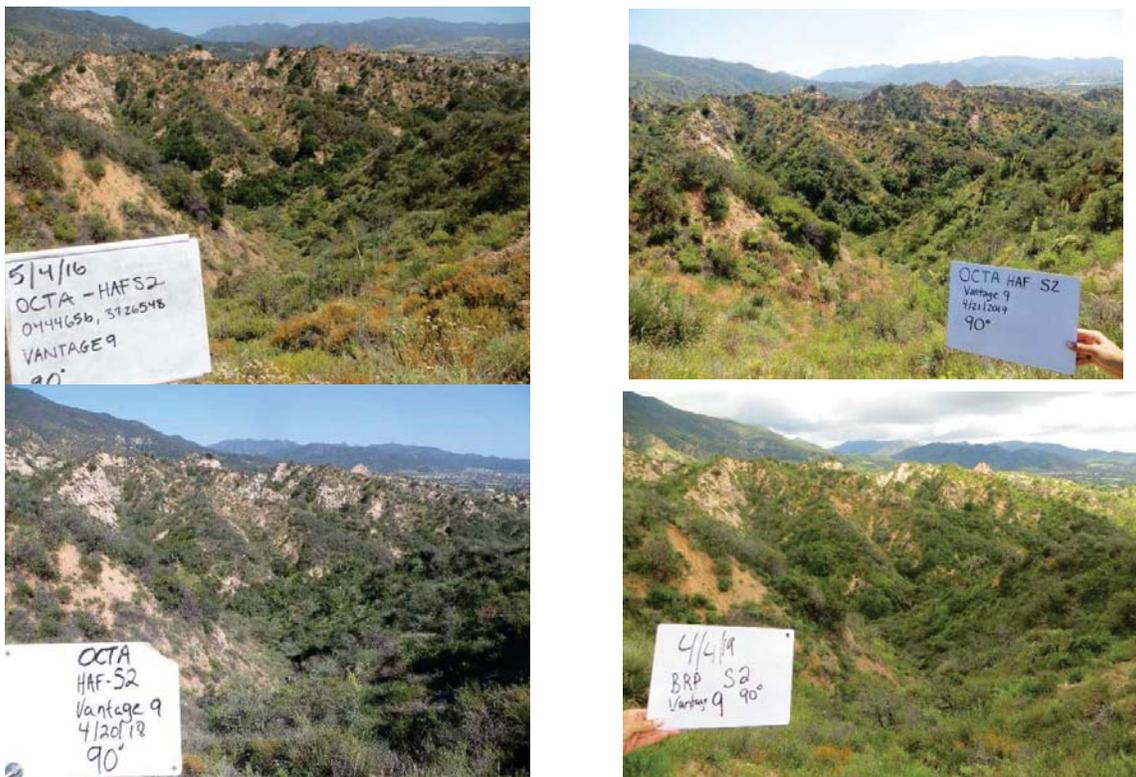
Fig. 29. Vantage point 9 photo of riparian woodland (in the wash at the base of two slopes near the photo center) from 2016 on Bobcat Ridge preserve (V9C).

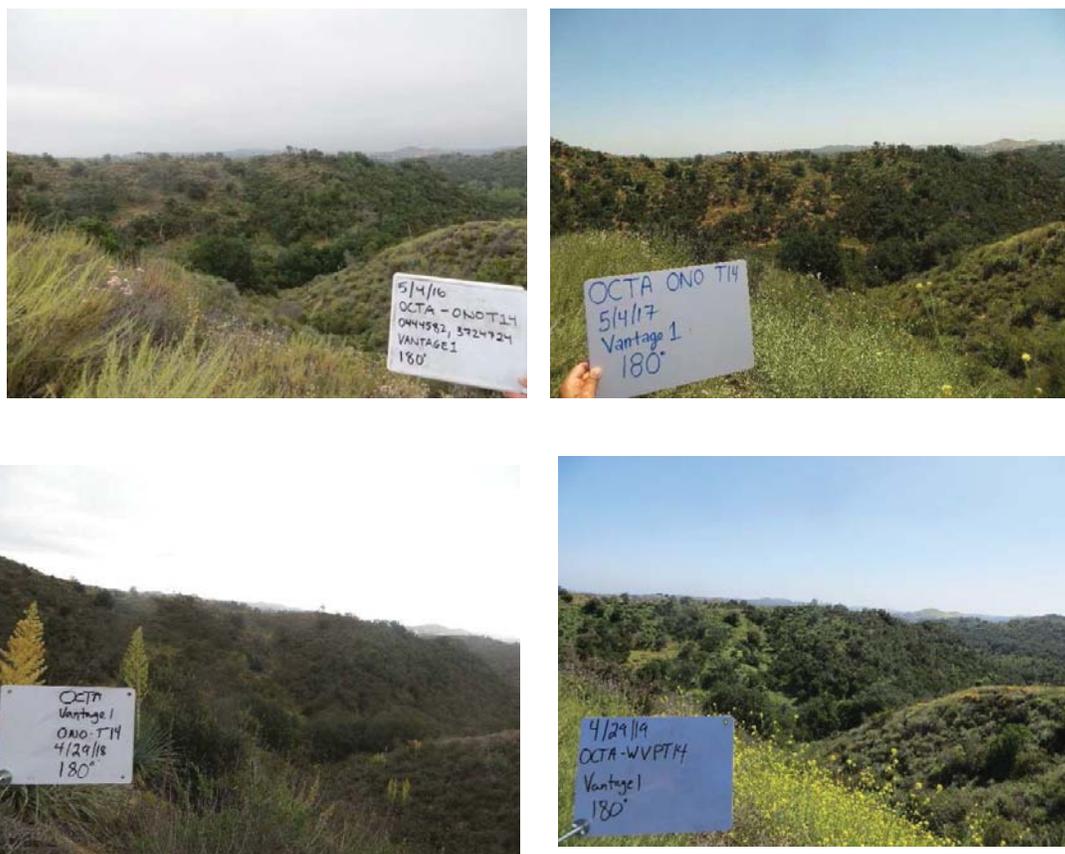
Fig. 32. Vantage point photo of coast live oak woodland in 2016-18 on Wren's View preserve (V1 T14, 180 degrees).

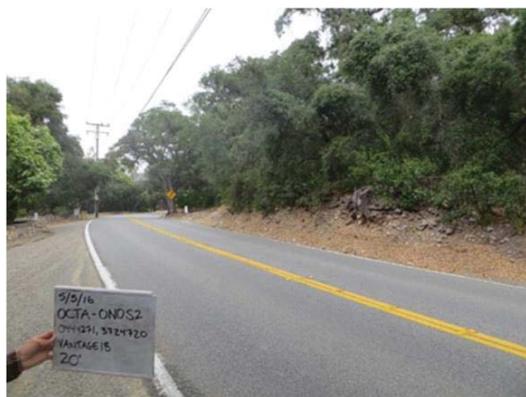
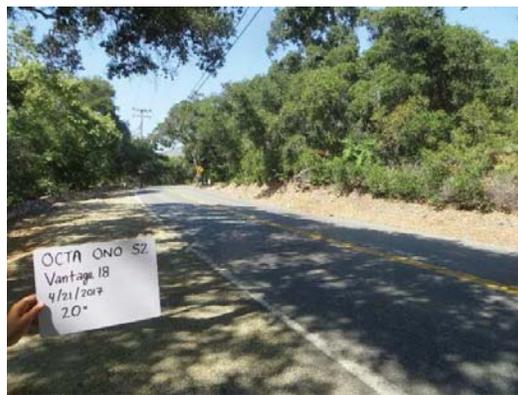
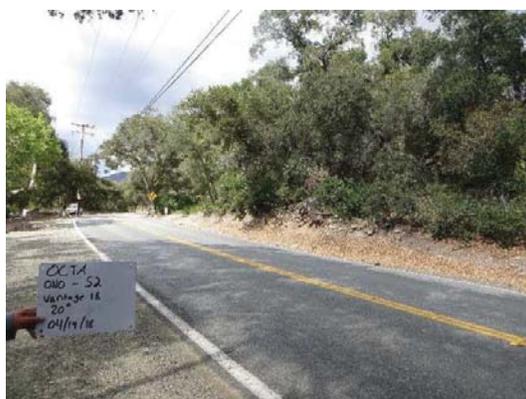
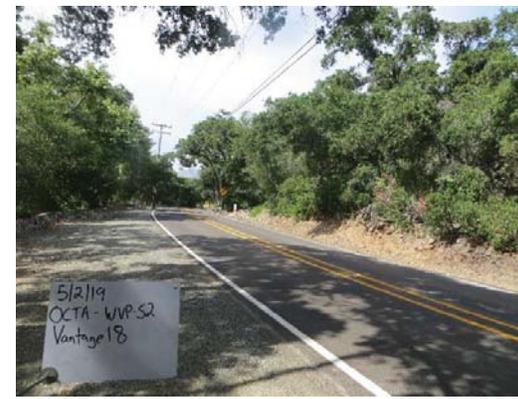
Fig. 33. Vantage point photo 18 taken in 2016-18 of coast live oak woodland on Wren's View preserve (V18, S2, 20 degrees).

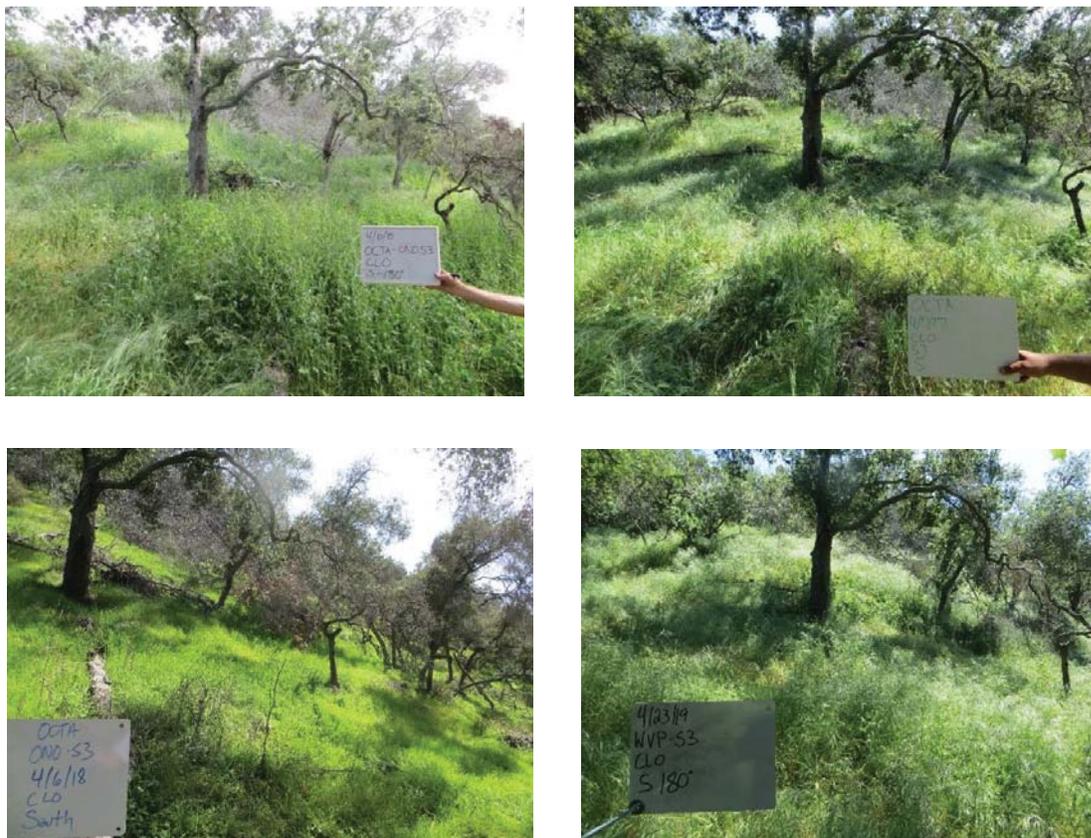
Woodlands cover only about 11% of the Wren's View preserve. In 2016 there were marked differences between the cattle-disturbed woodland at the west edge of the preserve and the other relatively pristine woodland polygons. In the understory in 2016, Wren's View woodlands had the highest numbers of non-native species. Similar trends continue in the woodland understories in 2017 - 2019: non-native annual grasses were observed in the cattle-disturbed (and other) woodlands and overall relatively higher cover (10-40%) of the native evergreen shrub *Q. berberidifolia* than at other preserves (Fig. 30). The woodland canopies appear sparser and the crew observed more dead trees as has been the case in the past only in the cattle-disturbed woodland. (Figs. 31 - 33). In the (formerly) cattle disturbed woodland, oak canopies continue to appear sparse and, additionally, one oak near an OCTA dirt road had signs of tree pest and disease, i.e. staining with exit holes (Figs. 34 - 35). Human disturbance was detected in 2019 only in the woodland adjacent to Live Oak Canyon Road.

Fig. 34. Vantage point photo from 2016-19 (year in top left photo incorrect) of under and overstory of cattle-disturbed coast live oak woodland on Wren's View preserve.

We further reiterate the importance of continued monitoring of woodland health and the removal of olive trees in Live Oak Creek as well as ornamental and other potentially invasive species (e.g. fennel) from the area mapped as oak woodland in the northwest corner of the Live Oak Creek preserve. The abandoned buildings in this area have the potential to become a hazard. Planting of oaks may help to close the canopy and perhaps reduce the non-native cover in the understory of the formerly cattle-disturbed Wren's View woodland.
