# Coastal Rail Resiliency Study

Initial Assessment Technical Memorandum

Cities of Dana Point and San Clemente, CA

Last Updated: February 13, 2024

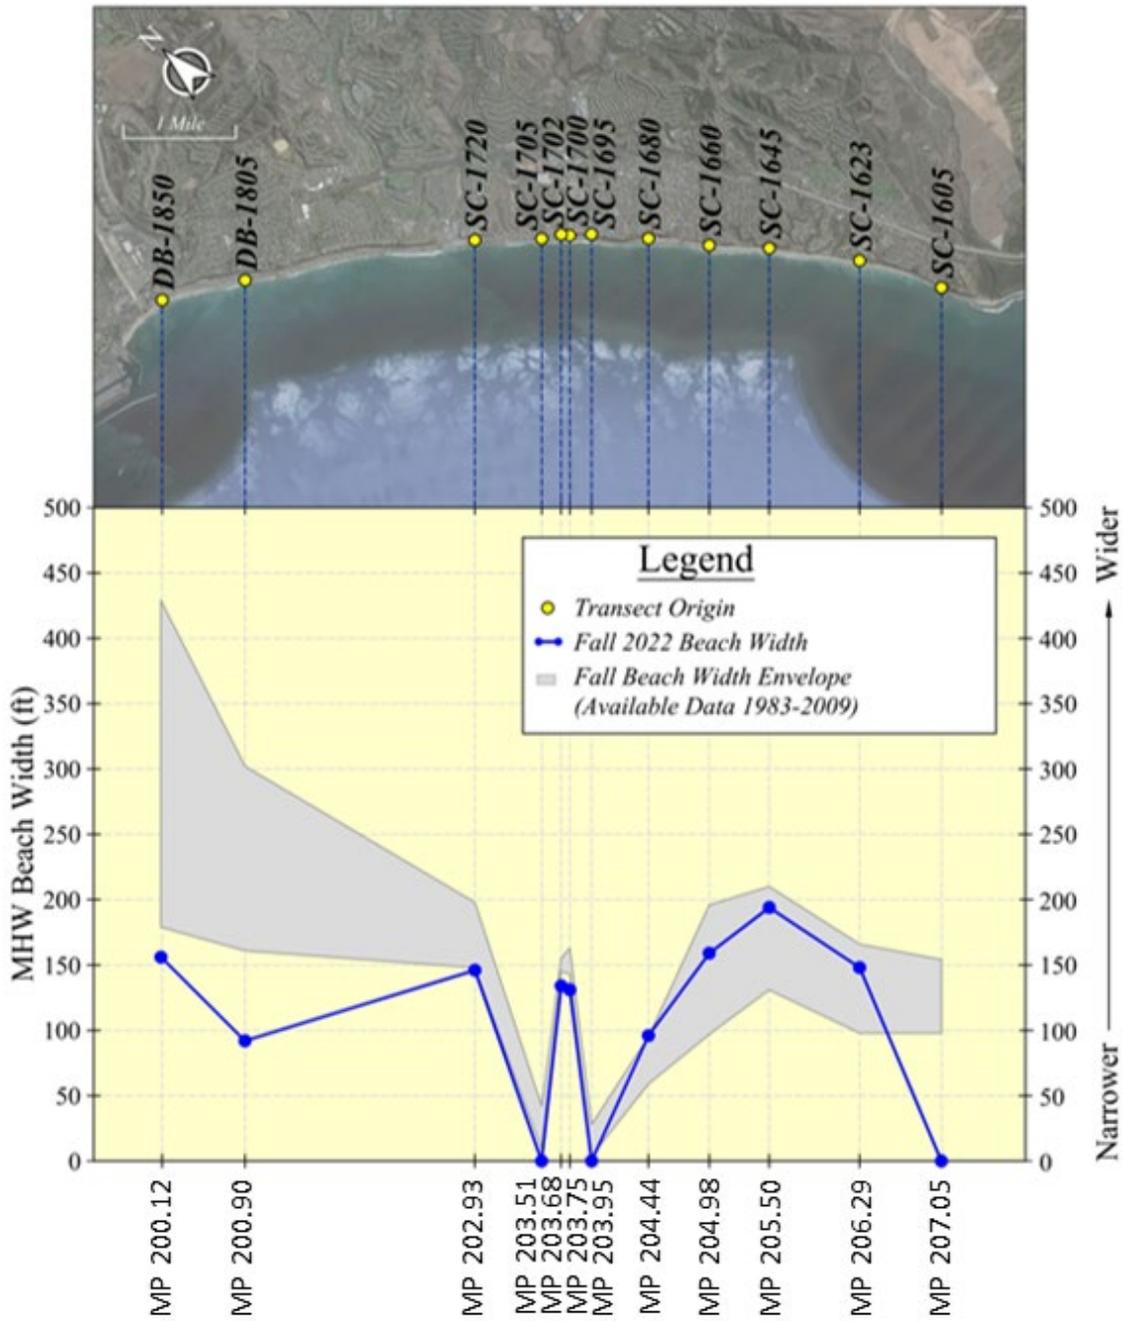
Figure 3 Fall 2022 Beach Widths Relative to Historic Shoreline Position per Survey Comparisons Conducted by Coastal Frontiers

Figure 3 shows the mean high water (MHW) level beach width, which represents the width of the beach from the backshore edge of sand seaward to the MHW elevation. The MHW beach width is generally considered to represent the *dry beach width*. The shaded gray area illustrates the envelope of historical measured beach widths based on available data from 1983–2009. The dark blue line shows the beach width measured in fall 2022, when beach survey monitoring was reinitiated. Between MP 202.00 to 203.00, the beach monitoring results show the fall 2022 beach width to be at or below historic minimums, and up to 50 feet narrower than the historical range; however, dry beach width remains in this area and the rail is set back from the shore. Between MP 203.00 to 204.00, most of the beach remains at or near historic minimum width, with no dry beach through much of this area. A more dramatic reduction in dry beach width is demonstrated in the vicinity of Cyprus Shore (MP 207.05) where, in fall 2022, there was no dry beach measured. Survey measurements prior to 2009 (range shown in gray) near Cyprus Shore indicate a beach not narrower than 100 feet. These measurements are consistent with the onset of coastal erosion and related flooding and damage within the Rail Corridor that warranted emergency remedial shore protection and stabilization construction at that location.

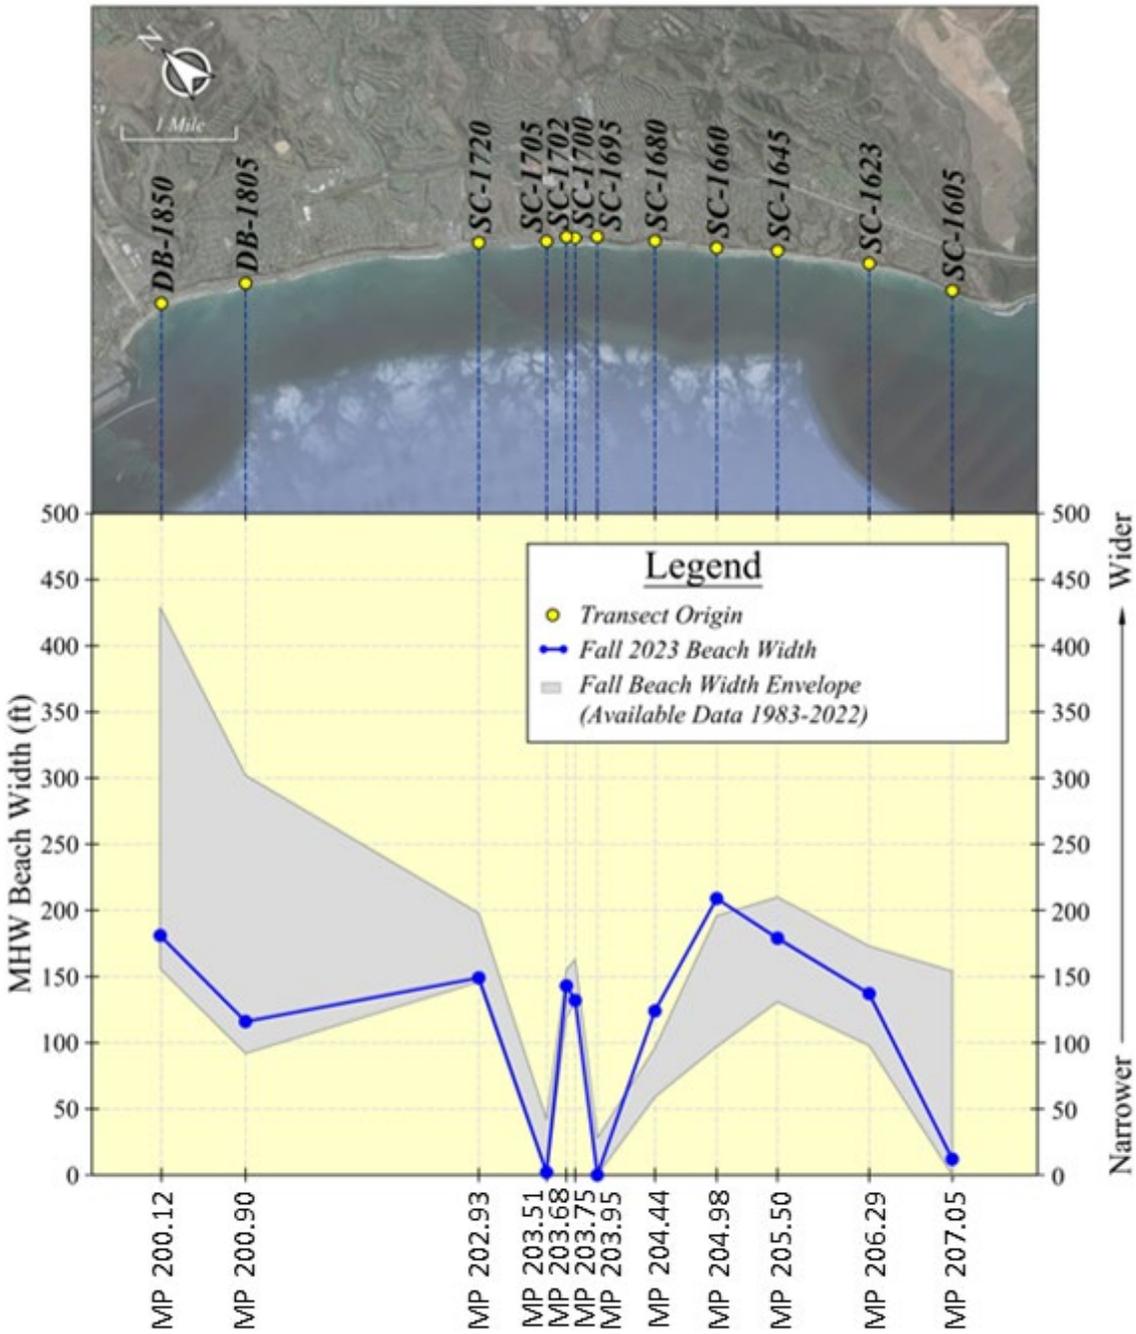
Figure 4 Fall 2023 Beach Widths Relative to Historic Shoreline Position per Survey Comparisons Conducted by Coastal Frontiers

Figure 4 includes the fall 2023 beach width and illustrates relatively little change compared to the fall 2022 shoreline position.

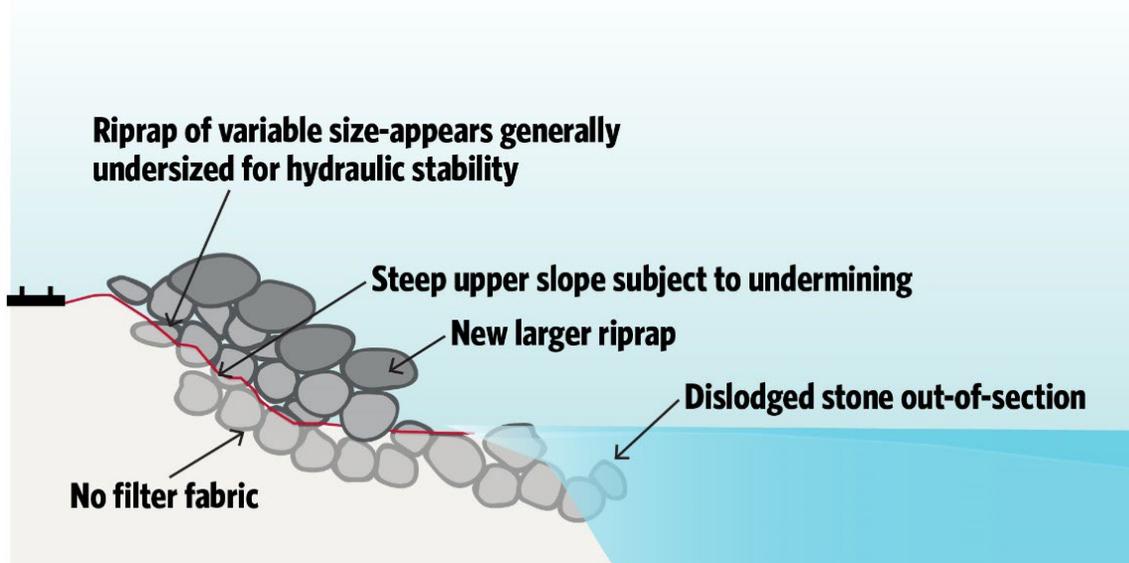
Figure 13. Potential Temporary Reinforcement Solution for Sites 1 and 2 where existing riprap exists

- Metrolink personnel identified an area of recent shoreline erosion and subsequent riprap installation near MP 203.85.
  - The riprap slope, historically stacked from railcars along this reach, has face profiles exceeding ratios of 1:1 (horiz:vert) (see Figure 8 and Figure 12, below).

Place new rock and/or rework existing rock that has fallen out of section to restore the structure slope and crest elevation, thereby providing beach erosion protection and reduction in wave overtopping. Where possible, place new, larger rock and/or rework existing rock in a way that reduces the slope, thereby improving the stability of the rocks. See Figure 12 and Figure 13.

overtopping. Where possible, place new, larger rock and/or rework existing rock in a way that reduces the slope, thereby improving the stability of the rocks. See Figure 13.

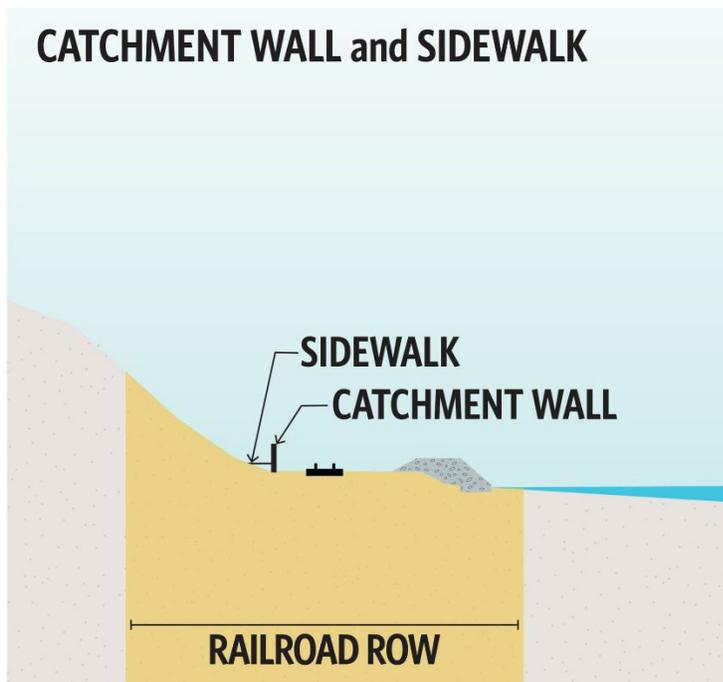
Figure 16. Potential Solution for Reinforcement Site 3

Figure 15. Potential Reinforcement Site 3: MP 204.00 to 204.50, steep bluffs, potential to impact tracks, poor track-side drainage with potential for liquefaction – January 21, 2024

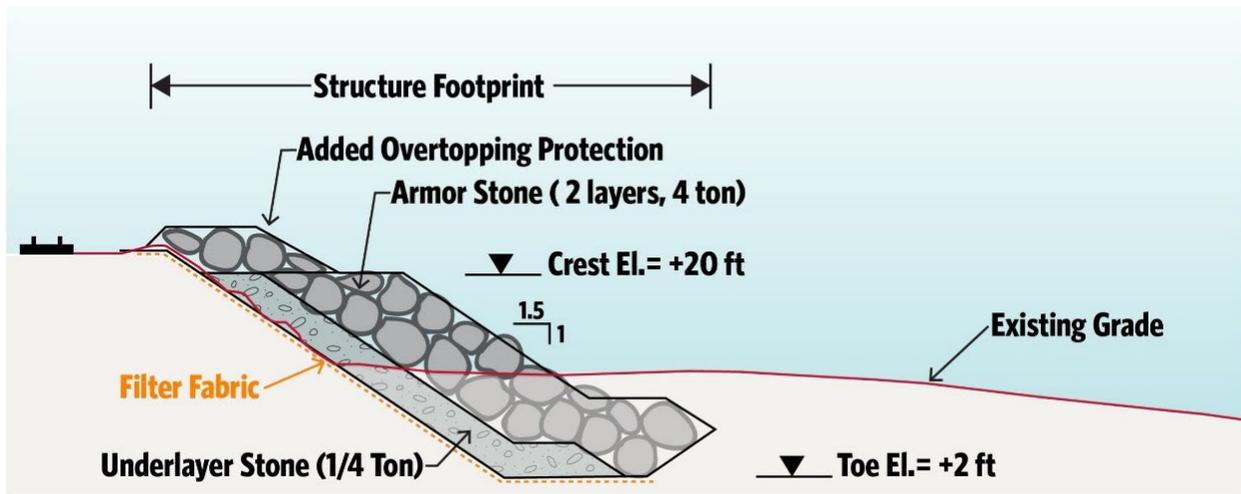
Figure 18. Potential Solution for Reinforcement Site 4 with Engineered Revetment Section

Loss of riprap exposes unstable deposits of beach sand, slide debris, and/or fill deposits beneath ROW, subject to rapid retreat as erosion and toppling during future storms.

Installation of an engineered revetment with filter fabric to minimize piping (movement of fine-grained sediment through voids in the rocks) and a layered-stone placement design with keyway founded in bedrock or to a toe elevation of +2 ft or lower is recommended. Dual purpose of revetment is to arrest continued landward retreat of soils into Rail Corridor. See Figure 17 and Figure 18.
